BUSHIPS

MAY

THIS ISSUE
CROSS MODULATION INTERFERENCE

1951

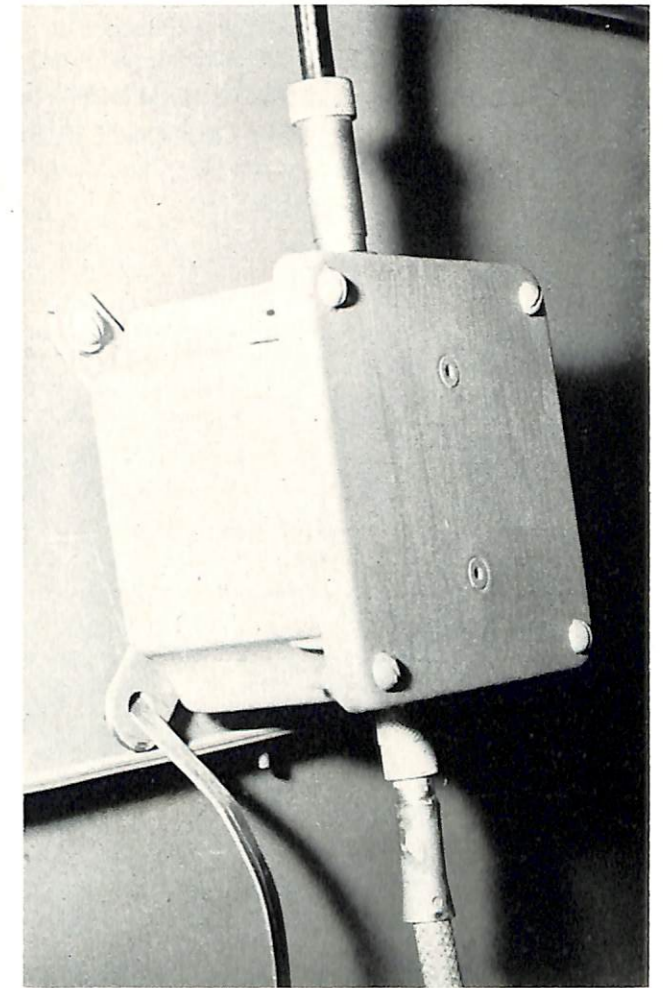
View of the low-pass filter designed to eliminate broadcast station interference on 500 k.c. at the Navy Radio Station, Belle Chasse, La.

that the problem could best be solved by removing the strong 1060-kc signal from the receiver with a suitably designed low-pass filter. Accordingly, an m-derived filter having a cut-off frequency of 850 kc and theoretically infinite attenuation at 1060 kc was designed. The circuit of this filter together with the measured attenuation curve is plotted on Figure 2. This curve was plotted with a Model LP signal generator having a 50-ohm internal impedance and an AN/PRM-1 field intensity meter which was calibrated directly in db.

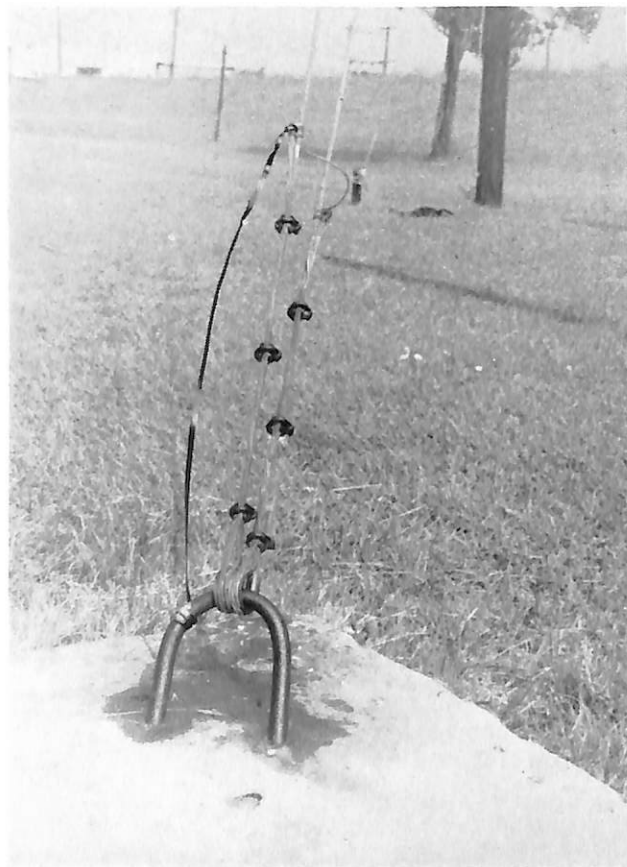
Bonding of antenna stays to eliminate points of rectification near receiving building at NCS Algiers, Louisiana.

"5—Detection was found to be taking place at many of the corroded joints between sections of the guy wires supporting the antenna masts. When the joints were shorted across, the interfering signal in the immediate area was eliminated.

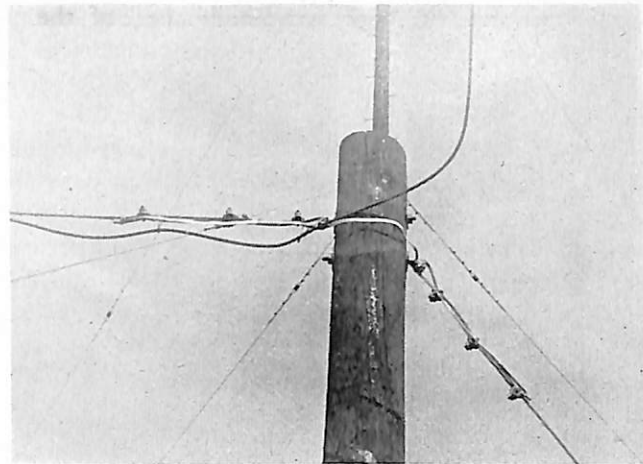
Bonding of points of rectification along the receiving antenna stays at NCS Algiers, Louisiana.

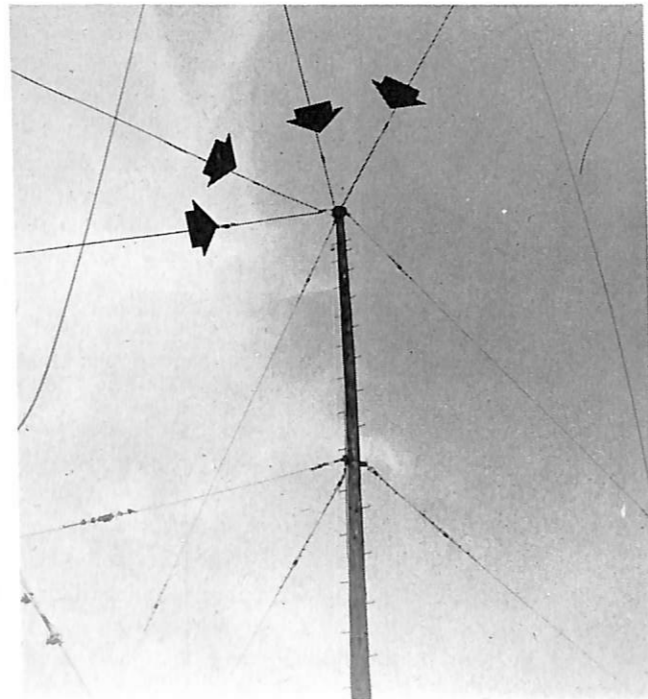
Arrows point to some of the numerous points of rectification along the receiving antenna system of the Naval Communication Station, Algiers, Louisiana.

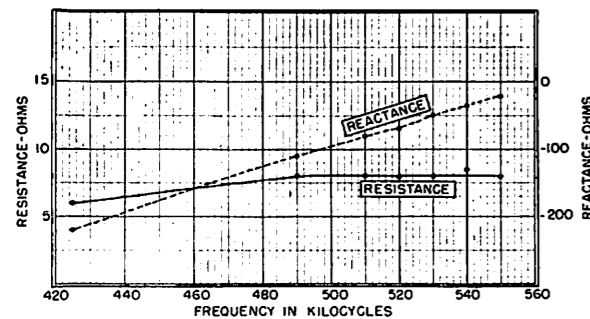
The receiving antenna consisted of an inverted "L" approximately 500 feet long with a vertical height of about 90 feet. The measured resistance and reactance of this antenna are plotted in Figure 1. The fact that the antenna resistance varies little with the frequency indicated that most of the resistance is due to losses which in turn are probably caused by an inadequate ground system. This antenna is to be used at two frequencies: 500 kc and 425 kc. In order to effect a partial impedance match, a coil was constructed with a reactance of approximately 150 ohms at 500 kc. This was placed in series with the antenna lead. In addition to increasing the efficiency at the operating frequencies by cancelling a portion of the capacitive reactance, this coil also provided some discrimination against stations in the broadcast band, inasmuch as the antenna is inductive at these frequencies and the coil increases the overall series impedance of the circuit.

FIGURE 1—Impedance of low frequency antenna, Belle Chasse, Louisiana.

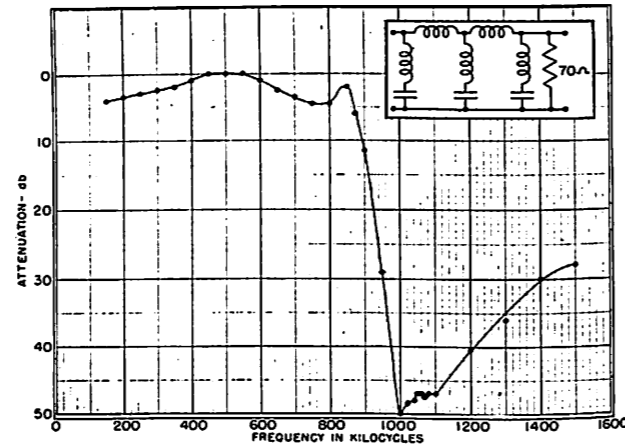
It was the opinion of this engineering firm that internal rather than external cross modulation was the major cause of the difficulty. It was determined therefore,

FIGURE 2—Low-pass filter circuit and attenuation curve.

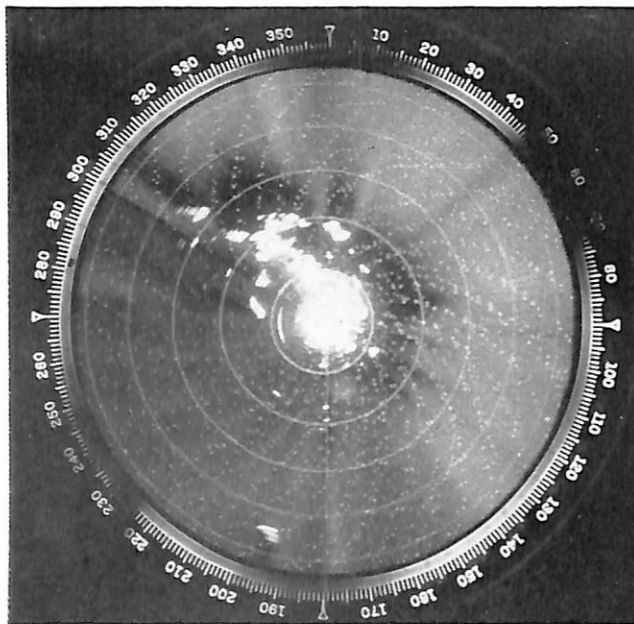
A ghost echo was detected at a range of approximately 80 miles, bearing 214°, see Figure 1. This echo will be referred to as "Ghost 80". Another ghost echo of semi-circular character was observed at 42 miles between the bearings of 244° and 285°, see Figure 1. This echo will be referred to as "Ghost 42". The permanent landscape and island targets may all be readily identified by comparison of the PPI presentation with

FIGURE 1—L-Band P.P.I. presentation showing a ghost echo at a range and bearing of 80 miles and 214°. Another echo of semi-circular character is shown between the bearings 244° and 285° at 42 miles range.

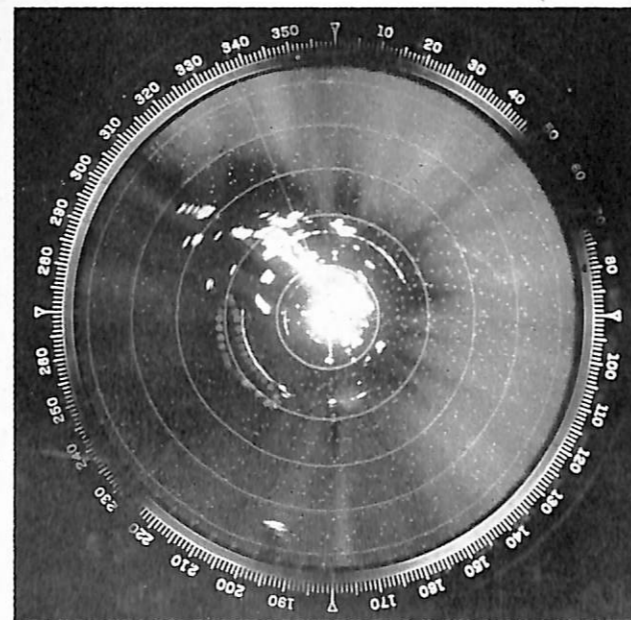
The semi-circular character of the ghost echoes is immediately suggestive of antenna side lobe radiation. If, indeed, Ghost 80 and Ghost 42 were caused by side lobe radiation, it would seem that spurious echoes should be observed from several of the more prominent island targets, as for example from Santa Catalina (range 63 miles, bearing 305°) and San Clemente (range 55 miles, bearing 278°). However, no spurious echoes were observed at the ranges of 63 miles or 55 miles and off-bearing with respect to these islands. It may be seen from the photographs that prominent landscape echoes are prevalent at a range of approximately 80 miles and a bearing of 320°. An exploratory investigation with an A-scope revealed that an extremely strong echo did in fact come from a bearing of 320° and range 83 miles.

FIGURE 3—L-Band P.P.I. presentation 9 minutes after that shown in Figure 1, showing a semi-circular ghost echo at 80 miles range between the bearings of 210° and 275°, between 340° and 65°, and between 155° and 165°. The semi-circular ghost echo is shown at 42 miles range and between the bearings 245° and 310°.

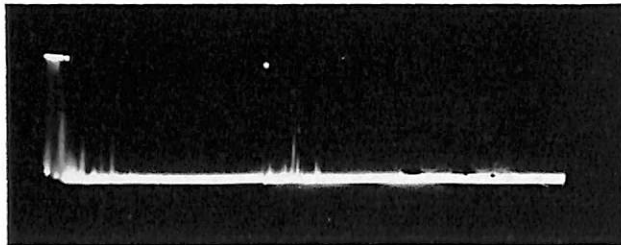
FIGURE 4—An A-scope presentation recorded two minutes after showing the structure of the ghost echo at 83 miles range and bearing 214°.

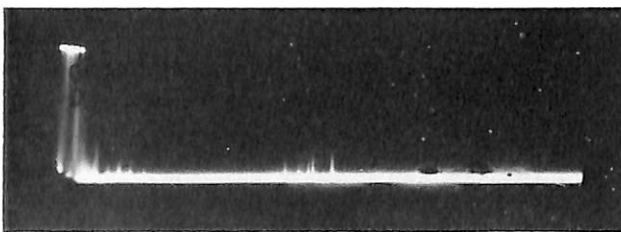
FIGURE 5—An A-scope presentation of the ghost echo at 83 miles range and bearing 214°. This echo structure is strikingly similar to that received on the main lobe from the terminal island—Long Beach area (range 83 miles, bearing 320°).
