Section 4
DIRECTION-FINDING EQUIPMENT
D Series

SECTION 4. DIRECTION-FINDING EQUIPMENT

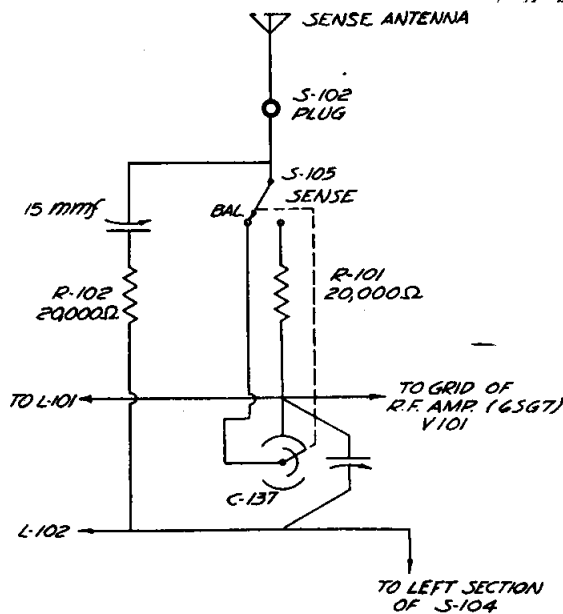
FIGURE 1.—Schematic of circuit.

switch S-105 is opposed by the potential introduced by the 15-mmfd. variable capacitor and the 20,000-ohm resistor, causing these potentials to cancel. This in turn balances the loop circuit. It should be noticed in Figure 1 that R-102 must be of the same value as R-101 in order for the circuit to balance.

The 15-mmfd. variable capacitor and the 20,000-ohm $\frac{1}{2}$ -watt resistor should be mounted on an insulator pedestal as shown in Figure 2 and

should be mounted approximately three inches back of the front panel of the case on the top side of the chassis midway between the balance capacitor and the tuning capacitor as shown in Figure 3. The rotor is connected to the antenna terminal of the sense balance switch and the free end of

the resistor is soldered to the forward side of the forward section of the balance capacitor stator.

In operation, the 15-mmfd. condenser is adjusted to cause the reciprocal bearings to be exactly 180° apart. After this capacitor has been initially adjusted it needs no further adjusting.

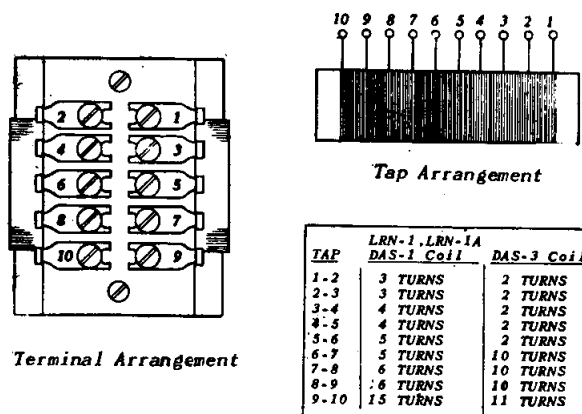
FIGURE 1.—Terminal and tap arrangement of loading coil.

(1) Improper adjustment of the loading coil. In many instances the entire number of coil turns is used (from tap 1 to tap 10), and no attempt has been made to adjust the number of turns (by selecting appropriate taps) for maximum signal strength. The loading coil should be connected so that it is in series with the antenna lead-in and the center conductor of the coaxial cable. The active number of turns is the number between the two taps to which the two flexible leads (one from the antenna, one from the coaxial cable center conductor) connect. The tap arrangement is somewhat peculiar, as shown in figure 1, and should be carefully noted.

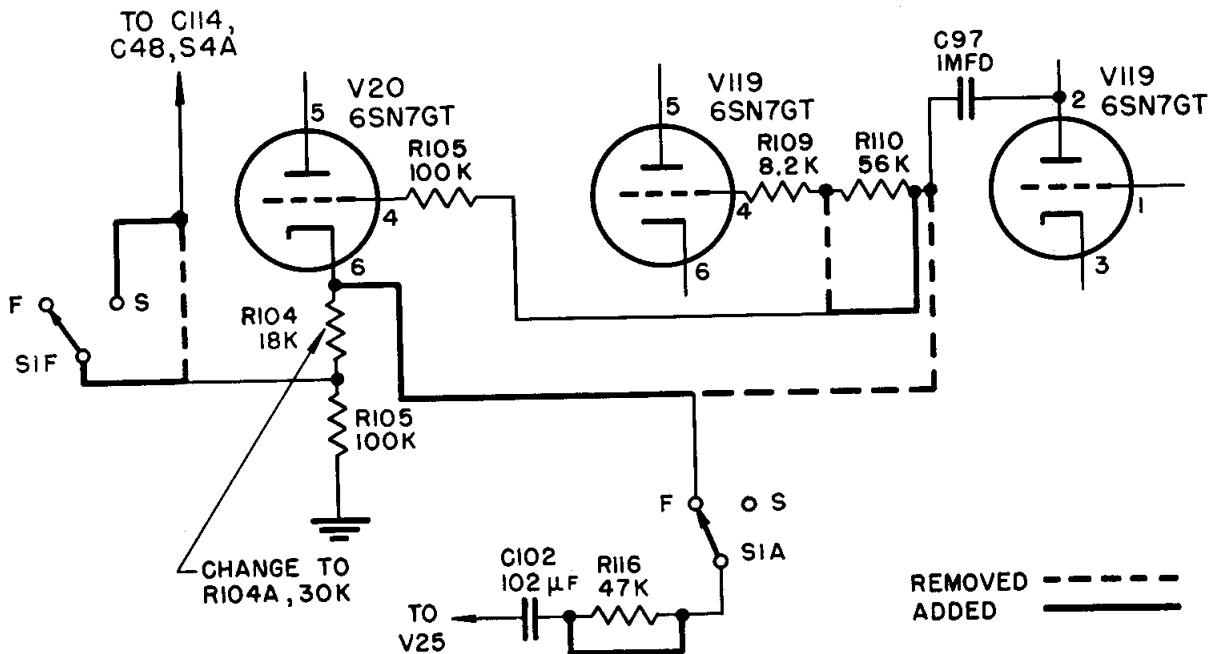
FIGURE 1.—Schematic for field change No. 4 for LRN-1 A.

The fundamental difficulty with the original design when used with tubes having excessive grid leakage is that the intensifier voltage which would normally be maintained below cut-off except during the operation of the pedestal generator, leaks up into the conducting range before the fast sweep is triggered and thereby creates the bright spots at the beginning of the traces. The problem, then, is to drive the intensifier down so far during the off period that even with leakages up to 50 microamperes it won't be able to drift up past cut-off before the next positive kick from the pedestal generator.

intensifier driver during the fast sweeps. Extra connections to existing switches are used, one existing resistor (R116) is shorted out, and one new resistor is needed (30K, 1/2-watt) to replace R104.

- (1) Disconnect the wire at the junction of R110 and C97 that runs from the pedestal generator V-19 to switch S1A, and connect it to pin 6 of V-20, the cathode follower.
- (2) Disconnect the wire at the junction of R109 and R110 which runs through R105 to pin 4 of V-20, and connect it to the junction of R110 and C97.
- (3) Short circuit R116.
- (4) Replace R104 with a 30K 1/2-watt resistor, R104A.
- (5) From the junction of R103 and R104A connect to an unused section of S1 (the slow-fast sweep switch) in such a way that the circuit will be closed back to C114 in the slow sweep position and open during the fast sweeps.

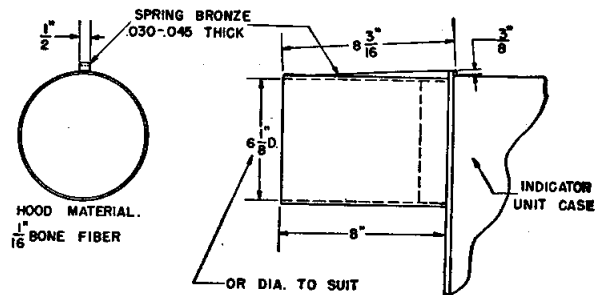
FIGURE 1.—Removable Hood . . .

The removal of outside glare from the scope of the Model DAS series equipment may be accomplished by the use of a removable extension hood. It can be mounted while a reading is being taken and then removed. Such a hood should be used only on equipments where the present hood does not provide adequate light shielding.

The removable hood is shown in figure 1.
10/1/50.

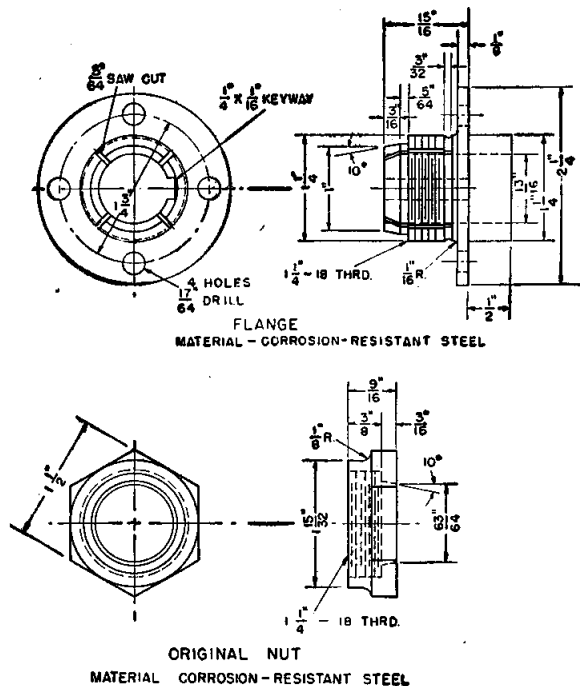
FIGURE 1.

This item replaces an item which described a method of repairing Model DBM and DBM-1 antenna spinner bases which have broken hubs. The method has been found to be unsatisfactory due to the excessive stress placed on the four mounting screws holding the new hub.

An improved type of hub is shown in Figure 1. It differs from the original modification by the addition of the $1\frac{1}{4}$ " collar and a larger flange. It should be machined from corrosion resistant steel. The nut shown is the original

locking nut. The spinner base must be bored to take the $1\frac{1}{4}$ " collar of the hub and then counterbored $\frac{1}{8}$ " for the $2\frac{1}{4}$ " flange. Four matching holes must be drilled in the spinner base and the hub attached by means of four screws, nuts, and lockwashers. Whenever possible, this repair should be effected rather than the replacement of the entire unit. 10/1/50.
