Section 6
COMBINATION TRANSMITTING AND
RECEIVING EQUIPMENT
M Series

SECTION 6. COMBINATION TRANSMITTING AND RECEIVING EQUIPMENT

MODEL MN SERIES TROUBLE SHOOTING NOTES

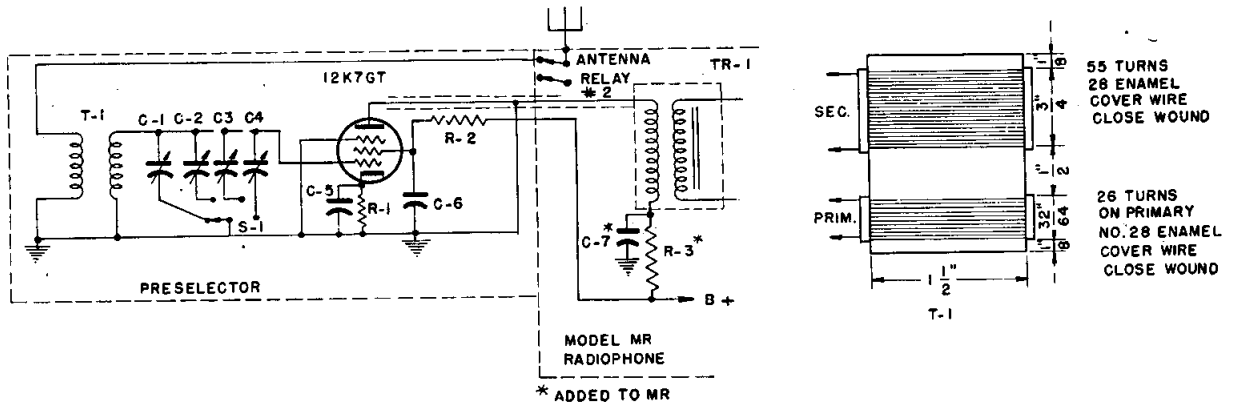
FIGURE 1.—Schematic of preselector for model MR radiophone.

factured by the Gray Radio Company, produces a strong radiated signal and for security reasons should not be used on vessels employed on off-shore missions.

suitable preselector which prevents radiation of the local oscillator. When the preselector is incorporated in the equipment, the model MR may be used aboard ship. Figure 1 is the schematic diagram of the preselector. Figures 2 through 5 inclusive show constructional views of the preselector.

Switch S-1 provides for switching for the four fixed channels. The tuning condensers C-1, C-2, C-3, and C-4 are tuned on switch positions 1, 2, 3, and 4 respectively for any frequency in the range of the equipment. The tuning condensers have been so connected that the tuning of each channel is independent of all others. Adjustment

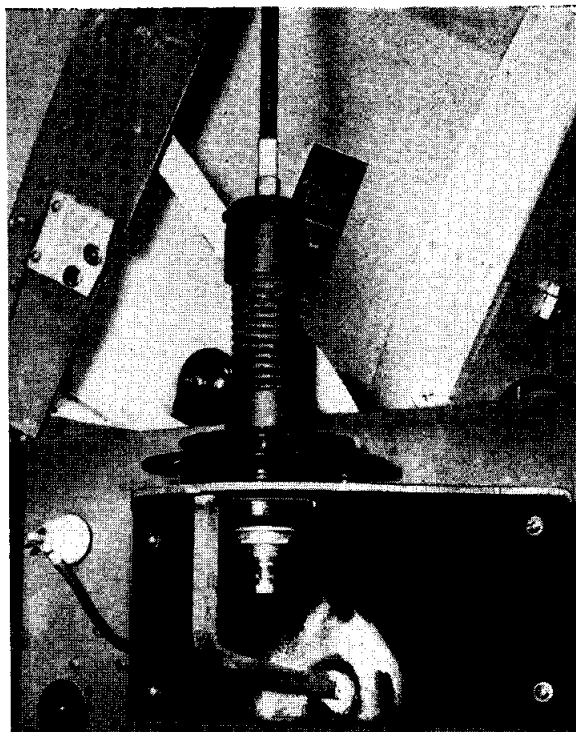
FIGURE 1.— Method of mounting a type MP-37 whip assembly on an MAM equipment.

The necessity for communication with aircraft 5 and 10 miles distant from the signal officer requires more radiation than is obtainable from the whip antennas furnished with model MAM equipments.

Experiments indicate that by supplanting the whip antenna furnished with a type BG-56A whip, or equivalent, the needed performance is obtained without interfering with other equipments at adjacent fields.

The photograph of Figure 1 shows a close-up of the method employed in mounting a complete type MP-37 whip assembly, including the spring base employed to prevent the whip from snapping off.

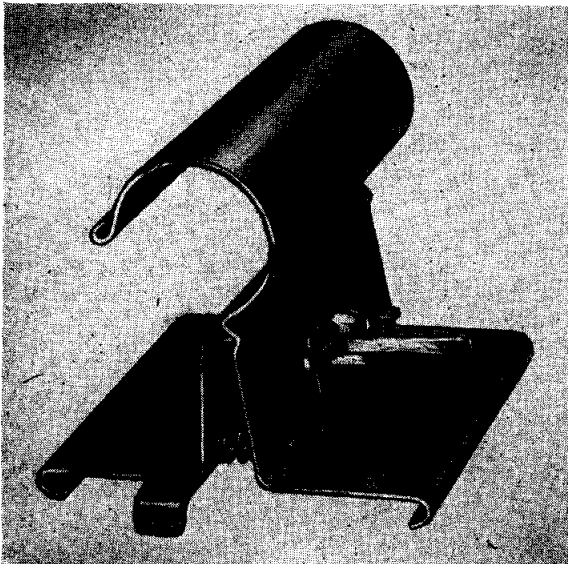
FIGURE 1.—Crystal oven extractor.

It has been brought to the attention of the Bureau that considerable difficulty is being encountered in removing the crystal ovens from models TDZ, RDZ, MAR, and RDR UHF equipments when servicing is necessary.

has procured a quantity of crystal oven extractors, Navy type 10552 depicted in the accompanying photograph, which will facilitate the extraction of the crystal ovens when necessary.
