Section 9
TRANSMITTING EQUIPMENT
T Series

COMMUNICATION EQUIPMENT MAINTENANCE BULLETIN

SECTION 9. TRANSMITTING EQUIPMENT

MODEL TU SERIES TROUBLE SHOOTING NOTES

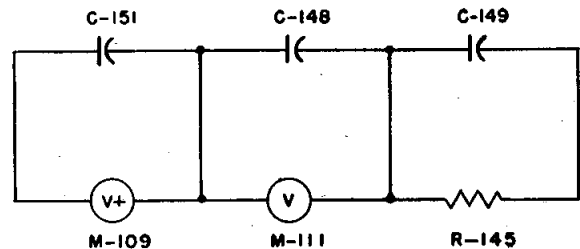
BEFORE

General.—Reference to the schematic diagram in the instruction book for the subject models indicates that the failure of meter bypass capacitor C-149 will short circuit the me-

ter multiplier R-145, thereby applying a very high potential directly across the meter. By placing the "low" side of C-149 directly to ground at the junction of M-111 and C-148, the failure of C-149 would not damage the meter in any way.

Purpose.—To preclude failure of meter bypass capacitor C-149 and short-circuiting of meter-multiplier R-145.

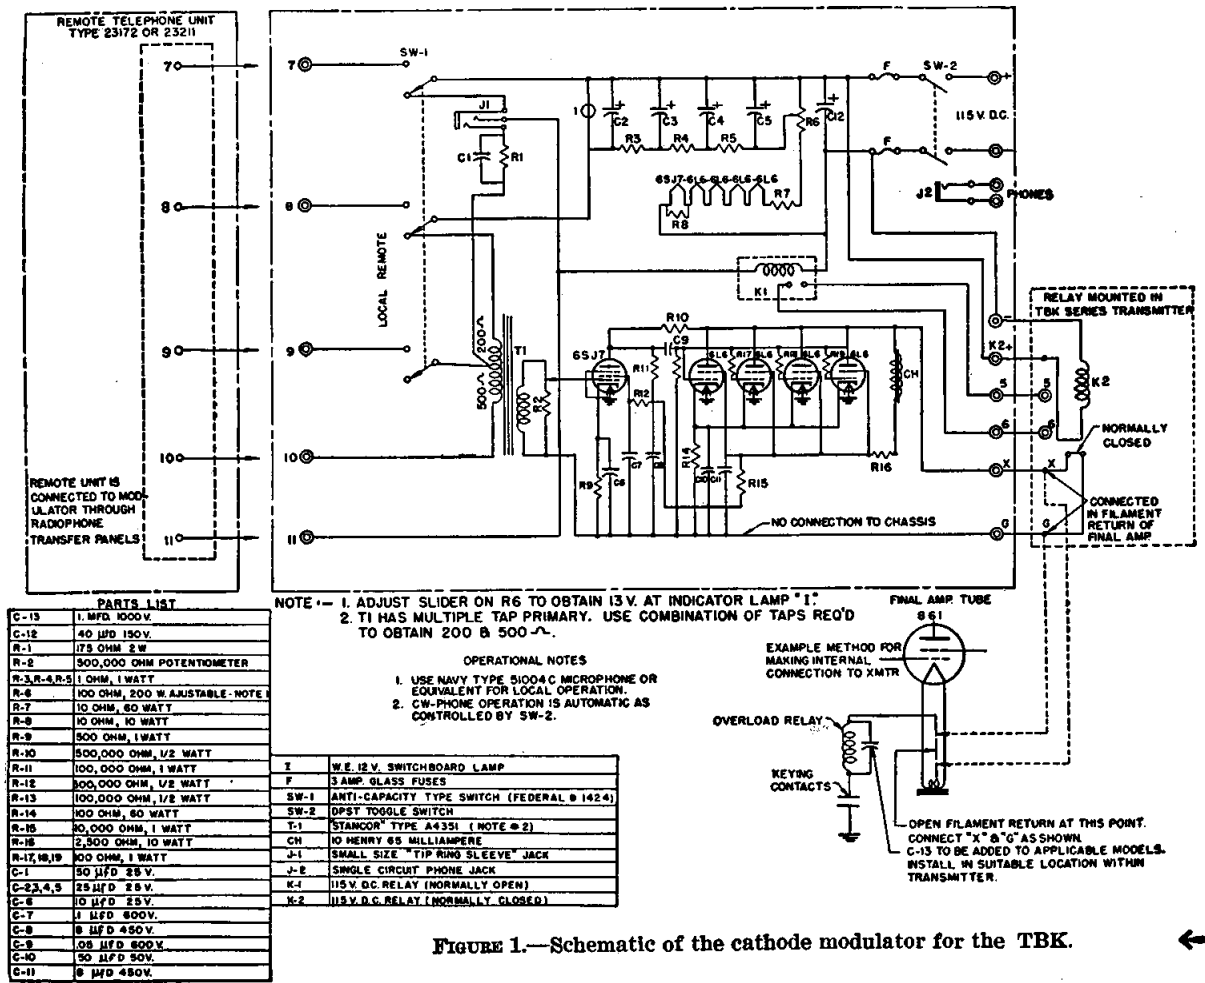
The circuit diagram of the model TBK cathode modulator, Figure 1 on page TBK:3, Supplement No. 8 of the C. E. M. B., incorrectly showed the choke (CH) next to the final 6L6 as being short-circuited. With supplement No. 20 there has been included a new page TBK:3 with Figure 1 shown in its corrected form. 10/1/47 ←

FIGURE 1.—Schematic of the cathode modulator for the TBK.

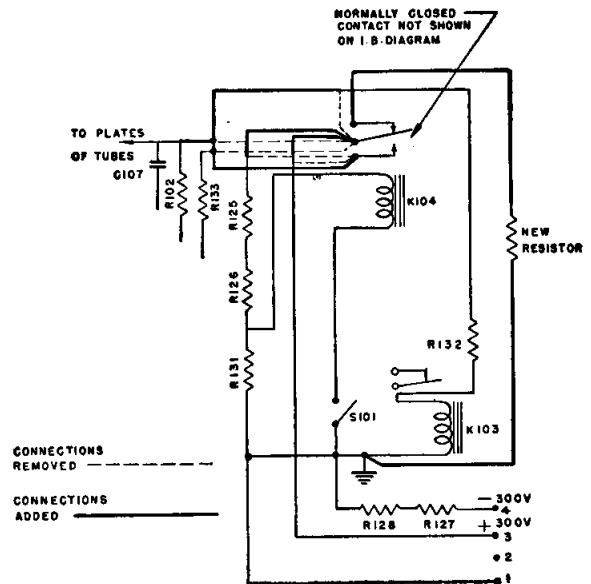
FIGURE 1.—Modification to improve the reliability of relay K-101 in the TBS equipments.

Purpose.—To improve the reliability of relay K-101.

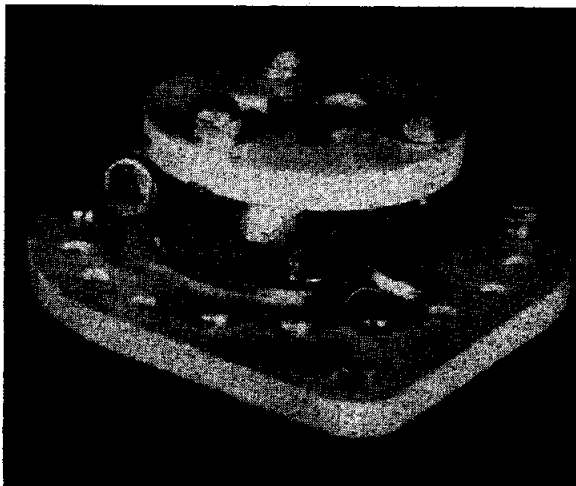
General.—Modification should be made at the earliest opportunity to correct this fault in equipments now in service as this failure is serious under Naval service conditions since no spare switches are provided and a remedy of the condition calls for a major disassembly of the transmitter, thereby placing the equip-

FIGURE 1.—Damaged tap switch.

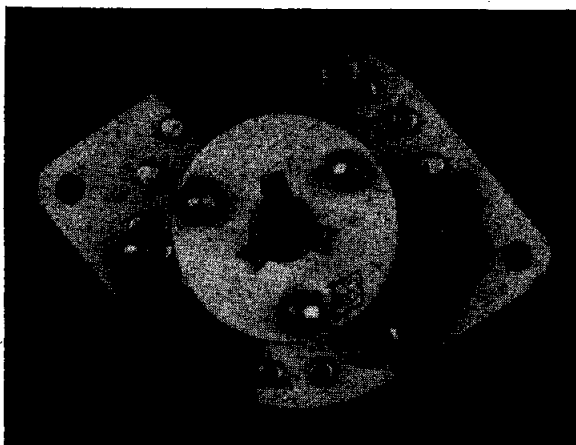
FIGURE 2.—Modified tap switch.

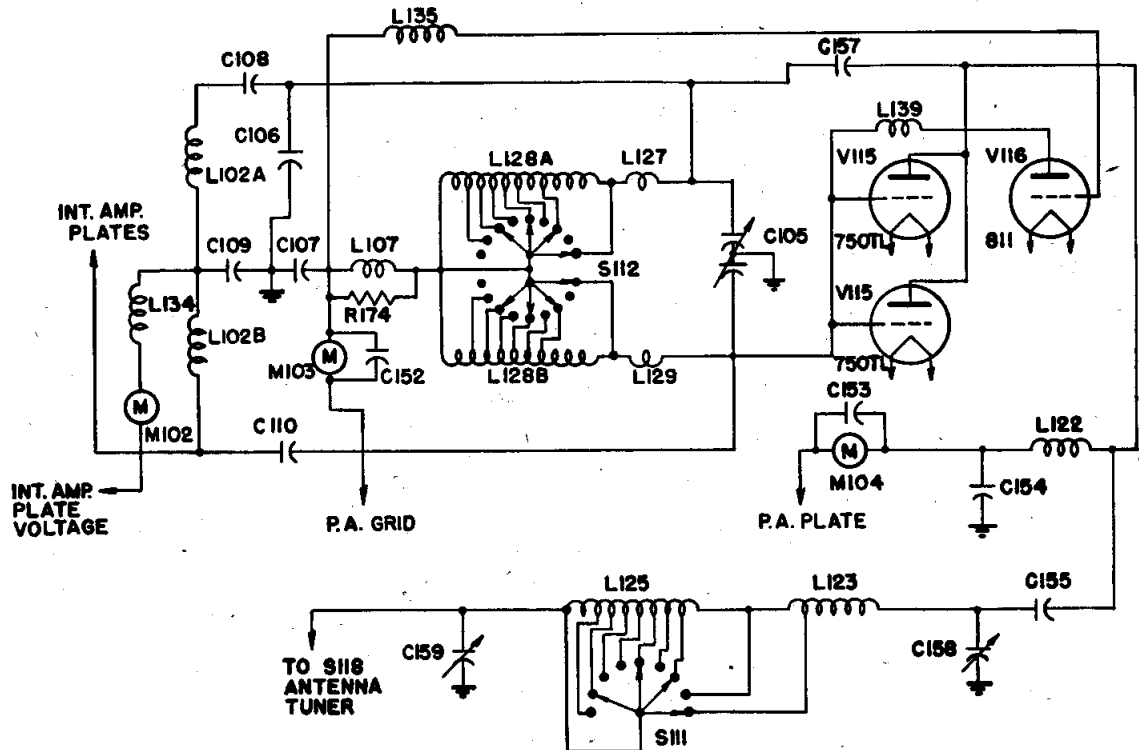
The Bureau has no information relative to the number of equipments shipped possessing the above discrepancies; however, it is probable that all instruction books contain the errors enumerated herein. Figure 81 should be corrected according to the accompanying diagram. 8/1/46

FIGURE 1.—Corrected wiring diagram of TDH-4 final amplifier.
