MODEL RAH SERIES TROUBLE SHOOTING NOTES**DIFFICULTY ENCOUNTERED****CAUSE AND REMEDY**

HIGH HUM LEVEL IN MODELS RAK/RAL SERIES RECEIVING EQUIPMENTS

→ RAK RADIO RECEIVING EQUIPMENT FIELD CHANGE NO. 1 and RAL RADIO RECEIVING EQUIPMENT FIELD CHANGE NO. 1 PROVIDING CONCENTRIC ANTENNA JACK

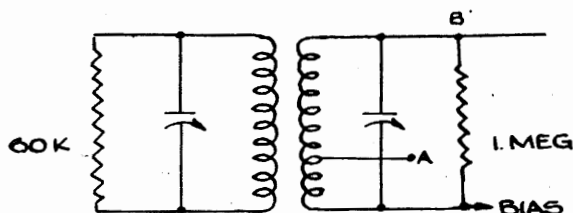
REVISED I.F. 1 & 2

FIGURE 2.—Revised first and second i-f stages.

was increased by decreasing the distance between the primary and secondary coils from $1\frac{1}{2}$ " to $\frac{7}{16}$ ". It was necessary to apply heat to the porcelain coil form to accomplish the movement of the primary coil.

(2) The secondaries of the first and second stage intermediate-frequency transformers have a tap to which the grid was connected in the original installation as shown at "A" in Figure 1. The grid connection was removed from this tap and attached to the extreme end of the coil which

is connected to the stator plates of the trimmer condenser as shown at "B" in Figure 2.

(3) A 1/2-watt resistor of 60,000 ohms was connected in parallel with the primary circuit of each i-f stage, as shown in Figures 2 and 3.

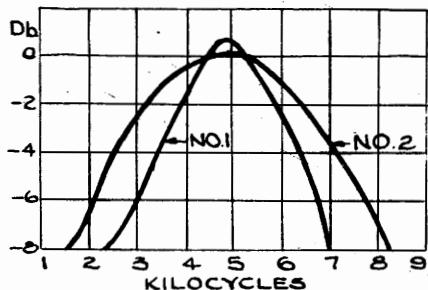
FIGURE 4.—Selectivity before and after the modification.

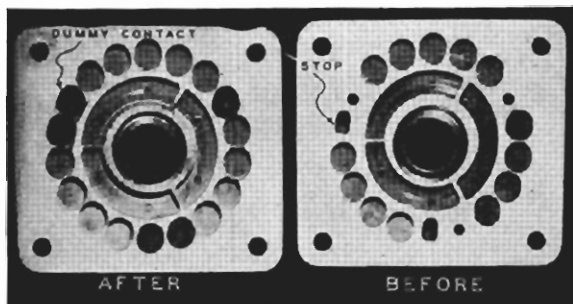
FIGURE 1.—RBB/RBC receivers band switch stators—before and after modification.

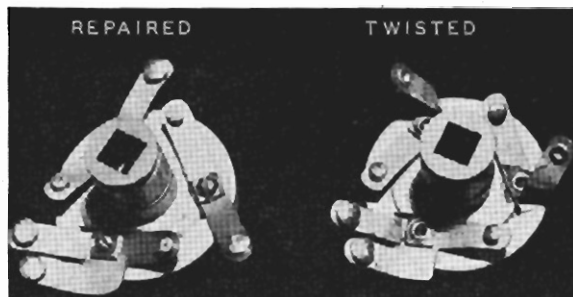
FIGURE 2.—RBB/RBC receivers band switch rotors—twisted and repaired.

Purpose.—To prevent the band switch rotor contacts from twisting.

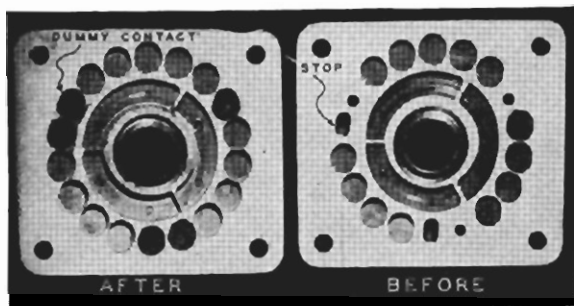
FIGURE 1.—RBB/RBC receivers band switch stators—before and after modification.

suggested by C. E. Swiger, RT 1/c of the U. S. S. *Cascade* (AD-16), consists of removing the stop pins and filling the holes on the band switch with plugs made of bakelite or

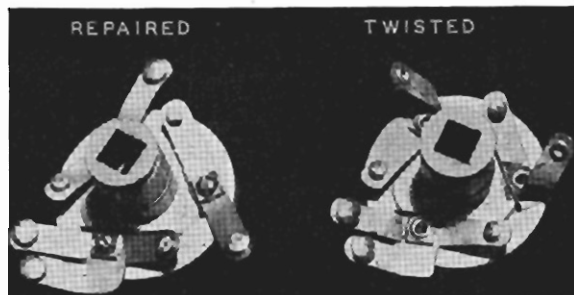
Purpose.—To prevent the band switch rotor contacts from twisting.

FIGURE 2.—RBB/RBC receivers band switch rotors—twisted and repaired.

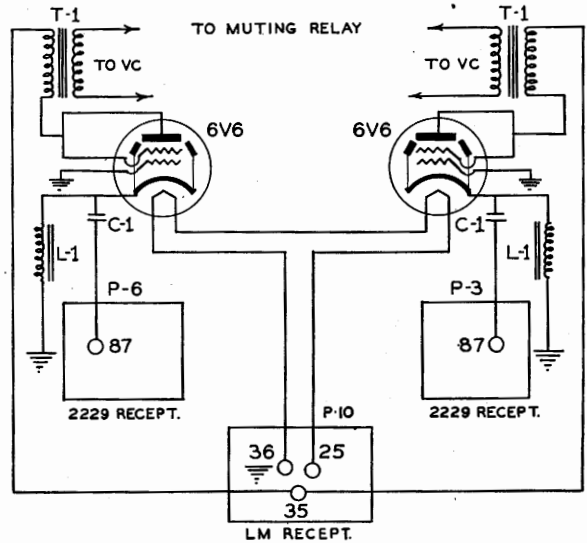
FIGURE 1.—Modification of power pack of model RU receiving equipment.

— CHANGE R-10 IN GF-RU-LM POWER SUPPLY TO
 A 5000Ω 10 WATT RESISTOR
