4-1 INTRODUCTION

Signal Distortion Resulting from Improper use of Audio Distribution Amplifier Model AD-2 (Cooke Engineering Company)

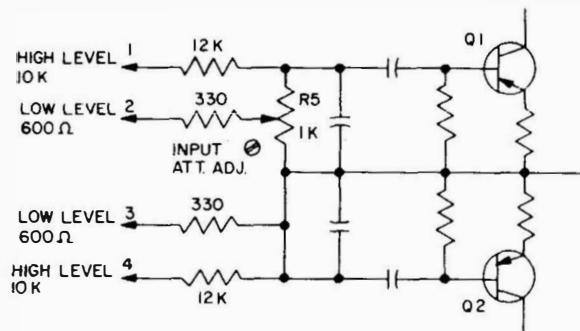
Figure 1. Input Circuit of AD-2 Distribution Amplifier (1-Channel)

Serious distortion of the input signal can result unless particular attention is paid to the input signal level or to the manner in which the input signal line is connected to the amplifier. For example, the signal level applied to the LOW LEVEL 600 OHM input should never exceed -10 dbm. The reason being that the input attenuator adjustment potentiometer R5 becomes extremely critical to adjust if the input signal level exceeds approximately -10 dbm, see figure 1. Mis-adjustment of the input attenuator adjustment potentiometer R5 can cause the input transistors Q1 and Q2 to be over driven resulting in a seriously distorted output signal. Adjustment of the output level potentiometer will not correct for distortion developed in the input stage of the amplifier.

There are two relatively simple solutions to the problem: (1) install signal line level adjustment pads ahead of the AD-2 Distribution Amplifier and set the level of the input signal not to exceed approximately -15 dbm., or (2) connect the signal lines to the HIGH LEVEL 10K OHM input terminals of the AD-2 Distribution Amplifier, as shown in figure 2.

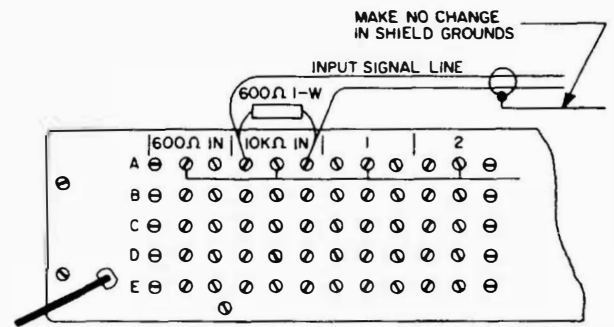
Figure 2. Signal Line Connections for High Level Signals. Note Terminating Resistor

Since this input is a high impedance input, normally used for bridging applications, the signal line should be terminated with an impedance approximating 600 ohms. The value is not critical and a 620 ohm $\pm 5\%$, 1 watt resistor, FSN 9N-5905-279-2629, is satisfactory. This manner of connection will accommodate signal lines on which the signal level nominally averages between -10 dbm and +1 dbm.

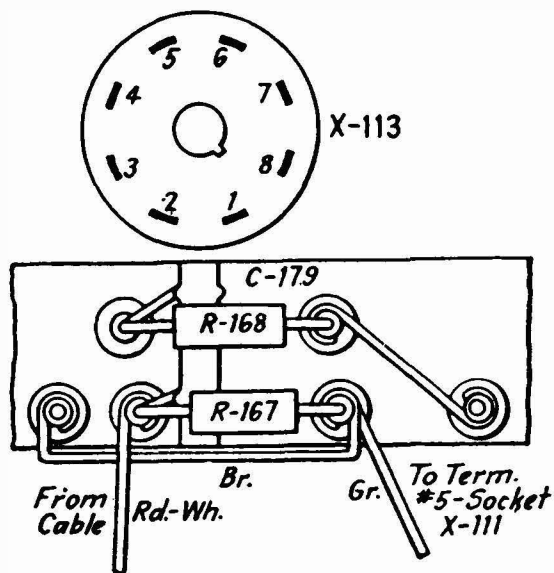
FIGURE 1.—Original arrangement

Investigation of several failures of capacitor C-179 in AN/ARC-1 equipments has led to the conclusion that the mounting arrangement should be changed as shown in Figures 1 and 2 and a capacitor with higher voltage rating substituted.

Electrical test on a quantity of these capacitors taken from the production line at Western Electric has shown that they are not adequate for this circuit application. In addition, the capacitor is mounted in the set as shown in figure 1 and may possibly have become misplaced to such an extent that the end nearest to tube socket X-113 was actually in contact with the terminals projecting from the socket. In this case the bakelite insulation on the condenser would soon wear through and result in a contact between the grounded end of C-179 and socket terminal No. 2 (heater terminal 18 volts) or No. 3 (plate terminal). It is believed, therefore, that the difficulty might be due either to random defective condensers or misplacement in the assembly or both.

Perhaps a warning to service men that C-179 should have at least 1/8" clearance from the terminal of socket X-113 is all that is warranted although the change is one that could be readily made at any repair shop. This change will also be shown on the wiring diagram, Figure 43, of the maintenance handbook when it is reissued.

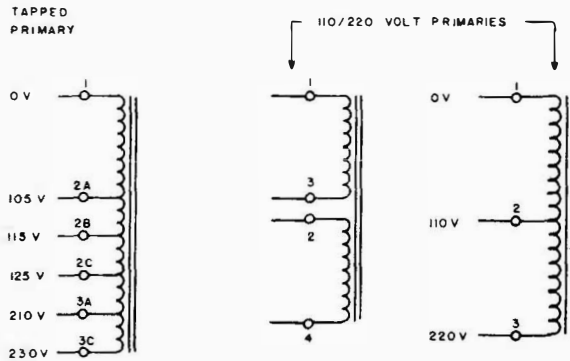
The type of transformer in use can be determined by comparing the notation on the transformer primary connections with the notations for three different transformers shown in figure 1.

Activities using any of the equipments (or components thereof) listed in the subject for this article are directed to inspect their respective equipments to ascertain if the power transformers have 110/220 volt primaries or if tapped primary power transformers are used. Those activities finding 110/220 volt transformers in their equipment are further directed to take remedial action as necessary to correct the deficiency at the earliest opportunity.
