**Adjustment Procedures for Amplifier Group AN/GSA-33 and Audio Amplifier AM-413A/G Background.**

**POTENTIAL SHOCK HAZARD IN POWER SUPPLY  
PP-3565/GRC-100A**

**COMMUNICATIONS****AN/PRC-6 REPLACEMENT CAPACITOR C-43**

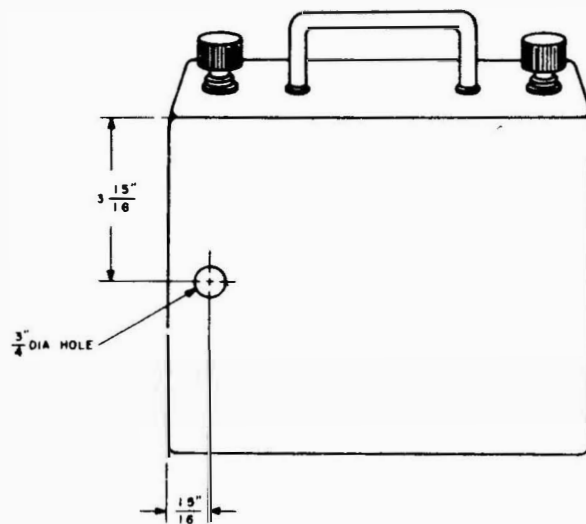
Figure 1. Case modification AN/PRC-39.

The Bureau of Ships has been notified by NAS Brunswick that difficulty exists in tuning the final tank circuit of the AN/PRC-39. Each time the metal case is removed and replaced, the capacity effect of the metal case will detune the final tank circuit. Drill a hole of sufficient size in the case directly over the final tank circuit to allow the final tank circuit to be resonated for maximum RF output upon reinsertion into the case. This hole, when not in use, is sealed with a rubberized knock-out plug to maintain watertight integrity of the equipment.

Drill a  $\frac{3}{4}$ -inch-diameter hole in the aluminum case directly over the final tank circuit in accordance with figure 1 of this article. Insert a  $\frac{3}{4}$ -inch rubberized knock-out plug into the hole. The stock number of the plug is: KZ5340-893-8798. (608)

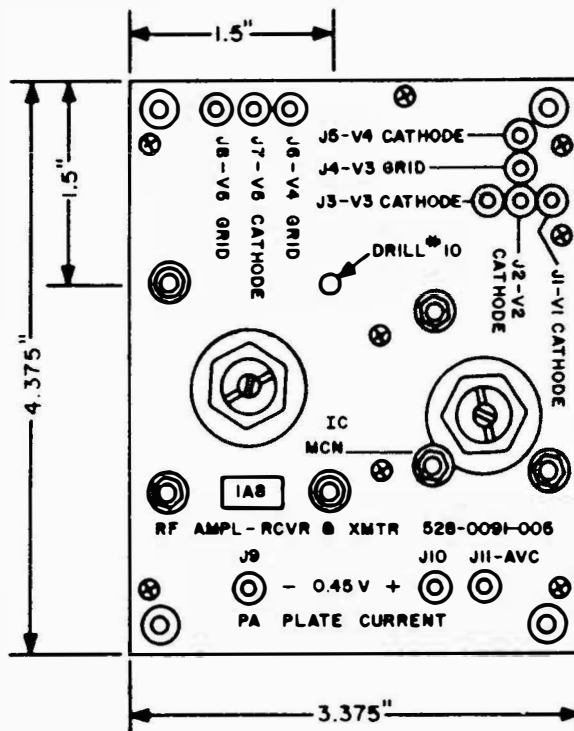
Figure 1. Location of Drilled Hole in Module Top Plate

Activities servicing Radio Sets AN/PRC-41 are advised of a modification to the RF and power amplifier module (1A8) which permits replacement of a ceramic screw in the grid stator assembly (1A8 MP30). Access to the screw is normally blocked by the module top plate (1A8 MP34) and requires disassembly of the module to replace in the event of failure. Access can be obtained by drilling a hole through the top plate, as shown in figure 1.

with a #10 drill bit. Use a 6-32 tap to remove the broken ceramic screw and to clean out the threads. Insert the new ceramic screw and tighten very carefully with a screw-driver which is inserted thru the drilled hole. This hole will not affect the operation of the RF and power amplifier module but will reduce the time required to make the repair. Implementation of this modification is recommended for all Radio Sets AN/PRC-41 which require replacement of the ceramic screw in grid stator assembly (1A8 MP30). (836)

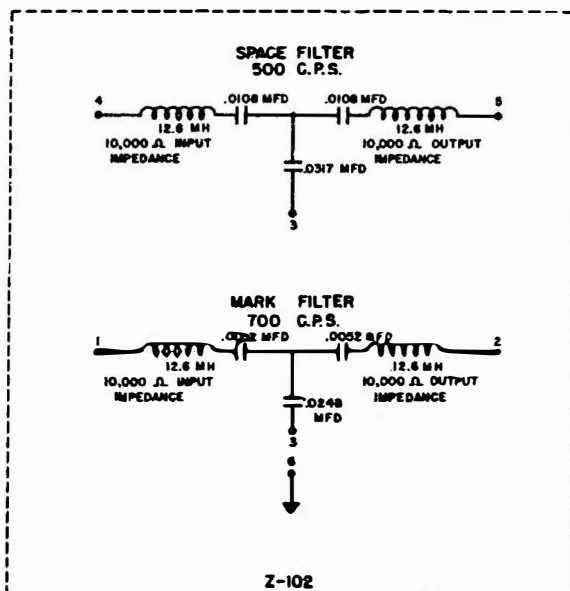
FIG.1 ELECTRICAL CONFIGURATION OF FILTER

The test data indicate that the frequency of peak response on almost all filters has drifted downward. However, all filters have less than 5 db loss at the operating frequency except the mark filters for equipments 227 and 338.

In addition to the power consumed in the filter, another power loss of 7 db is incurred when the harmonics of the fundamental frequency are removed from the square wave output of V-102. When these losses are added, the total may be 10 to 12 db. This value corresponds closely to the

If the insertion loss of the filter at the pass band exceeds 5 db or if the rejection of the undersired frequency is less than 12 db, the filter is defective and should be replaced.

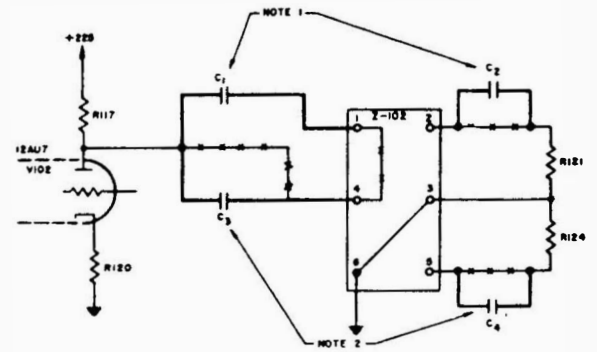
FIG. 3 CONNECTION OF EXTERNAL CAPACITORS

If a replacement is not readily available, emergency repairs may be made on some filters where the frequency of peak response has shifted downward. The emergency

repairs are made by connecting external capacitors in series with the filter. The schematic diagram of the connections is shown in figure 3. The values of capacitors, which will give optimum performance, are best determined by trial and error. To select the range of values to be tried, Table IV may be used as a guide. The test procedure, to determine the performance of the filter should be repeated after each group of external capacitors have been connected into the circuit. If an improvement is noted, the capacitors may be bolted to the chassis and any splices covered with spaghetti. The physical dimensions of the capacitors, are shown in figure 4.

NOTES:  
 1. ADD CAPACITORS C1 & C2 (SEE TABLE III) TO RAISE THE FREQUENCY OF THE MARK FILTER  
 2. ADD CAPACITORS C3 & C4 (SEE TABLE III) TO RAISE THE FREQUENCY OF THE SPACE FILTER

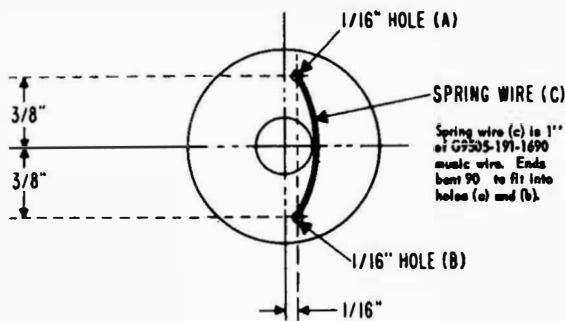
FIGURE 1

(b) S-101C Channel selector C acted much as did Channel selector A. This problem was more pronounced in positions 1 and 2 which affected L-101 and L-102 and was more critical than the situation described above. The rollers may be stabilized on the stationary shafts by the addition of a spring loaded contact as illustrated in Figure 1."

It is recommended that ships experiencing difficulty with the AN/SRA-20 coil rollers in the R F tuner unit, modify these rollers as described.
