**AN/SRC-10(), -11(), -12(), -13(), -14(), -15()
REMOVAL OF AUDIO RECEPTACLE WATERPROOF
CAPS**

**AN/SRC-10() THRU -15() AN/SRC-16() THRU -18()
MISLEADING RF OUTPUT INDICATIONS**

**AN/SRC-10 through 15 and AN/URC-16 through 18 Series
Radio Sets-Possible Wiring Discrepancy**

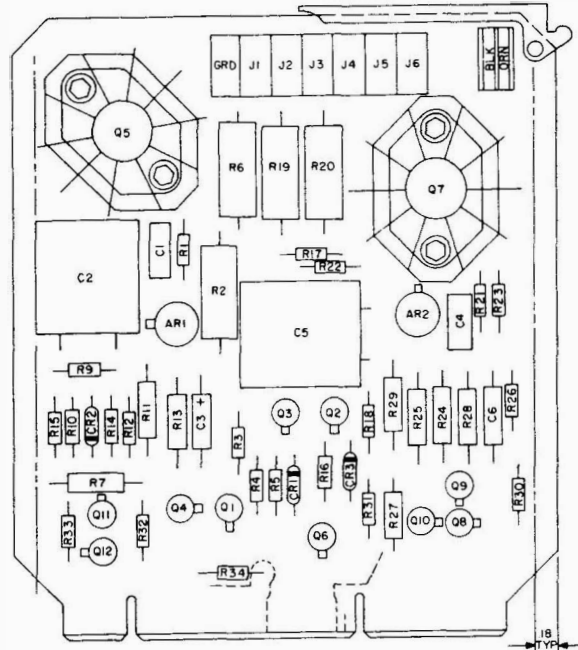
Figure 1 — Parts Location Diagram.

If BT6 (+16 VDC) battery has failed, transistor Q3 (2N2907) and resistor R2, 33 ohm, $\pm 10\%$, 2 watts, are burned. If BT7 (-16 VDC) battery has failed, transistor Q6 (2N2222) and resistor R19, 33 ohm, $\pm 10\%$, 2 watts, are burned. In many cases, the items are burned and thus are easily identified. Refer to figure 1 for component location and to figure 2 for a schematic diagram of the PS board.

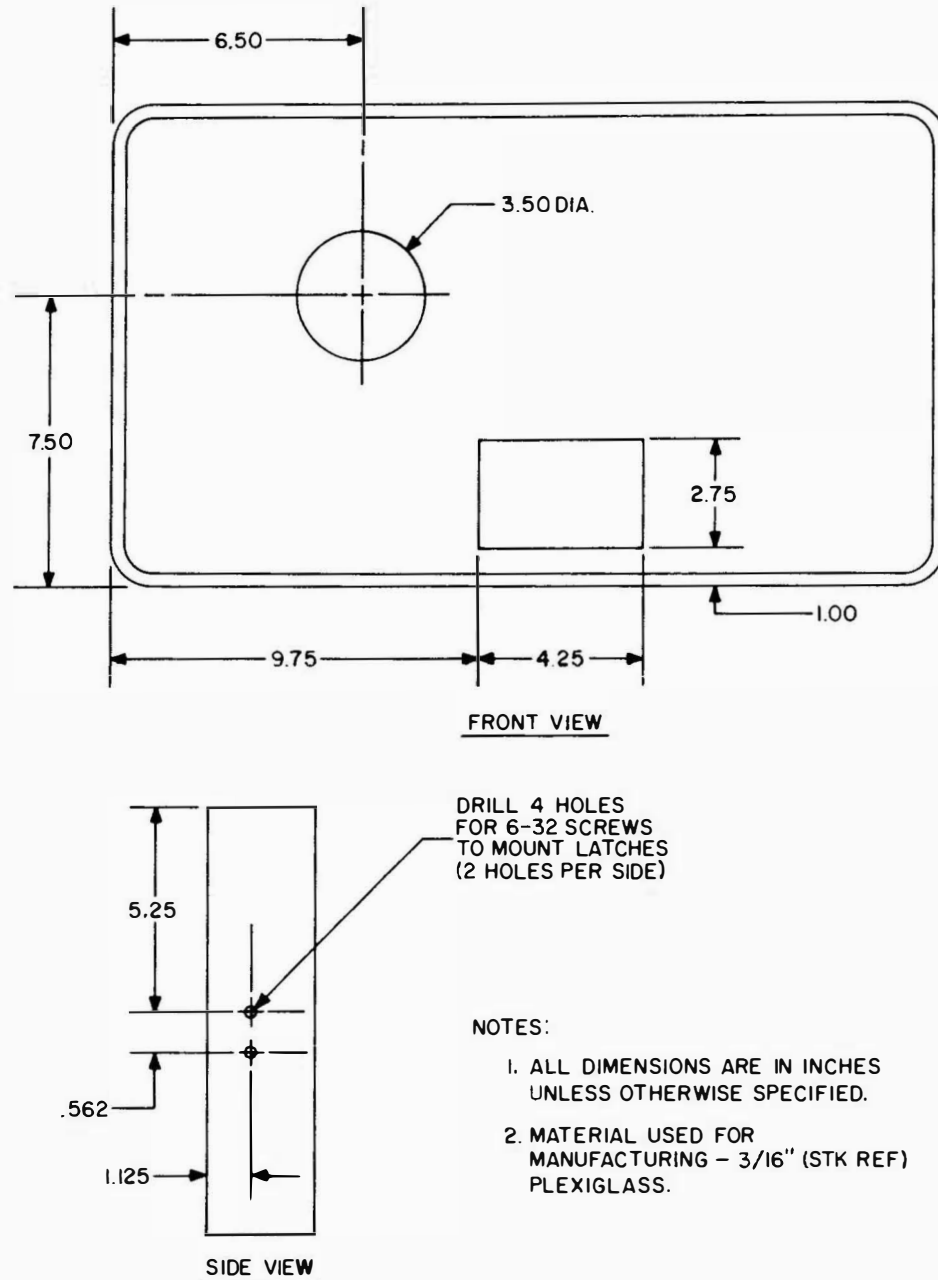
Figure 1. AN/SRN-15 Protective Cover - Front and Side.

Construction details are shown in figures 1 and 2. The cover is attached to the RT-1084/SRN-15 using suitcase catches similar to those used to secure covers on portable test equipment. Two holes are drilled in the front of the cover to provide access to the

This modification is authorized for installation by ship's force personnel when authorized and funded by the ship's Commanding Officer.

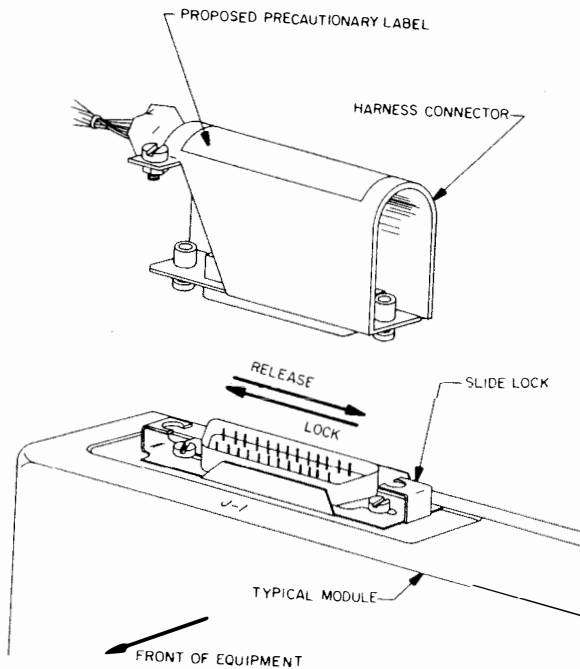
Figure 1. Typical AN/SSR-1 Module Connector

The purpose of this article is to point out the existence of the slide bar locks on the wiring harness connectors in the AN/SSR-1 drawer units. This slide lock is not readily apparent to those personnel not familiar with the connector. Attempts to disconnect the wiring harness during removal of modules from the MD-900/SSR-1 and the TD-1063/SSR-1 without properly releasing the slide lock may result in irreparable damage to the J-1 connector.

Figure 1 of this article shows a typical harness connector and mating jack with the slide lock. Before removing the connector, the slide must be moved to the right to release the catch. After re-connection, moving

the slide to the left will lock the connector in place.

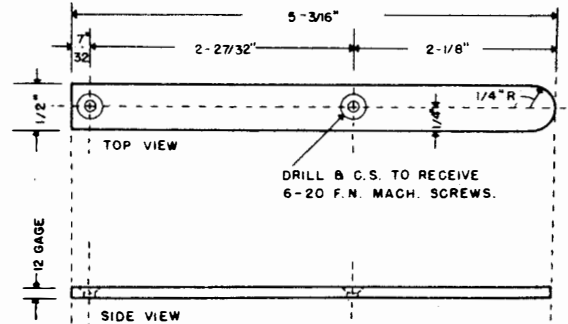
FIGURE 1.

The suggestor points out that a bracket of other dimensions—longer or wider—of any strong metal would be suitable for protection to the equipment. This suggestion may be used at all activities where the AN/TGC-1 is in use to prevent similar damage to the equipment.
