**MK 3 Ships Inertial Navigation — Maintenance
Hint**

NAVSEA 0967-LP-000-0010

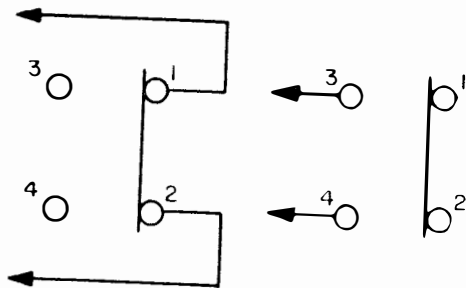
Figure 1. Wiring Connections AN/SYA-4 Foot Pedal Switch

This instruction is to provide correct "Push-to-Talk" sequencing with the communication footswitch on the Height-Size Video Display Console. On some consoles it has been necessary to depress the footswitch for a "listen" condition.

7. Replace the front panel of the base, then check the inter-communication system again to insure that the footpedal is depressing the switch. (691)

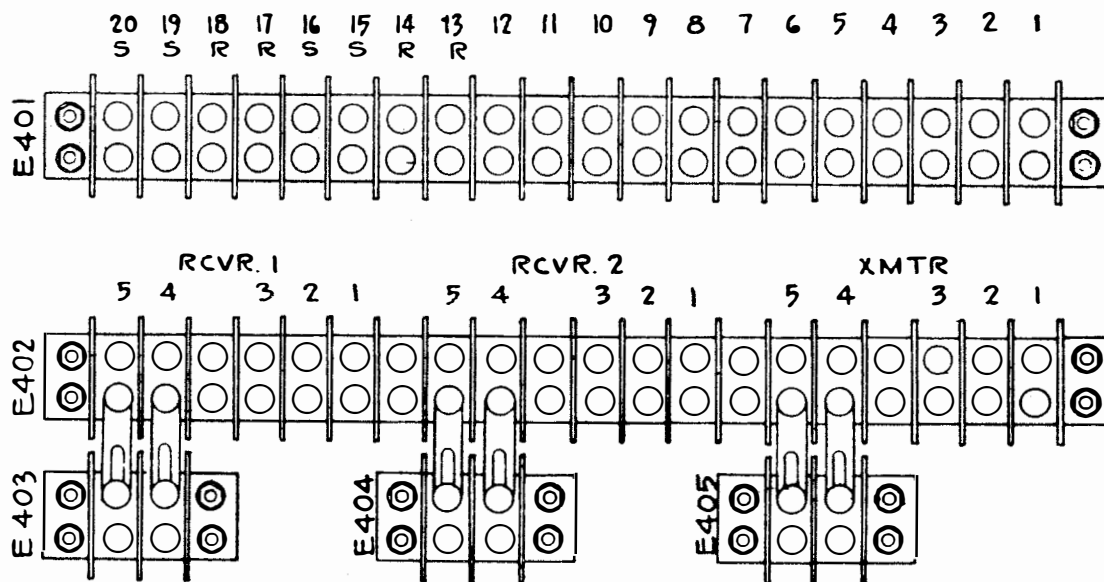
FIGURE 1.--Terminal strip markings on type CQC-23496 remote control indicator unit

The Bureau has recently received information that several Remote-Control Indicator Units Type-23496 were found to have no identification markings for the terminal strips mounted in the back of the cabinets. For the convenience of those installing activities finding this condition, the accompanying diagram is published. Additional copies are available from the Bureau of Ships.

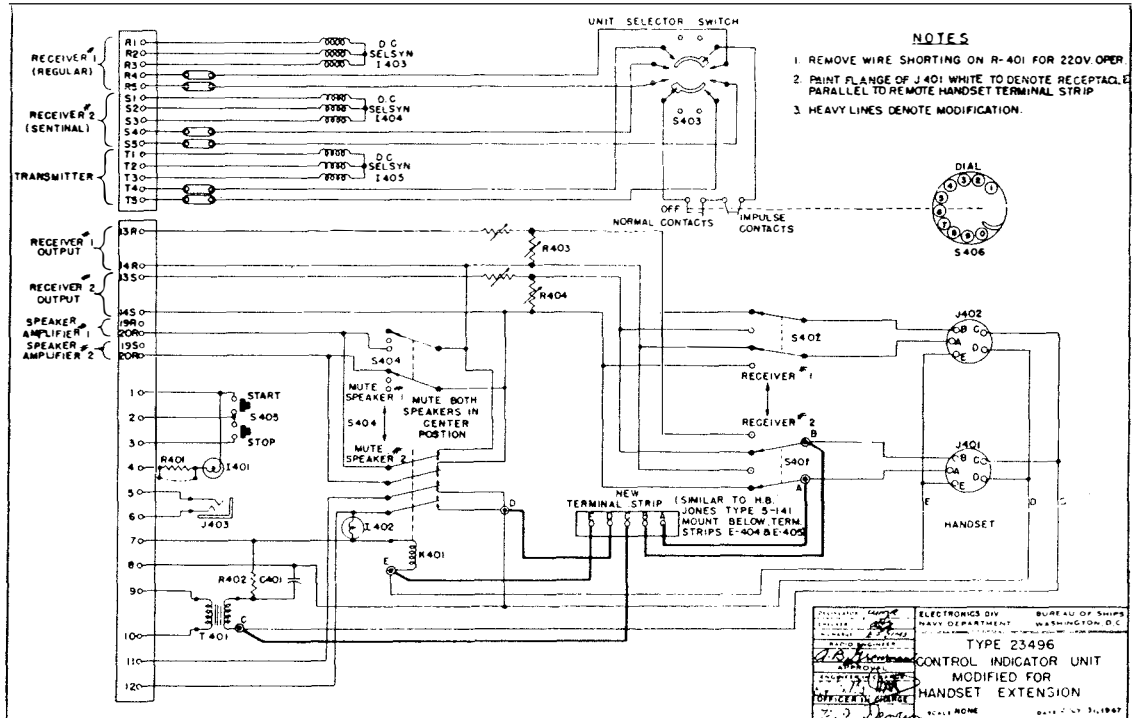
FIGURE 1.-- Type -23496 control indicator unit modified for handset extension

facilitate wiring. The back of these points is indicated in Figure 1 by a circle and designated by a letter which corresponds to the pin designation in the handset jack. The wiring to the new terminal strip is drawn in heavy lines. Inasmuch as there are two handset receptacles in the -23496, the Bureau desires that the flange of receptacle J-401, to which the new terminal strip is set parallel, be painted white.

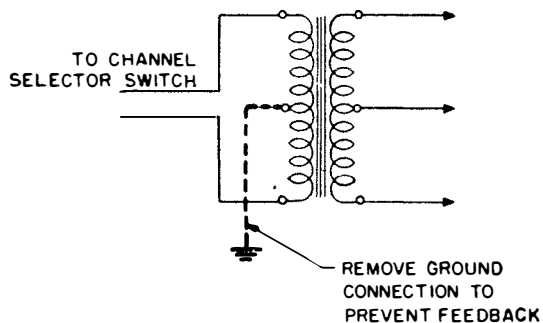
FIGURE 1. --The center-tap lead on the primary of input transformer should be removed

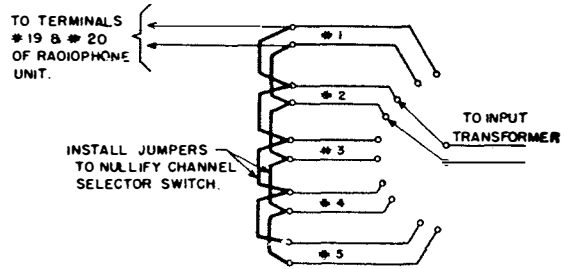
FIGURE 1.--Jumpers installed across input terminals of type 49131 speaker-amplifiers

To eliminate the possibility of the above condition, it is recommended that all types 49131 units installed on single communication circuits be modified according to Figure 1. Jumpers are installed across the input terminals as indicated, permitting the speaker to operate regardless of the position of the switch.

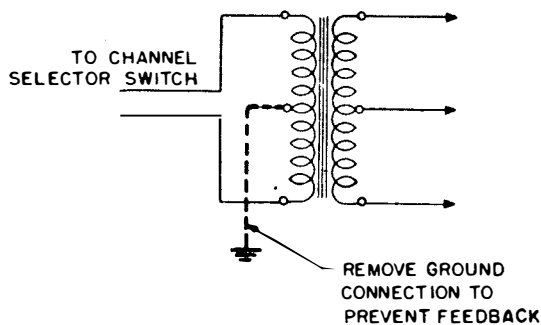
FIGURE 1.--The center-tap lead on the primary of input transformer should be removed
