CHANGES AND ADDITIONS  
TO BULLETINS 1108B (ISSUE 2) AND 1126B (ISSUE 1)  
PARTS - REPERFORATOR TRANSMITTER (MODEL 14)

This correction sheet supersedes correction sheets 659EE, 692EE, and 741EE.

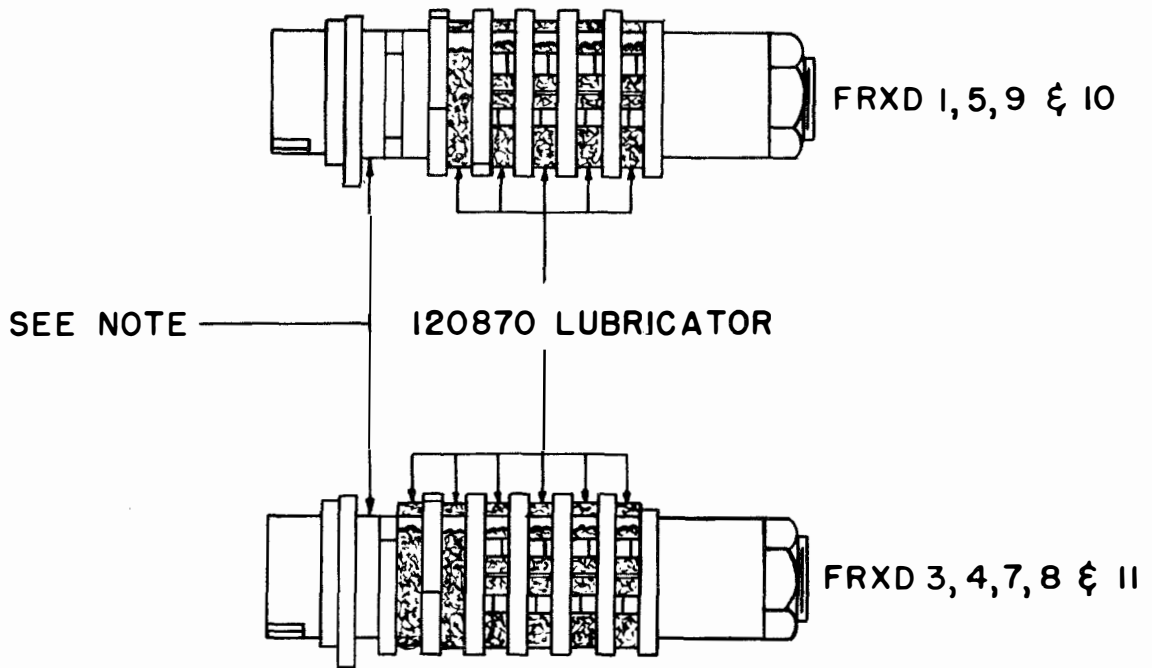
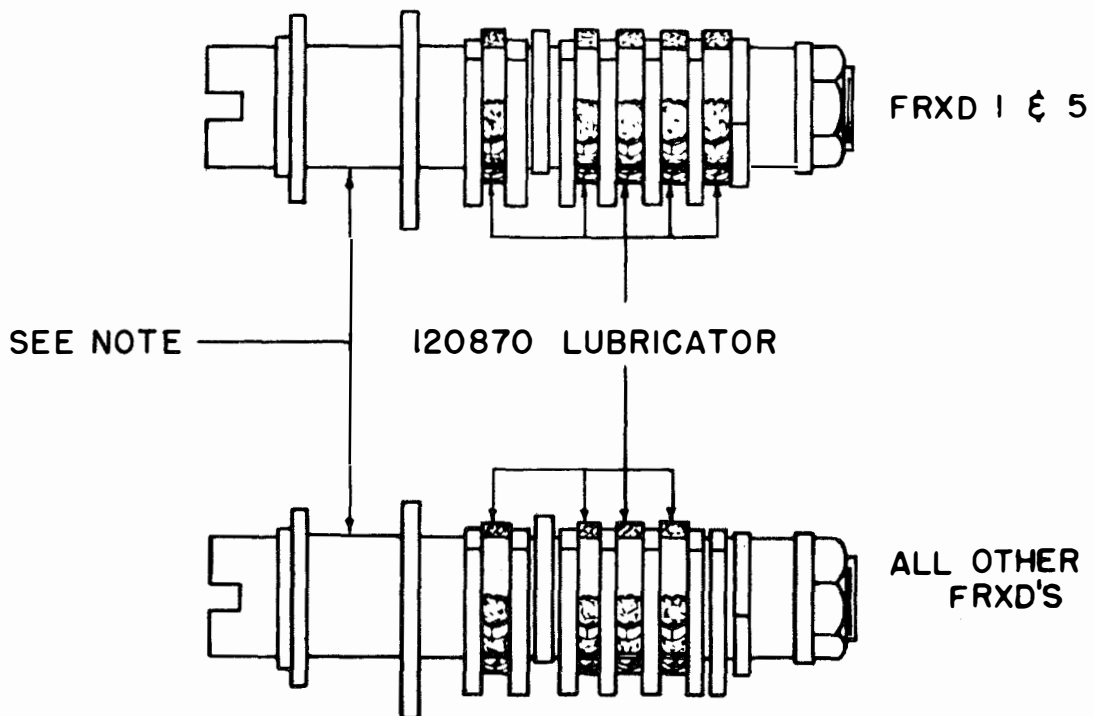
FIGURE 1

The 120870 Lubricators have been added to the sensing and distributor cam sleeves. See Figure 1 for parts.

NOTE: THE 120870 LUBRICATOR IS REQUIRED IN THIS POSITION ONLY WHEN THE 123535 DETENT LEVER (FIGURE 6) IS USED.

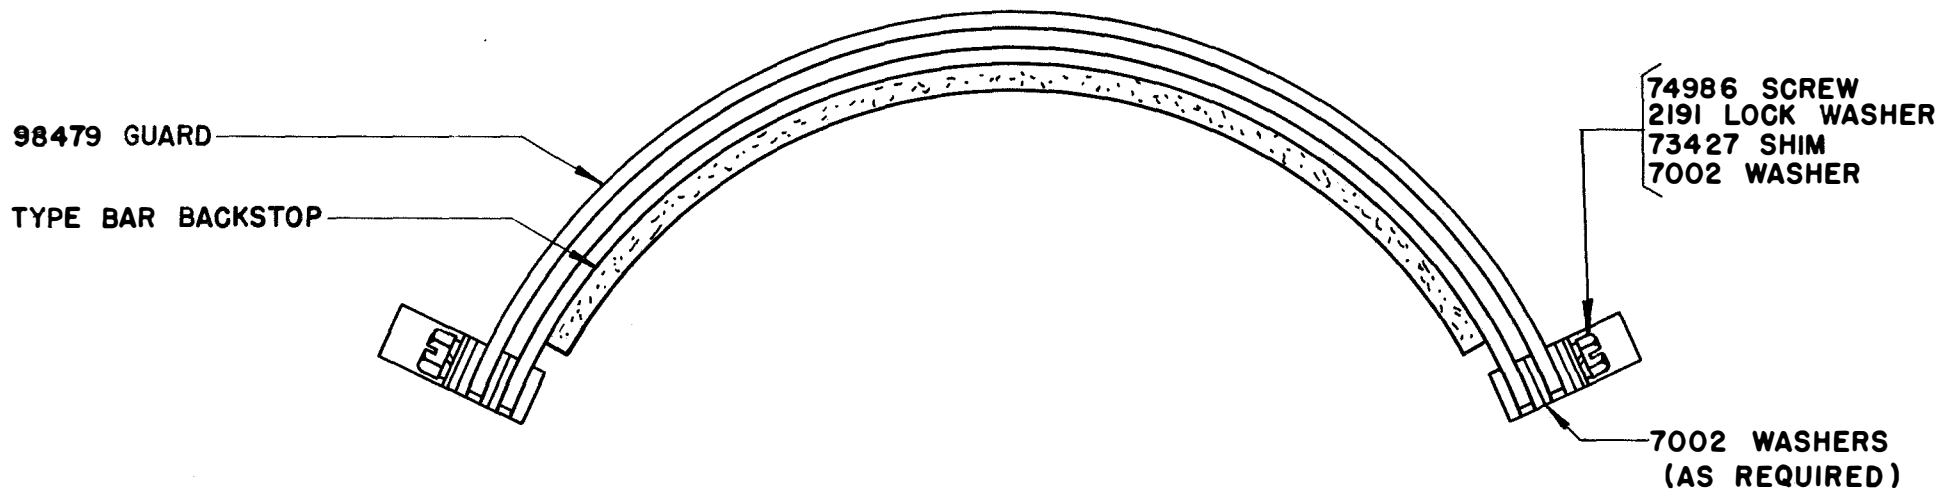
FIGURE 2

The 98479 Guard for the type bar backstop as shown in Figure 2, now applies to all models.

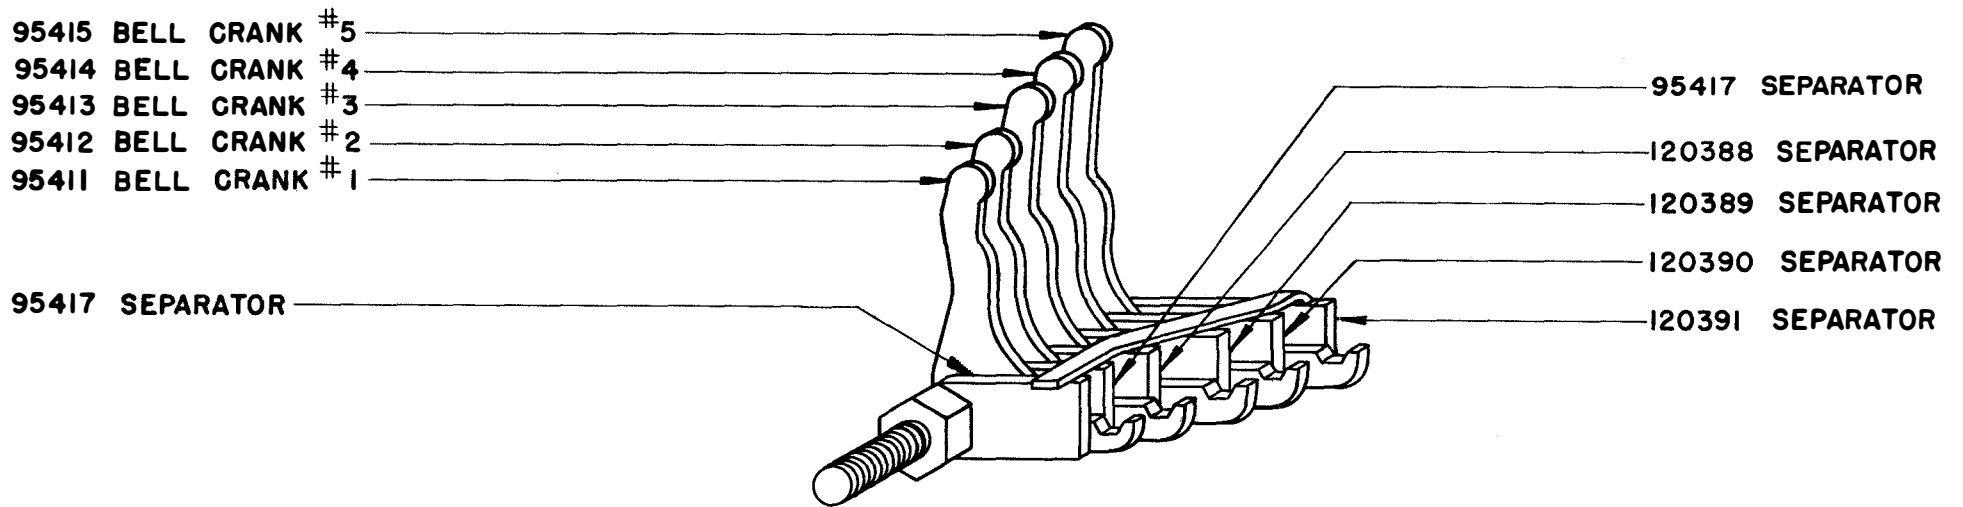
FIGURE 3

Four of the six 95417 Separators have been replaced by four separators of new design. See Figure 3 for parts. In the upper illustration, the 7603 Spring replaces the 115978 Spring in Bulletin 1108B and the 112634 Spring in Bulletin 1126B.

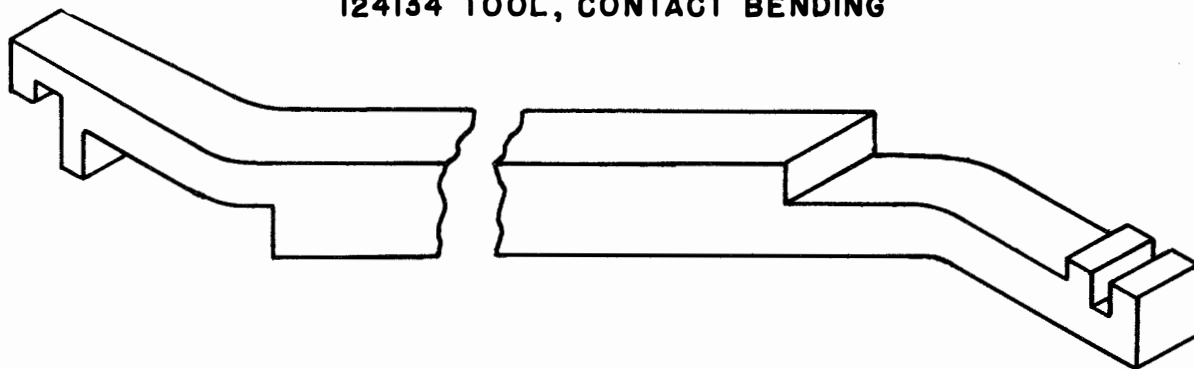
FIGURE 4

The 124134 Spring Bending Tool is recommended for adjusting the distributor contacts. See Figure 4.

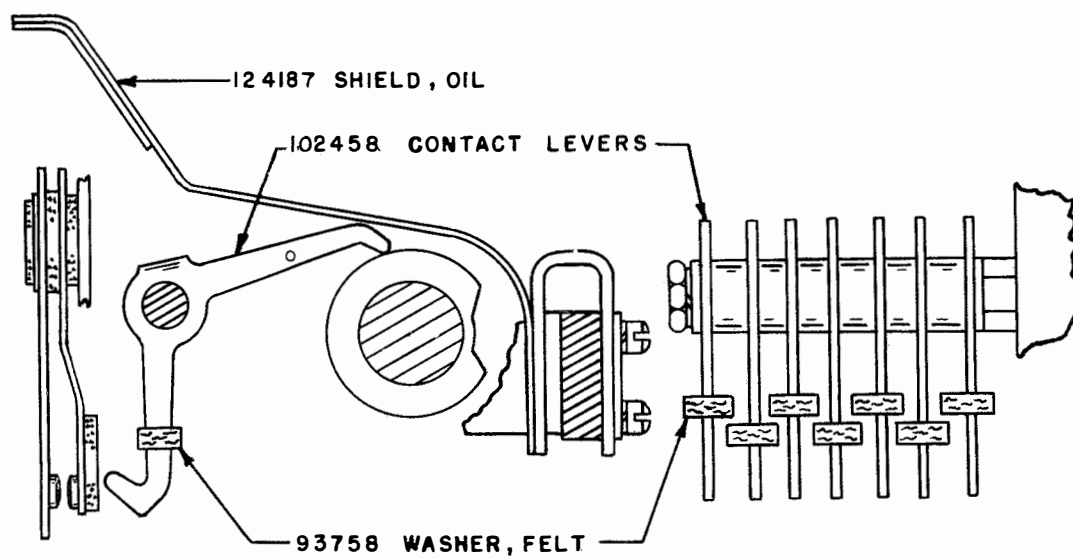
FIGURE 5

The 103516 Oil Shield for the distributor contacts has been replaced by a 124187 Oil Shield. (Figure 5).

The 93758 Washers have been added to each of the 102458 Contact Levers (as indicated in illustration) to absorb excess oil. (Figure 5).

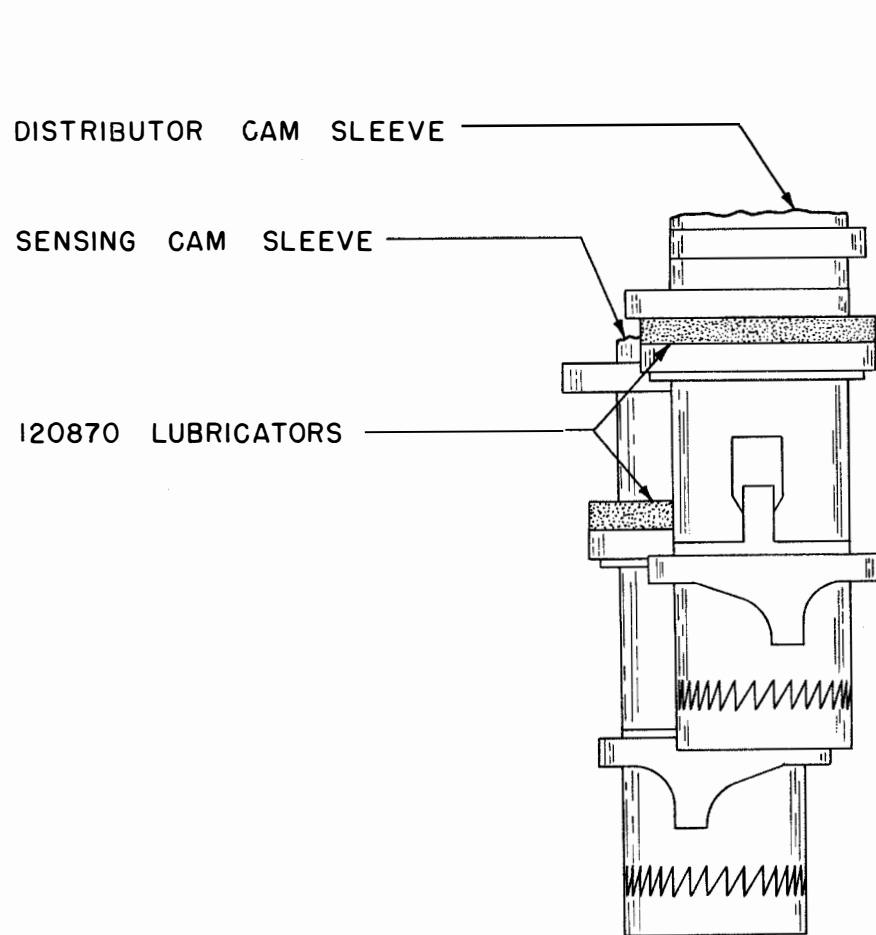
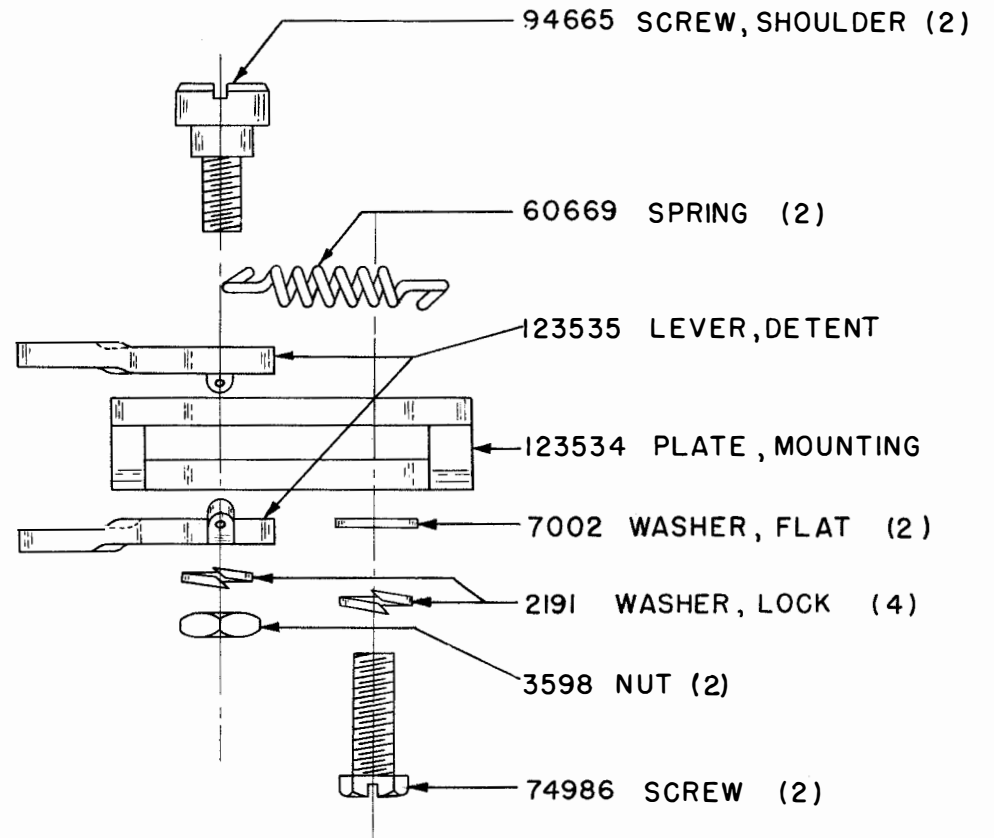
FIGURE 6

CLUTCH DETENT LEVER BRACKET AND TAPE-OUT CONTACT (ASSEM.) - The 115778 set of parts (Figure 6) replaces the following parts:

1047	Screw	102303	Roller
3598	Nut	102304	Lever, Detent
94665	Screw	125257	Spring
102028	Post, Spring

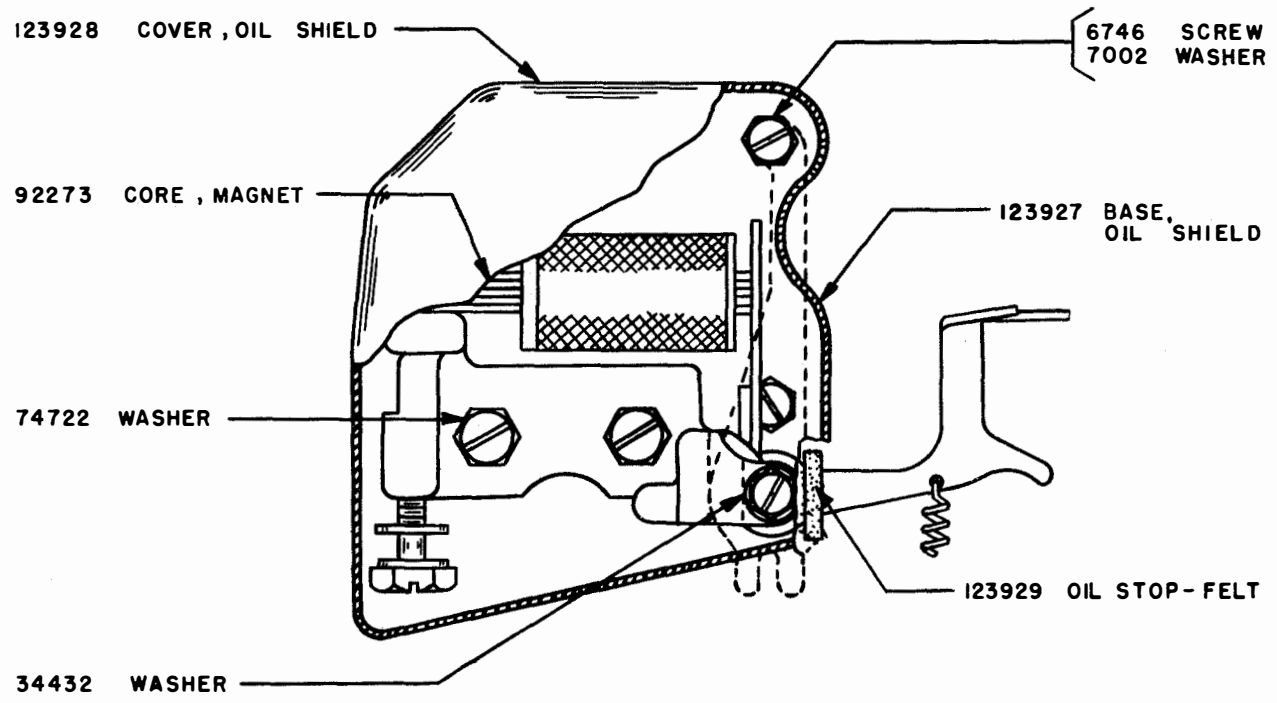
FIGURE 7

OIL SHIELD FOR SELECTOR MAGNET CORES - The 113693 Set of Parts (Figure 7) has been added to the holding magnet selector. New style 92273 Magnet Cores have a red spot on the rear surfaces for identification purposes.

\*Specification 5682S contains instructions for the installation of the 113693 set of parts.
