CHANGES AND ADDITIONS
TO THE FOLLOWING PARTS BULLETINS

<u>Model 14 Printers</u>	<u>Model 14 Typing Reperforators</u>	<u>Model 14 Non-Typing Selectors</u>	<u>Model 14 Typing Reperforator Transmitter</u>	<u>Multiple Reperforator</u>
1028 Issue 2	1082 Issue 2	1083 Issue 1	1108 Issue 2	1130 Issue 1
1030 Issue 2	1088 Issue 2	1107 Issue 1	1126 Issue 1	
1031 Issue 3	1100 Issue 2	1116 Issue 1		
	1117 Issue 2

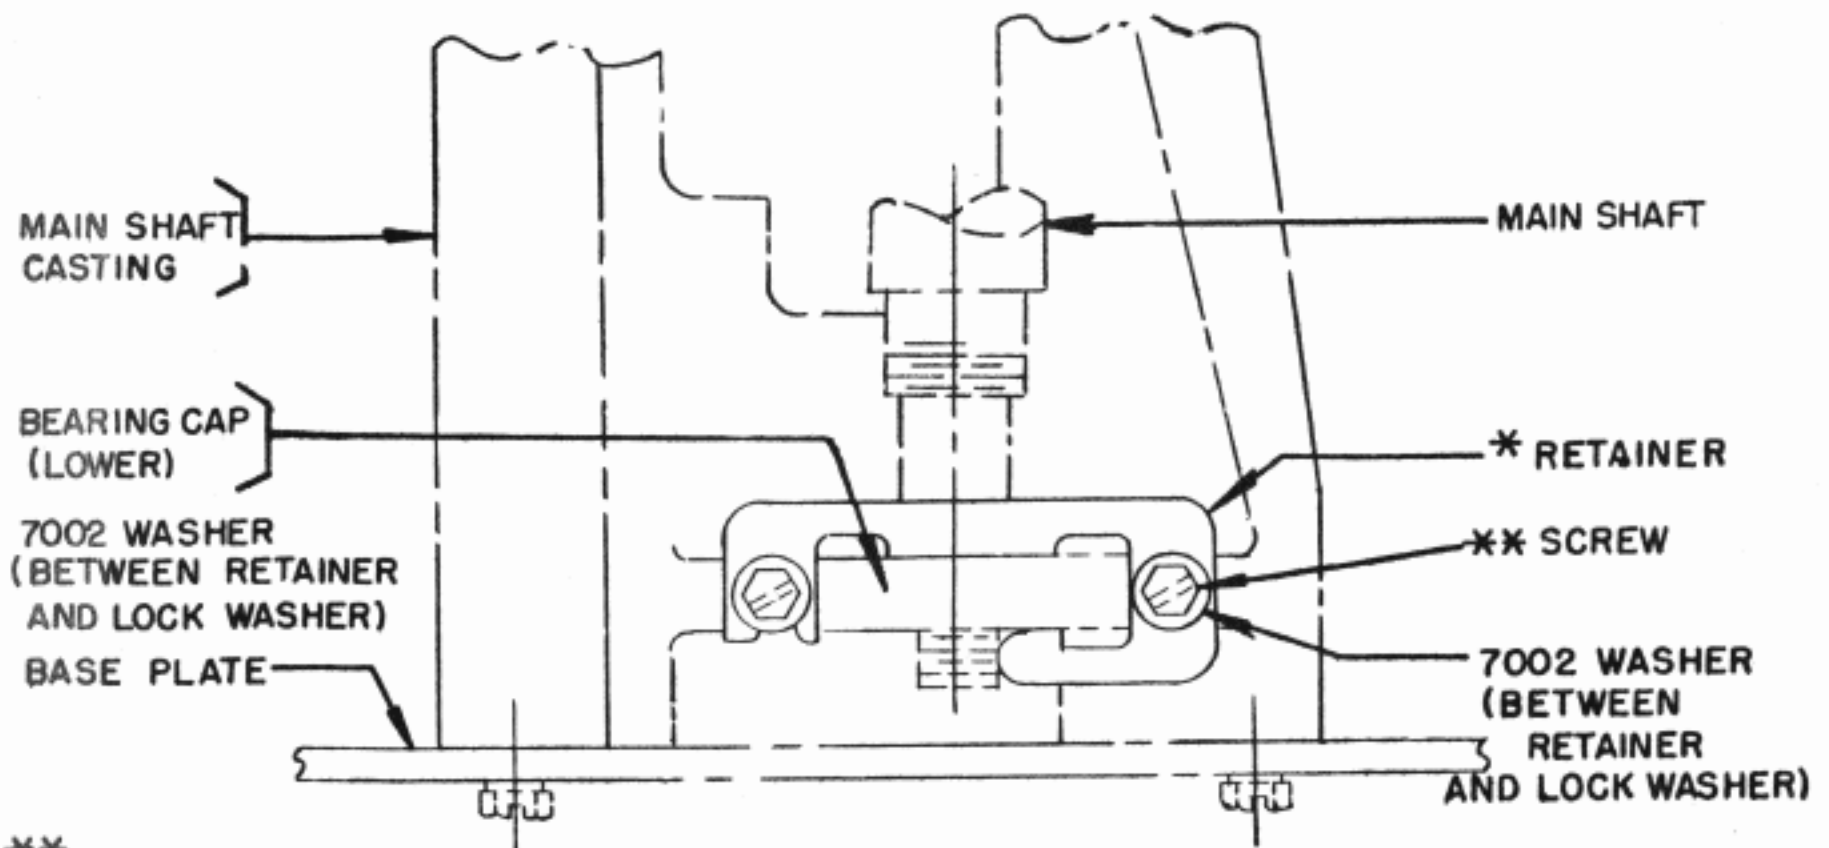
LOWER PORTION OF MAIN SHAFT CASTING

On units operating at high speed or after prolonged use, the main shaft shown in the above bulletins may have a tendency to shift under the bearing caps.

In order to prevent this, two 7002 washers have been added on the upper bearing cap; two 7002 washers and a * retainer have been added on the lower bearing cap and should be mounted as shown below:

- * 120895 retainer (for Bulletin 1130 only)
- * 117387 retainer (for all other bulletins)

** Units with serial numbers lower than 70,000 require 105960 screws (6-40 x 11/16) in place of the 72508 (formerly 6811-6-40 x 5/8) screws (6-40 x 3/4). When the threads of the tapped holes in the 7610 main shaft bracket become damaged a 124613 steel insert may be ordered.
