BUSHIPS

AUGUST 1950

ELECTRON

MODEL TED, A NEW U-H-F TRANSMITTER

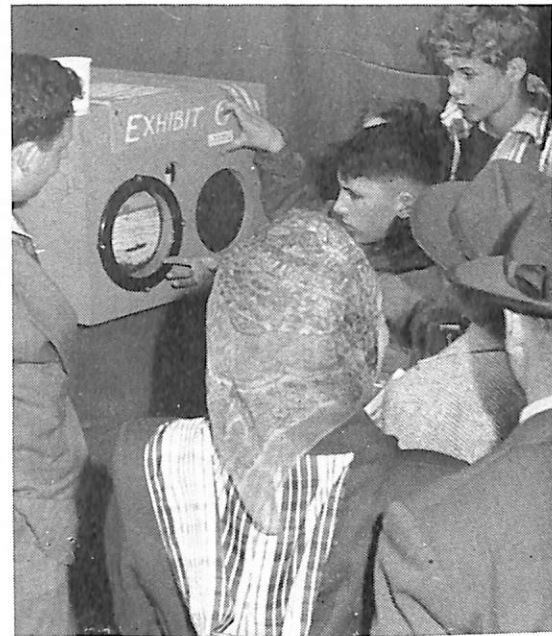
Ultrasonic Transmission—To illustrate the use of ultrasonics in detection, a narrow beam transmitting hydrophone and a receiving hydrophone were so positioned that visitors walking along a chalk line acted as targets, causing the transmitted energy to be reflected at the proper

Echo-ranging exhibit.
