BUSHIPS

ELECTRON

NavShips 900,100

A
MONTHLY
MAGAZINE
FOR
ELECTRONICS
TECHNICIANS

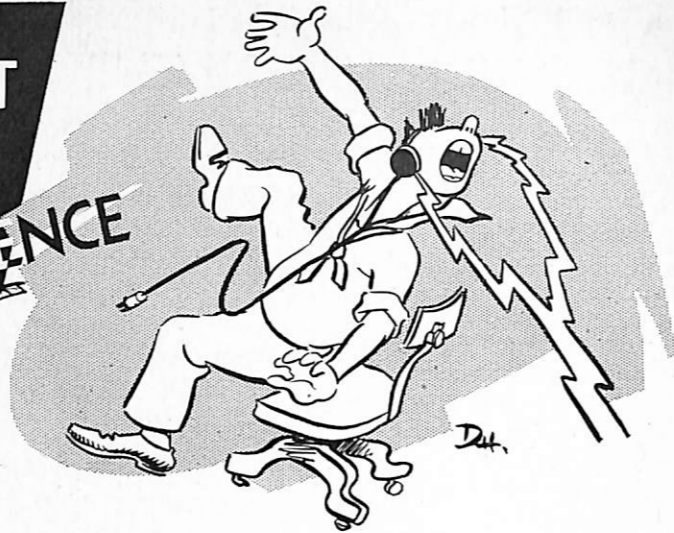
CABLE PLACEMENT AND RADIO INTERFERENCE

Radio interference studies of electronic installations aboard Naval vessels indicate that, frequently, insufficient thought is given to interference problems that may occur as the result of having high level and low level electronic cables installed close together. In the past, when examples of radio interference coupling caused by the improper placement of high and low level cables have been pointed out, the question usually asked is: "What about the cable armor; doesn't it act as a shield for the cables?" The answer is: "Yes, partly." Cable armor is designed for one purpose: cable protection. The fact that cable armor can also be used as radio-frequency shielding is a happy coincidence, but this property of cable armor must be used intelligently. Too often, the shielding effectiveness of cable armor is over-estimated. While the shielding effectiveness of various types of cable armor varies considerably, the greatest radio-frequency attenuation that can be expected from types now in use is approximately 40 db. Expressed as a voltage ratio, the maximum attenuation is approximately 100 to 1. It can be easily seen that considerable leakage of radio-frequency energy can be expected through cable armor, especially from armored cables which are carrying high levels of radio-frequency energy or radio interference.
