BUSHIPS

MAY

THIS ISSUE
CROSS MODULATION INTERFERENCE

1951

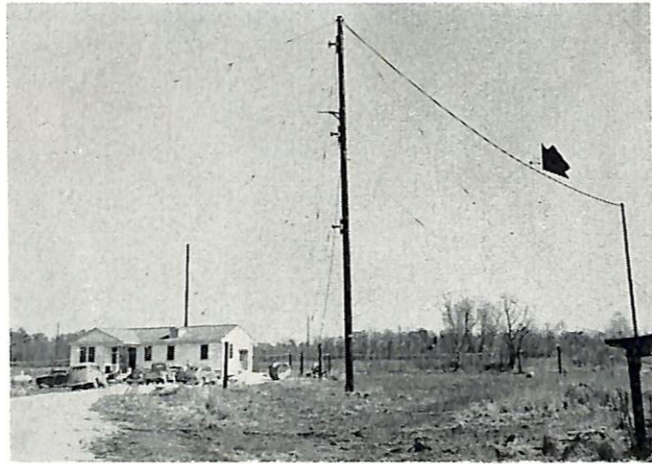
View of some of the antennas at the Navy Radio Station, Belle Chasse, Louisiana. The long wire antenna used with the R-100 receiver is indicated by the arrow.

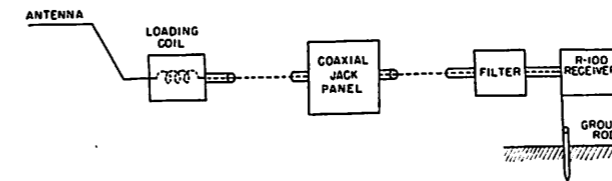
FIGURE 3—Low-frequency receiver circuit.

The filter was inserted in the antenna circuit as indicated in Figure 3. The effect of the addition of the filter and loading coil was immediately apparent. Before the addition of these circuit elements the interference, not only at 500 kc but in this entire region of the spectrum, from WNOE and other broadcast stations was such as to make the receiver virtually unusable. When these circuits were added, however, the interference was completely eliminated. A continuous watch was maintained on the receiver by a regular Coast Guard operator for a period of approximately 2 days, during which time no interference was received on any of the frequencies monitored by the Coast Guard on the frequencies below the standard broadcast band. It is believed, therefore, that this problem has been solved at the Belle Chasse receiving station.

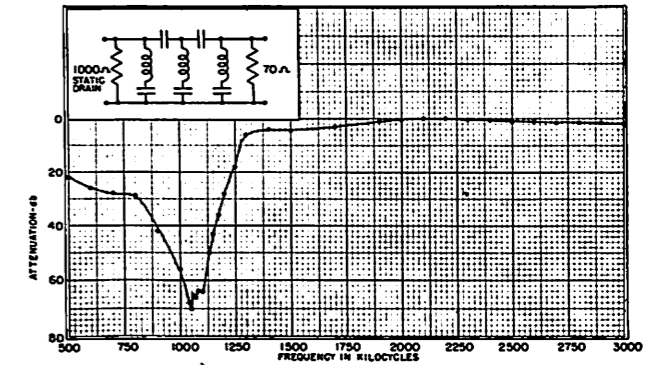
FIGURE 4—High-pass filter circuit and attenuation curve.

mately 1300 kc and theoretically infinite attenuation at 1060 kc. The circuit of this filter and the measured attenuation curve are shown on Figure 4. This filter was inserted in the circuit as indicated in Figure 5.

As the result of the insertion of the filter the interference to various high frequency signals was greatly reduced, and in most cases the interference present from WNOE was well below the noise level, although occasionally audible. In addition, second harmonic interference was noted from WSMB and WDSU.

3—The filter should be redesigned to reject WSMB and WDSU as well as WNOE. It is believed that the second harmonic pick-up from these stations may be generated inside the receivers rather than being radiated from the station itself. Although these harmonics are measurable on the field intensity meter, there is no way of knowing whether this is due to the generation of harmonics in the meter or to actual radiation. This will also eliminate the possibility of cross modulation due to the signals from these stations. In the event that second harmonic fields are still indicated, the only solution is to solicit the cooperation of the stations in installing proper harmonic filters.

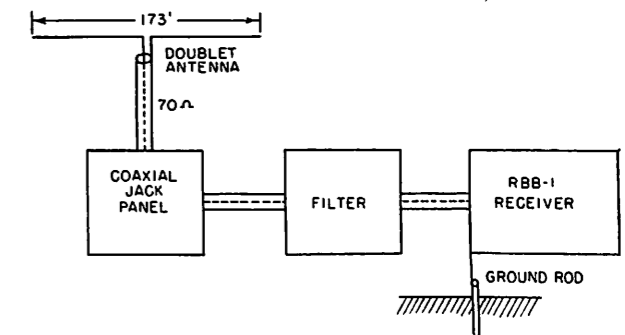
FIGURE 5—High-frequency receiver circuit.

The antenna which was used for this receiver was a doublet approximately 170 feet long and connected at its center to a coaxial transmission line having a characteristic impedance of 70 ohms. It was suspended approximately 90 feet above the earth. No transformer or other device was used to transfer the circuit from balanced to unbalanced operation. The input impedance of the transmission line was measured at 2670 kc and was found to be approximately 25-j70 ohms. Since an antenna of this length at this frequency would be expected to have an impedance very close to the characteristic impedance of the transmission line itself, this is not the expected value for the input impedance of the transmission line. It is believed that this discrepancy is due to the fact that no circuit was used to convert from balanced to unbalanced operation, and accordingly the vertical portion of the transmission line was acting partly as an antenna and partly as a line, thus resulting in an improper value of impedance at its terminals.

1—A balanced to unbalanced transformer be installed between the antenna and the transmission line. This will enable the outer conductor of the coaxial line to be maintained at ground potential. This will prevent pick-up of the strong vertically polarized field radiated by the broadcast stations. In addition, it will make the system less sensitive to pick-up of noise from fluorescent lights, automobile ignition, teletype machines, electric typewriters, etc., inasmuch as the doublet itself is removed some distance from these interfering sources and the coaxial line itself will no longer be sensitive to pick-up from them.

2—A suitable ground system should be installed. At the present time the only ground system consists of brass rods driven into the ground at various points. This is not sufficient to maintain an equi-potential surface. This increases the susceptibility of the system to pick-up in the power line leads and makes it impossible to maintain the outer conductor of the coaxial lines at ground potential.

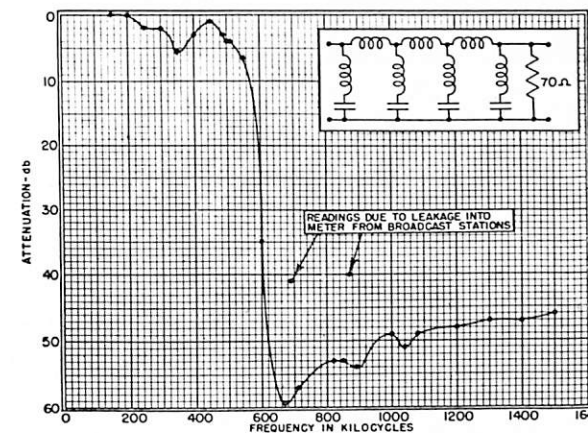
FIGURE 6—Low-pass filter with broad band attenuation.

between WNOE, WWL and WVEZ. At this location the signal strength from the three stations was much more nearly equal and was considerably stronger from WWL and WVEZ than at Belle Chasse. Accordingly, a filter which would reject all three frequencies was indicated. A circuit of the filter together with a measurement of the attenuation curve is shown in Figure 6. This was then inserted in series with the receiver as at Bell Chasse receiving station. As in the case of the high frequency receivers at Bell Chasse, this filter greatly reduced the interference at 500 kc but did not completely eliminate it, inasmuch as it could still be heard occasionally at a level comparable to that of atmospheric noise. In order to eliminate this problem completely at Algiers additional steps are indicated as tabulated below:

2—An adequate ground system should be installed. The ground system of this installation is particularly deficient. The system is for the most part for steam and water pipes which are in themselves a source of cross modulation. While the physical location of this receiving station is not such as to allow the installation of a really adequate ground system, a considerable improvement can be made over the present situation which would also make it possible to eliminate pick-up due to the power cords leading to the receiver.

3—All the receivers in this room should be provided

with filters which will prevent strong broadcast signals from entering them. If this is not done, there is always the possibility that cross modulation will occur within the receivers which will be reradiated and picked up by other receivers. Thus, it is not sufficient merely to provide filters for those receivers which are intended to be used at 500 kc.

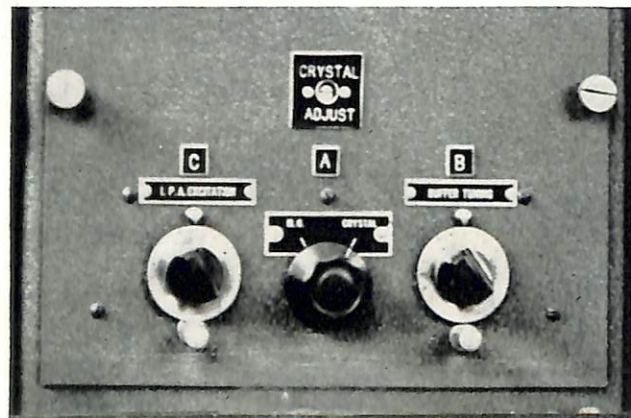
FIGURE 1—Model TDW front panel.

backward readily between the oscillator section and the transmitter frame opening. When this occurs, the cables jam and prevent closing the oscillator section. This necessitates withdrawal of an entire transmitter section to adjust the cables to provide for closing of the oscillator compartment. Safety requirements dictate that all transmitter sections, using the power supply providing power for the transmitter being adjusted, must be secured so that this cable may be properly placed.

oscillator control condenser C-1, to the inside of the oscillator compartment front panel as shown in Figure 1. This control is presently installed on the oscillator compartment deck. It is required that three holes be drilled in the front panel as shown in Figure 2. The lead from the crystal socket to C-1 is threaded through a grom-

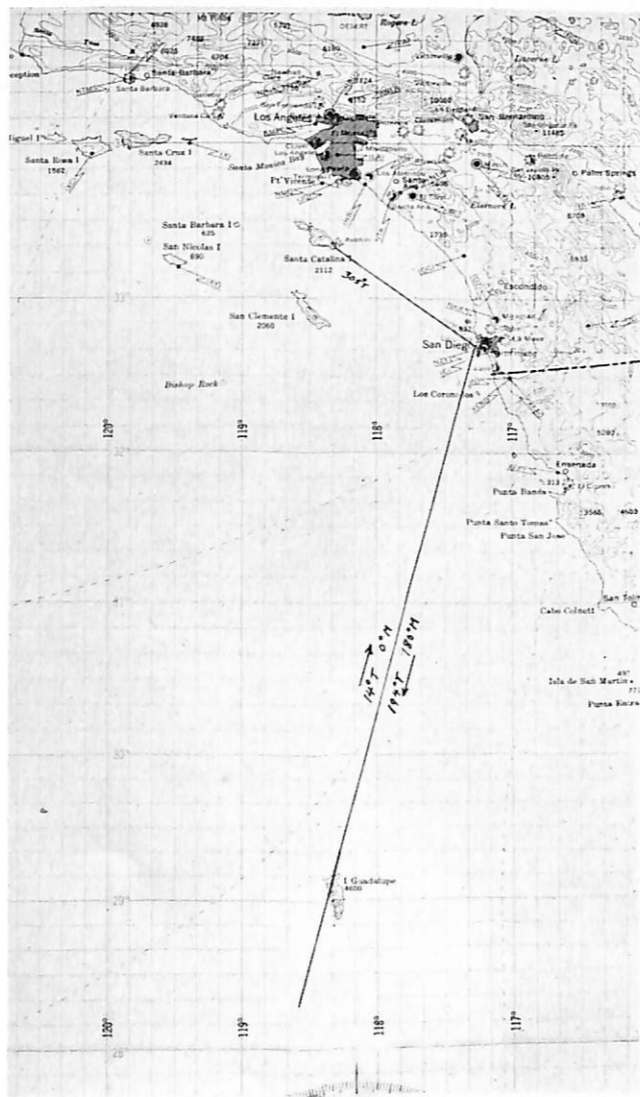
FIGURE 2—A map of the Southern California and Mexican region showing the coast and the islands.

the map, Figure 2. During an interval of time of nine minutes after detection Ghost 80 had gradually assumed a semi-circular character as shown in Figure 3. The intensity of Ghost 42 was observed to fade slightly. Fourteen minutes after detection the intensity of Ghost 80 was observed to fade and the semi-circular rings were noted to disappear. The intensity of Ghost 42 had faded considerably and the associated semi-circular rings had virtually disappeared. A typical A-scope presentation of Ghost 80 is shown in Figure 4. The range and bearing of the prominent echo is 83 miles, 210°. Figure 5 was taken two minutes later at which time the prominent 83-mile echo had markedly faded. The periodic fading in and out of Ghost 80 and Ghost 42 and their associated semi-circular rings proceeded at intervals of from fifteen minutes to two minutes during the course of the observations. The fading of these ghosts became more frequent and more marked as the course of the afternoon proceeded, during which time the effects of the

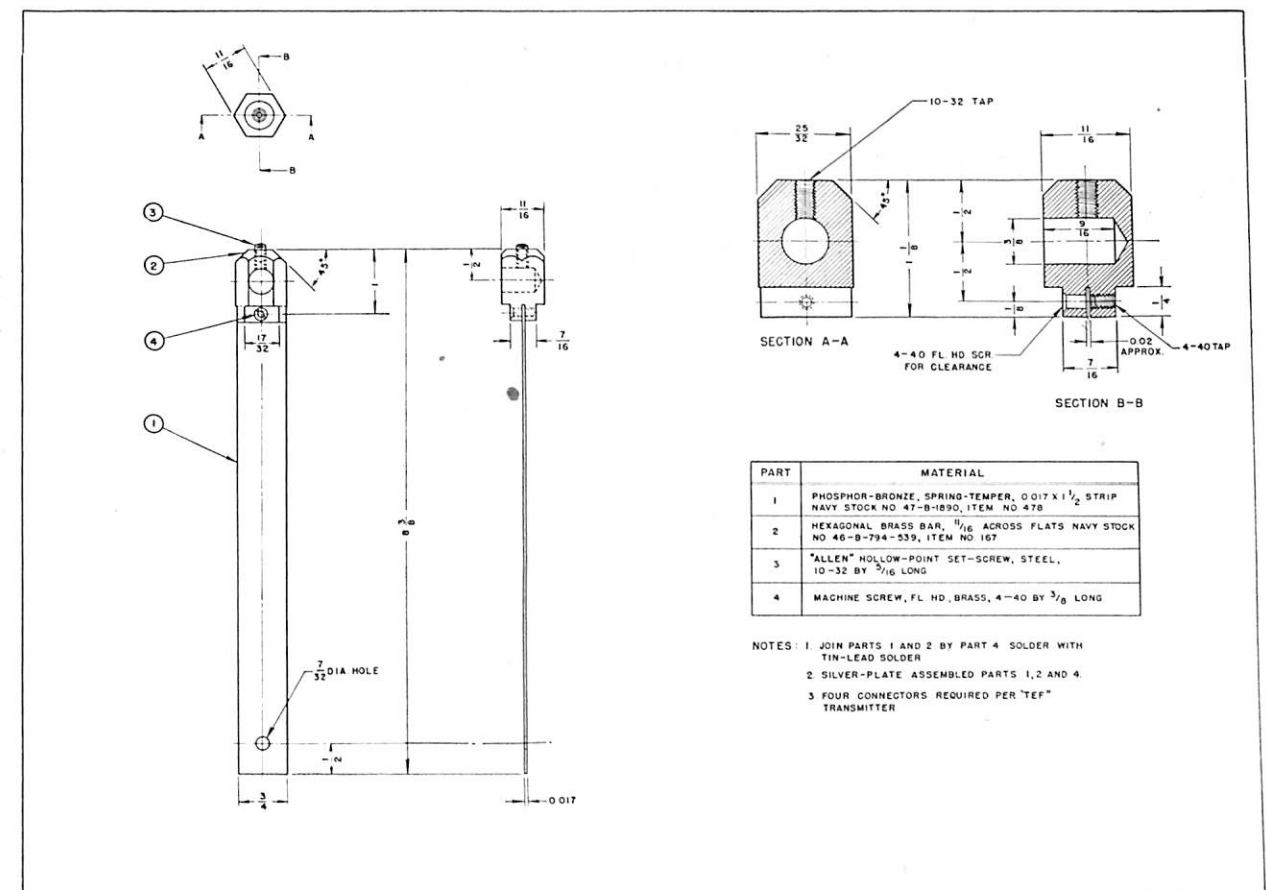
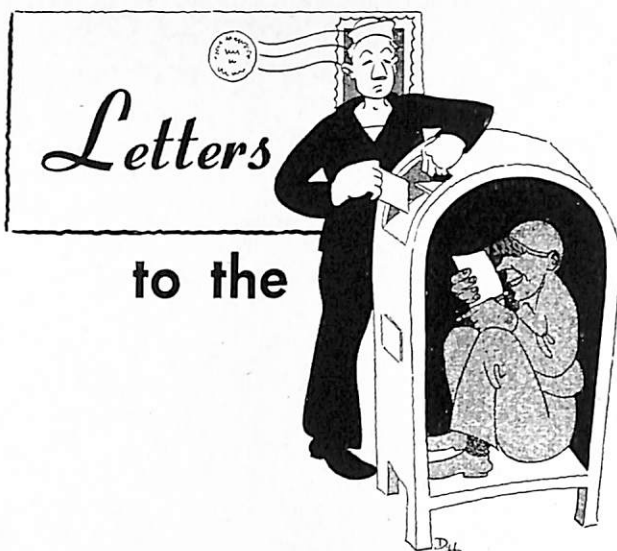
The Bureau has been notified that deficiencies exist in the power amplifier tube filament connectors of the Model TEF single side-band transmitters. The connector material is flat, tinned copper braid, used as flexible connectors. Both ends of the braid are filled with solder for about one-half inch to make them stiff. Holes are drilled in each stiffened end, for securing one end to a screw terminal, and for attaching a split cylindrical terminal to the other end. The cylindrical terminal is designed to fit over the tube filament prongs, relying on friction for mechanical and electrical contact. After prolonged usage the connectors show two deficiencies. The terminal screws loosen at both ends, due to cold flowing of the soldered braid, and the cylindrical sleeves overheat, discolor and lose stiffness due to insufficient metallic contact area for the filament current.

Navy Communication Station, Annapolis, has designed a connector which has overcome these deficiencies. The drawing shows this connector together with a list of materials and instruction for assembly.

The Bureau approves this modification to be made on an optional basis. No kits are to be provided. Materials may be obtained from Navy stock.
