Section 4
DIRECTION-FINDING EQUIPMENT
D Series

SECTION 4. DIRECTION-FINDING EQUIPMENT

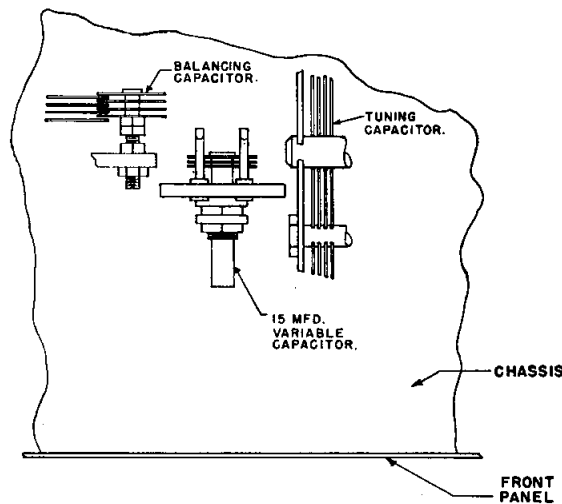
FIGURE 3.—Mounting position.

should be mounted approximately three inches back of the front panel of the case on the top side of the chassis midway between the balance capacitor and the tuning capacitor as shown in Figure 3. The rotor is connected to the antenna terminal of the sense balance switch and the free end of

the resistor is soldered to the forward side of the forward section of the balance capacitor stator.

In operation, the 15-mmfd. condenser is adjusted to cause the reciprocal bearings to be exactly 180° apart. After this capacitor has been initially adjusted it needs no further adjusting.
