Section 6
COMBINATION TRANSMITTING AND
RECEIVING EQUIPMENT
M Series

SECTION 6. COMBINATION TRANSMITTING AND RECEIVING EQUIPMENT

MODEL MN SERIES TROUBLE SHOOTING NOTES

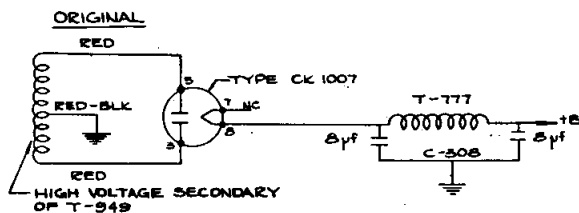
FIGURE 1.—Original socket connections.

In locations where there is considerable a-c line voltage fluctuation, it has been found that the life of the type CK 1007 gaseous rectifier tube in the model MS power supply is short.

The operation of the equipment may be improved by substituting a type 5U4G rectifier tube for the CK 1007 tube. Power is supplied to the filament of the 5U4G from a 110- to 5-volt step-down filament transformer. The secondary of the transformer should be capable of supplying 3 amperes continuously. Use of the 5U4G tube will require rearranging the socket connections as shown in Figures 1 and 2. Socket pin connections for the 5U4G are shown in Figure 3.

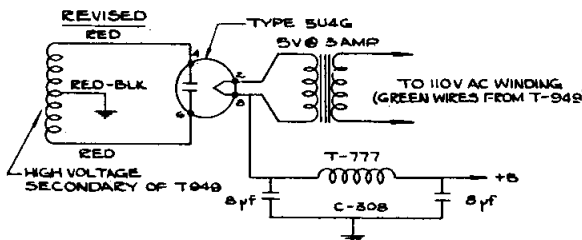
FIGURE 2.—Revised socket connections.
