Section 9
TRANSMITTING EQUIPMENT
T Series

COMMUNICATION EQUIPMENT MAINTENANCE BULLETIN

SECTION 9. TRANSMITTING EQUIPMENT

MODEL TU SERIES TROUBLE SHOOTING NOTES

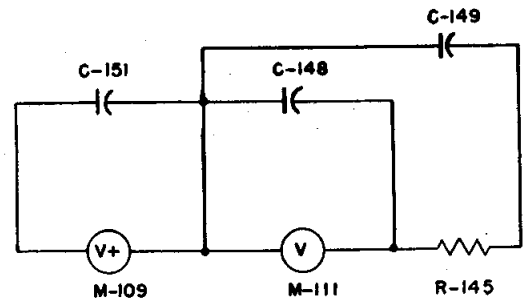
FIGURE 1.—Circuit before and after modification.

General.—Reference to the schematic diagram in the instruction book for the subject models indicates that the failure of meter bypass capacitor C-149 will short circuit the me-

ter multiplier R-145, thereby applying a very high potential directly across the meter. By placing the "low" side of C-149 directly to ground at the junction of M-111 and C-148, the failure of C-149 would not damage the meter in any way.

Purpose.—To preclude failure of meter bypass capacitor C-149 and short-circuiting of meter-multiplier R-145.

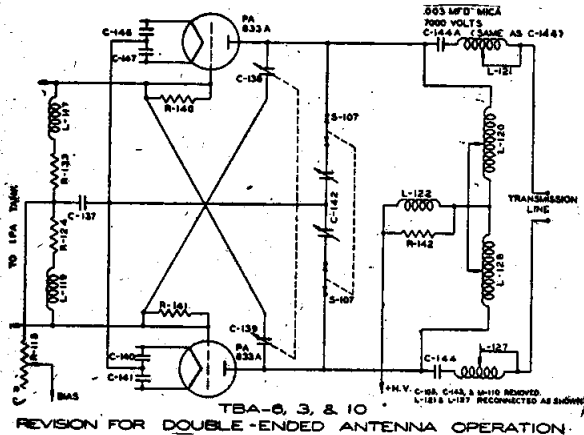
FIGURE 1.—Revision for models TBA-3, -6, and -10.

Purpose.—To obtain balanced output for double-ended antenna operation.

Procedure.—Revise the circuit as shown in Figure 1 to provide satisfactory loading into a 600-ohm transmission line.

Operation over the complete range may be obtained by the addition of a small amount of inductance in series with L-121 and L-127. The Navy type 50118 antenna coupling unit provides balanced output for the TBA series equipments and should be used whenever available, and may be obtained from an Electronics Officer.

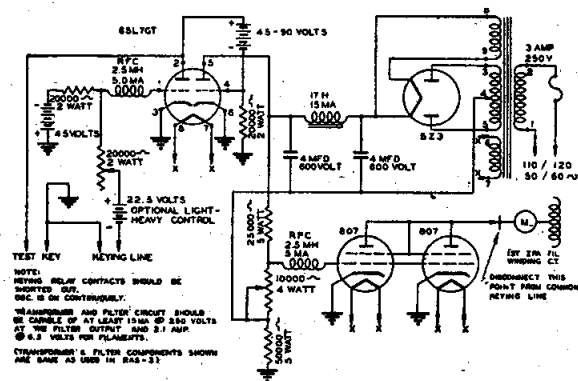
FIGURE 1.—Revision for model TBA-2.

Purpose.—To obtain high speed keying.

Procedure.—Revise circuit as shown in Figure 1 for high speed keying of the TBA-2.

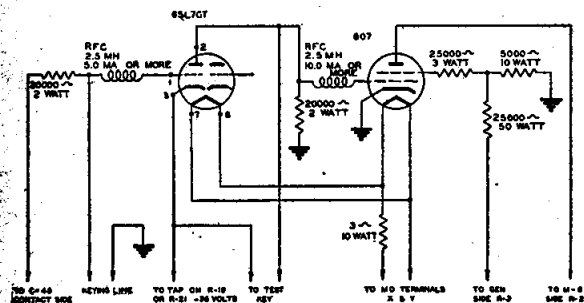
FIGURE 1.—Revision for TBK and TBM equipments not having a built-in keyer tube.

Purpose.—To provide parallel and high speed keying.

Procedure.—Revise the output circuit as shown in Figures 1 and 2.

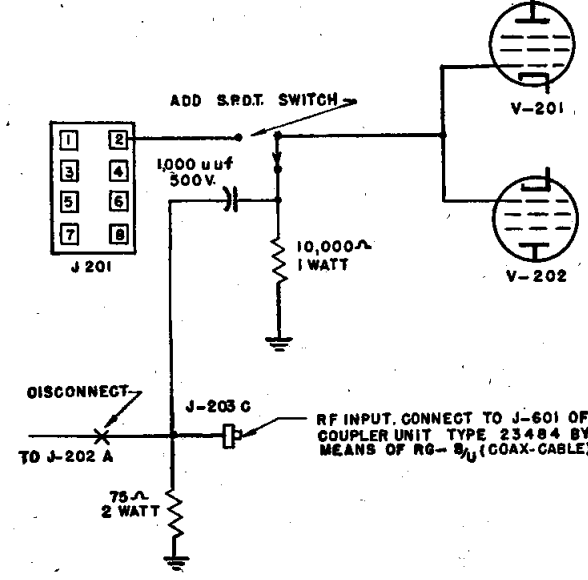
FIGURE 1.—Modification of the O-5/FR exciter unit to permit its use with the master-oscillators of the TBA, TBK and TBM series transmitters.

Purpose.—To permit use of the O-5/FR exciter unit with the master-oscillator of the equipments affected.

Procedure.—Modify the O-5/FR exciter unit as shown in Figure 1 (drawing RE67A107).

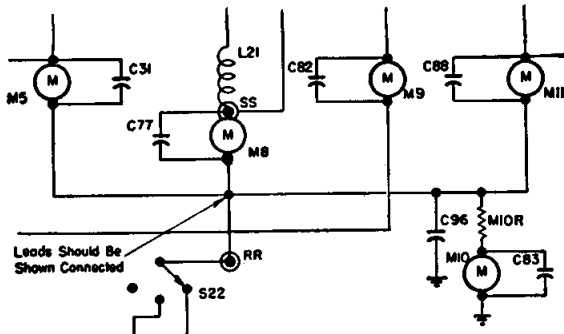
FIGURE 1.—Correction in schematic diagram of TBL-13 power supply.

the 220/440-volt, 3-phase, 60-cycle, a-c power supply of the model TBL-13 transmitter. The diagram appears in two books: the model TBL-13 preliminary instruction book, and the final instruction book for models TBL-5/6/7/12/13, NAVSHIPS 900,381.

The lead from the second amplifier plate-current meter (M-8) is connected to the leads from meters M-5 and M-11, and the diagram should be altered to show the connection as in Figure 1. 10/1/47

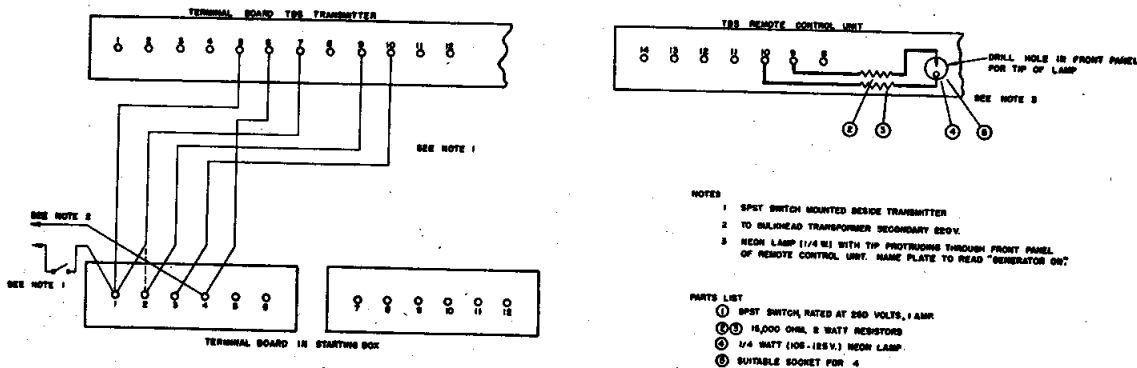
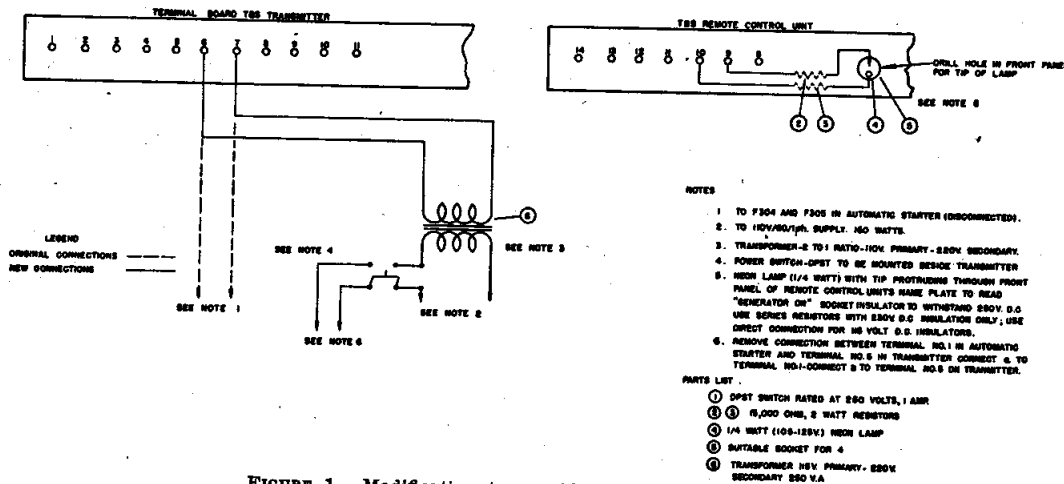
FIGURE 1.—Modification to provide stand-by circuit.

Equipments affected.—All model TBS through TBS-6 series transmitting equipments.
Purpose.—To provide a stand-by condition whereby the tube filaments are energized and the warm-up period eliminated.

Procedure.—(This change should be accomplished as shown in Figure 1.)

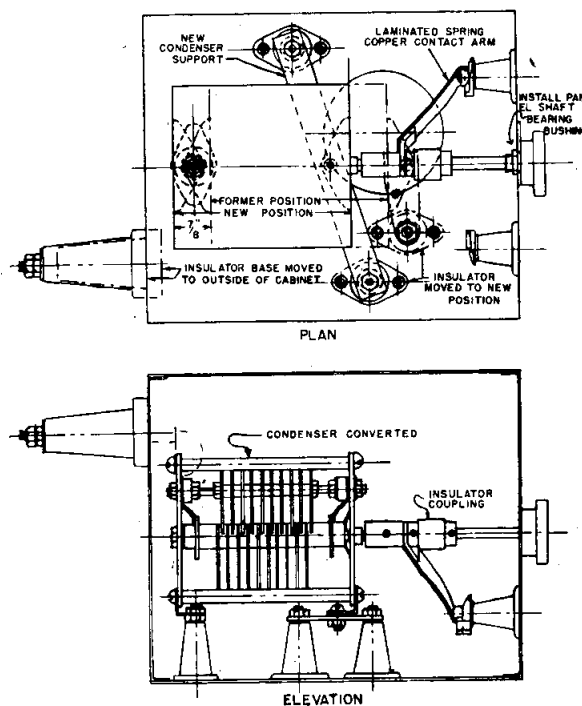
FIGURE 1.—Plan of modification.

(1) The panel end of the condenser shaft is "hot" with respect to radio frequency and operators have received burns through the pointer hand knob.

(3) The variable tuning condenser is center-rear-mounted upon a single stand-off insulator, and front-mounted upon a single stand-off insulator which is off center. A shorting switch, integral with the condenser shaft and employing condenser bearings, depends upon friction to make each of two stationary contacts at each end of approximately 270 degrees of rotation. These friction contacts and the stiff bar switch arm employed, when the switch is thrown, place sufficient strain upon the condenser mounting insulators to cause fracture and breakage.

(3) Remove bottom plate with condenser attached. Remove front-mounted stand-off insulator and replace front-mount with two insulators identical to the one removed. Construct a cross bar between the two insulators with a mounting hole for condenser frame centered on bar, thereby obtaining a solid tripod mount.

angles so condenser will be placed in reversed position, top to bottom, and approximately $\frac{5}{8}$ inch to rear of original position, when replaced in cabinet. This permits additional clearance from TCE feed-through bowl.

(11) Attach brass shaft to front end of insulated coupling to extend through panel bushing and mount pointer knob, lining it up with condenser rotor and with switch arm.

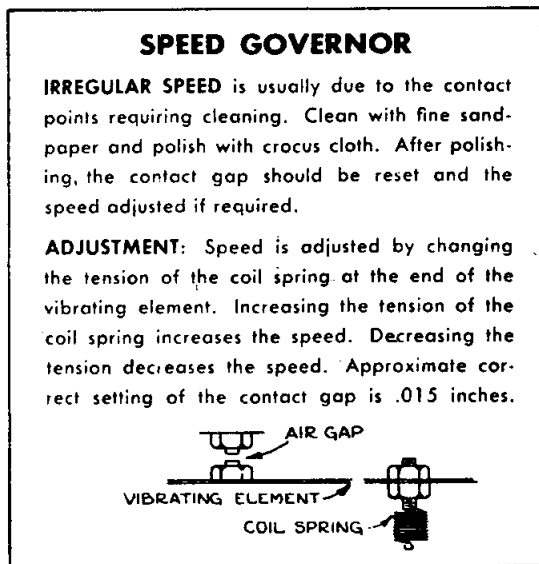
FIGURE 1.—Adjustment of speed regulator.

If under adverse circumstances, the voltage fails to build up when the set is started:

- (1) Check above points (1), (2) and (3).
- (2) Determine whether or not generator is operating at rated speed. If speed of d-c motor is too high or too low, and voltage at motor terminals is correct, then adjust speed regulator as per Fig. 1.
- (3) If generator still fails to pick up voltage, the fields may be flashed with a 1½-volt no. 6 d-c cell. (See Fig. 2 for connections.) Flash fields with machine operating at rated speed.

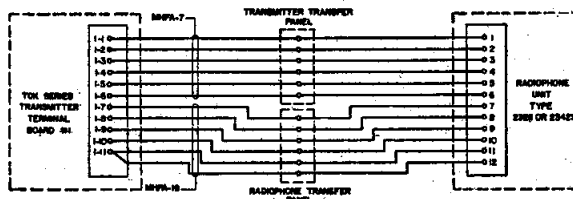
FIGURE 1.—Wiring necessary for interconnection of model TCK series transmitters with standard radiophone unit

Model TCK series transmitting equipment has recently been added to the radio allowance of certain Naval vessels. It is noted, however, that the instruction books for current models of this equipment do not indicate clearly the wiring necessary to incorporate the installation of the present "6-wire" system. This information will be included in the instruction books furnished with subsequent models. Meanwhile, the wiring shown in Figure 1 should be followed for current installations.

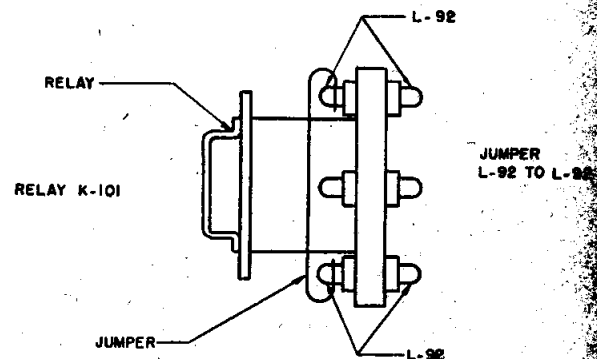
FIGURE 1.—Modification of relay K-101.

General.—Failure to make satisfactory contact when in the "energized" position is responsible for most of the difficulty. The trouble is reported to result from one or more of the following conditions: poor spring tension; contact

Procedure.—Place the jumper as indicated in Figure 1, from L-92 to L-92.

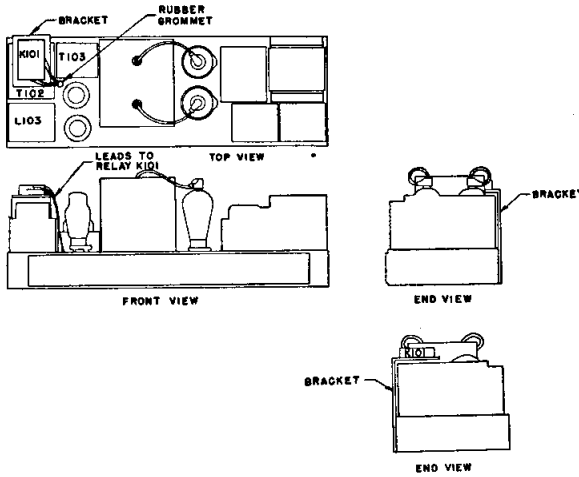
FIGURE 1.—Outline of power supply PP-338/U showing location of relay K-101.

is mounted on the under side of the chassis which renders it extremely difficult to maintain and inspect. Mounting this relay on the upper side of the chassis as shown in Figure 1 will effect a saving of time and personnel in the maintenance and repair of this unit. The modification requires construction and installation of

a simple angle bracket, as shown in Figures 1 and 2. The leads to the relay may be brought up through a rubber grommet, as shown in Figure 1. The modification may be performed by Navy Yard personnel using standard stock material. No special tools are required. 1/1/51

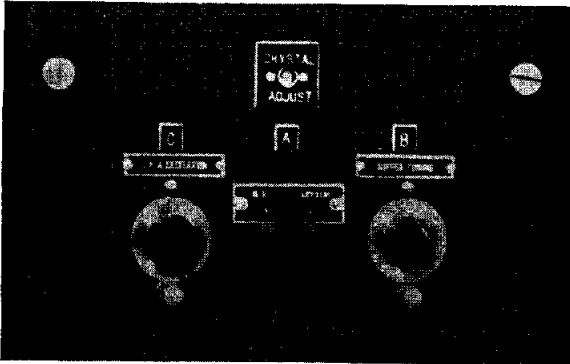
FIGURE 1.—Front panel of TDN equipment showing location of crystal adjust capacitor C-1.

C-1. Install ground wire direct from C-1 to crystal socket mounting screw.

1. Drill 3 holes in panel for relocation of C-1.
2. Install insulated bushing in shaft hole of original position of C-1 for lead from crystal socket to

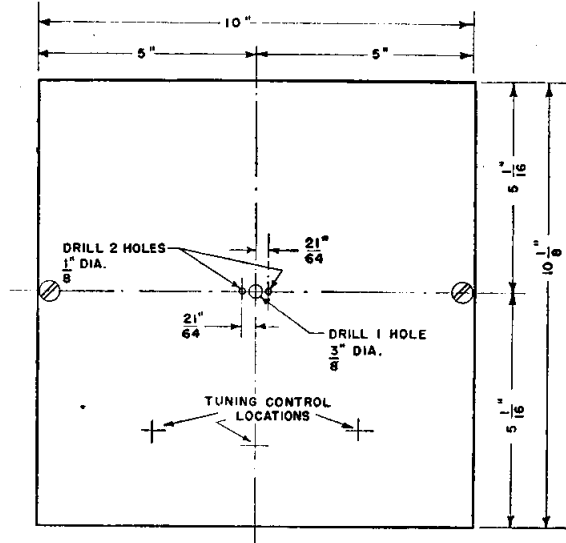
FIGURE 2.—Template for relocation of TDN capacitor C-1.

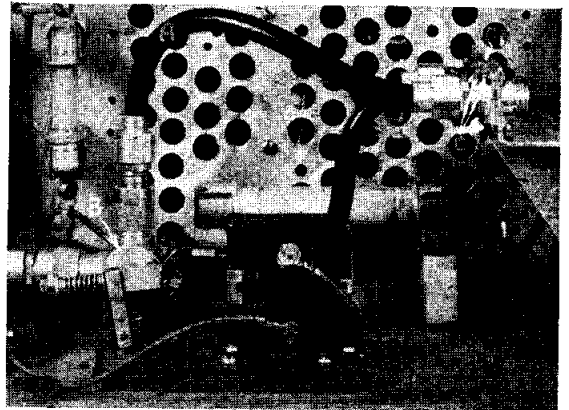
FIGURE 1.—Model TDQ before installation of transmission line filter.

The filter and associated male cable connector replace the existing cable connector between the antenna switch and the outlet chassis fitting. This is shown in Figures 1 and 2.

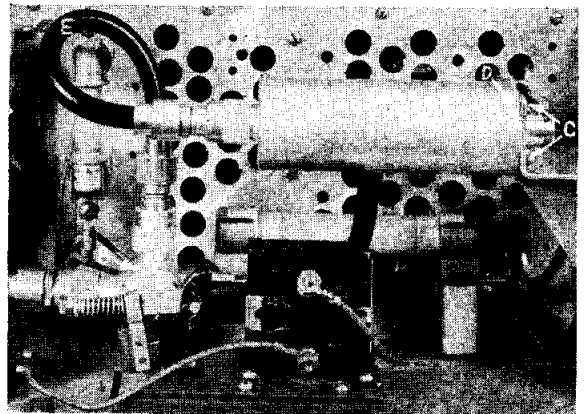
FIGURE 2.—Model TDQ with the transmission line filter installed.

(3) Remove burrs and any corrosion products from bracket in order to provide a good electrical contact. Secure the filter to the bracket with the four 4-40 machine screws C and lock washers previously removed.

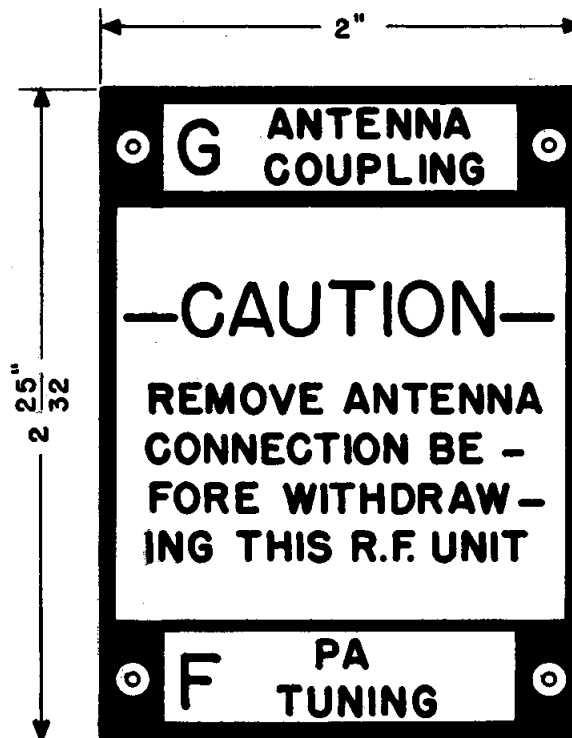
Purpose.—To aid in eliminating trouble when the transmitter r-f section is removed without first removing the antenna connection.

FIGURE 1.—New CAUTION nameplate for model TDQ transmitters.

Procedure.—Remove the G ANTENNA COUPLING and F PA TUNING existing nameplates. Install the new nameplate using the same mounting holes. Figure 1 illustrates the design of the new nameplate.

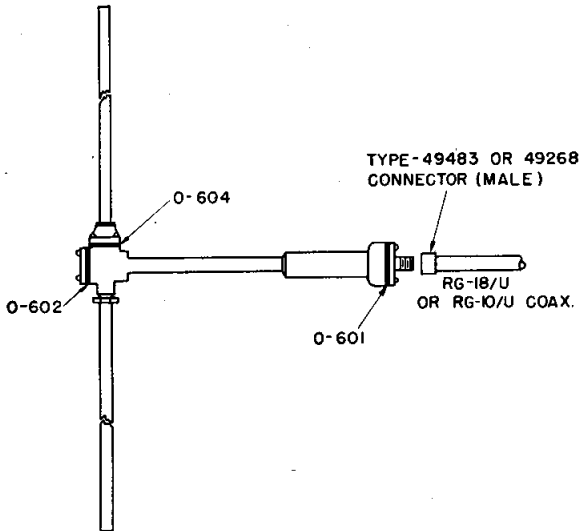
Several reports have been received by the Bureau recently concerning failure of the Type 66095 antenna as used with the Model TDQ equipment. Many of the reports state that the mounting-gaskets deteriorate over a period of time, allowing moisture to enter the housing and thereby grounding the antenna. Investigation reveals that these faults can be attributed either to poor installation or to loosening of the bolts by vibration.

Vibration is the cause of the majority of failures. It is therefore necessary that the Type 66095 antennas be inspected for low resistance

FIGURE 1.—Location of TDQ gaskets to be checked on antenna.

As to the former cause, installing activities are cautioned to install the gaskets and insulators properly and to make sure that the bolts are drawn up tight. Glyptol should be applied to the bolts to aid in preventing them from becoming loose.

and grounds more frequently than is done in routine maintenance procedure. It is recommended that the arrays be disassembled and inspected when low-strength radiation and reception are experienced. Failures of this type cannot be determined by visual inspection alone. After inspection and cleaning, the arrays should be reassembled. New gaskets should be used and care should be taken that the gaskets and insulators are installed properly and that the bolts are drawn up tight. Glyptol should again be applied to the bolts in each instance to insure against loosening due to vibration.

The gaskets are carried as part of the equipment, tender, and stock spares. Figure 1 is an illustration of the antenna, and shows the gaskets, 0-601, 0-603 and 0-604, that should be checked. 7/1/48

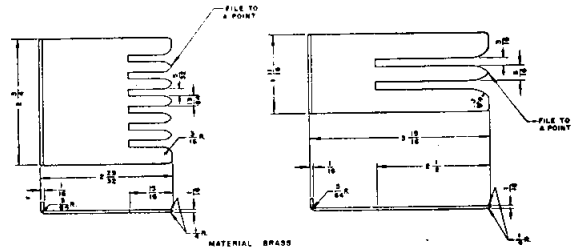
FIGURE 1.—TDQ contact alignment tool.

A beneficial suggestion submitted by Ellis C. Harder and Verne C. Harris of the Mare Island Naval Shipyard makes provisions for aligning the spring contacts in the rear drawer connectors of the TDQ transmitter. By use of this contact alignment tool the porcelain connector may be assembled in much less time than normally required to align these twelve (12) contacts and insert them into the top half of the porcelain connector.

sheet-brass formed as shown in Figure 1. The two comb-like pieces are inserted from adjacent sides of the contact assembly as shown in Figure 2. This compresses and aligns the spring contacts which allows the top half of the contact assembly to be easily placed in position. The tool is then withdrawn and the connector secured to the chassis in the required manner.

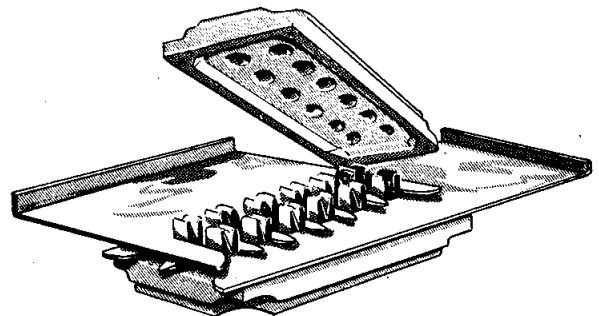
FIGURE 2.—Illustration showing the use of the TDQ contact alignment tools.

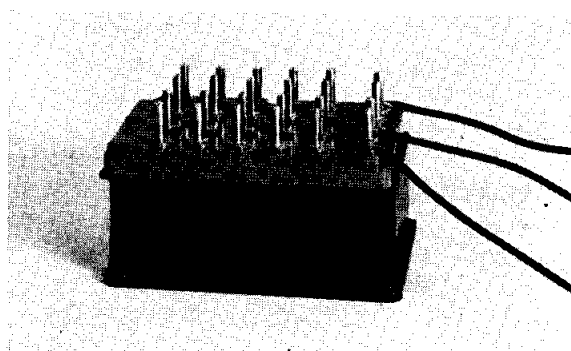
FIGURE 1.—Bottom view of crystal oven showing test leads connected to heater pins W, Y, and Z.

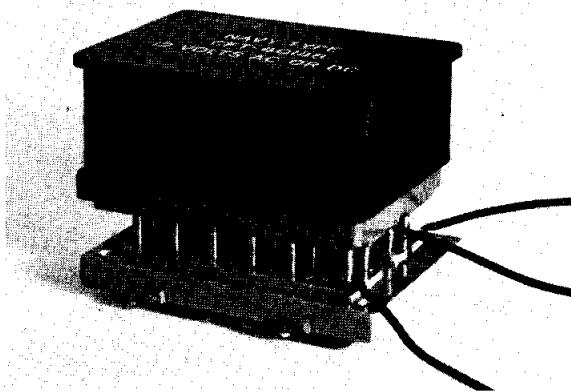
FIGURE 2.—Crystal oven and oven socket showing test leads connected.

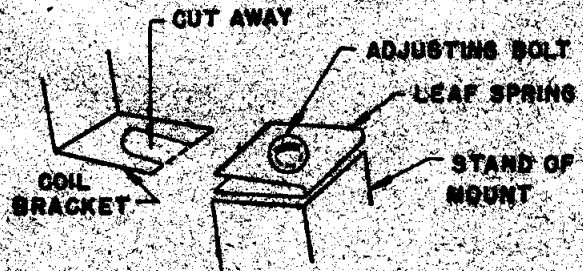
The variable inductances in the high power stages are very difficult to service. In order to

FIGURE 1.—Revised method of mounting the variable inductances of the model TED equipment.

facilitate their removal and replacement it is suggested that the following modification be made at the time of installation of the equipment. The inaccessible mounts of the coils should be modified by sawing slots to replace the mounting-holes on the coil brackets. Small phosphor bronze leaf-type springs should be mounted on the standoff insulators which the modified brackets normally are bolted to. The tension of the springs should be preadjusted by adjustment of the bolt to give a snug fit for the spade connectors on the coil mounts. Figure 1 shows this modification.

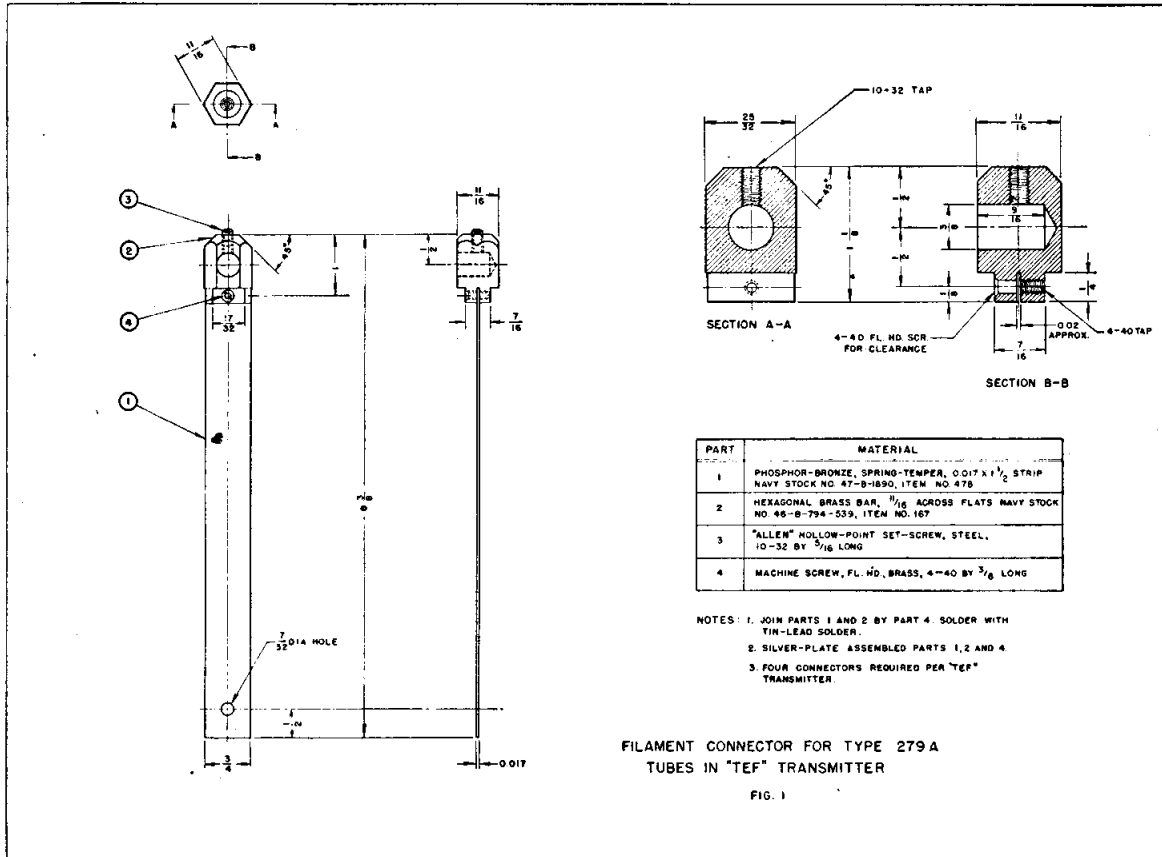
The Bureau has been notified that deficiencies exist in the power amplifier tube filament connectors of the Model TEF single sideband transmitters. The connector material is flat, tinned copper braid, used as flexible connectors. Both ends of the braid are filled with solder for about one-half ($\frac{1}{2}$) inch to make them stiff. Holes are drilled in each stiffened end, for securing one end to a screw terminal, and for attaching a split cylindrical terminal to the other end. The cylindrical terminal is designed to fit over the tube filament prongs, relying on friction for mechanical and electrical contact. After prolonged usage the connectors show two (2) deficiencies. The terminal screws loosen at both ends, due to cold flowing of the soldered braid, and the cylindrical

FIGURE 1. Filament connector for type 279A tubes in "TEF" transmitter.

sleeves overheat, discolor and lose stiffness due to insufficient metallic contact area for the filament current.

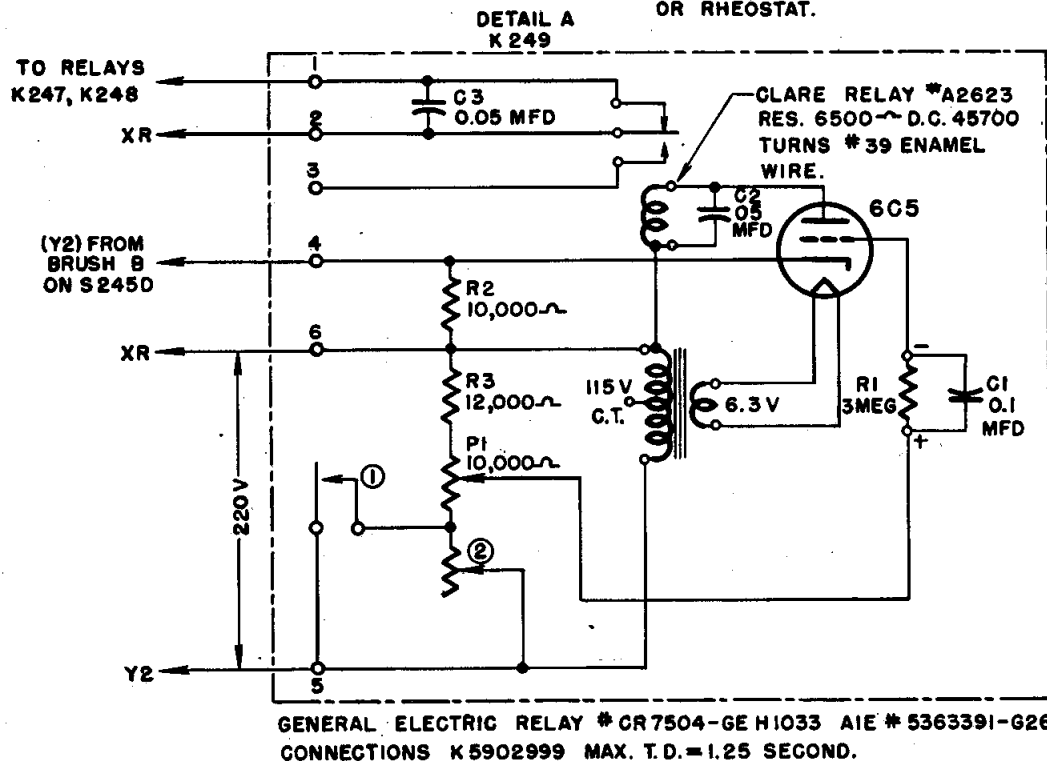
FIGURE 1.—Modified tap-changing timing relay K-249.

1- NORMALLY OPEN CONTACT ADDED TO CW ROTATION RELAY K-247 OR CCW ROTATION RELAY K-248.

2-10,000-OHM WIRE-WOUND POTENTIOMETER, OR RHEOSTAT.

changer rotation. The original timing circuit components are effective for one direction of rotation while in the other direction the additional potentiometer is in the circuit, automatically changing the grid voltage on the timing tube. The additional contacts are mounted on one of the tap-changing motor control relays, either on relay K-247 or relay K-248, depending upon which direction of rotation requires it.
