MODEL RAH SERIES TROUBLE SHOOTING NOTES**DIFFICULTY ENCOUNTERED****CAUSE AND REMEDY**

HIGH HUM LEVEL IN MODELS RAK/RAL SERIES RECEIVING EQUIPMENTS

→ RAK RADIO RECEIVING EQUIPMENT FIELD CHANGE NO. 1 and RAL RADIO RECEIVING EQUIPMENT FIELD CHANGE NO. 1 PROVIDING CONCENTRIC ANTENNA JACK

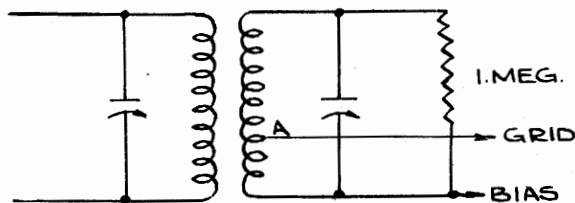
FIGURE 1.—Original connections.

(2) The secondaries of the first and second stage intermediate-frequency transformers have a tap to which the grid was connected in the original installation as shown at "A" in Figure 1. The grid connection was removed from this tap and attached to the extreme end of the coil which

was increased by decreasing the distance between the primary and secondary coils from $1\frac{1}{2}$ " to $\frac{7}{16}$ ". It was necessary to apply heat to the porcelain coil form to accomplish the movement of the primary coil.

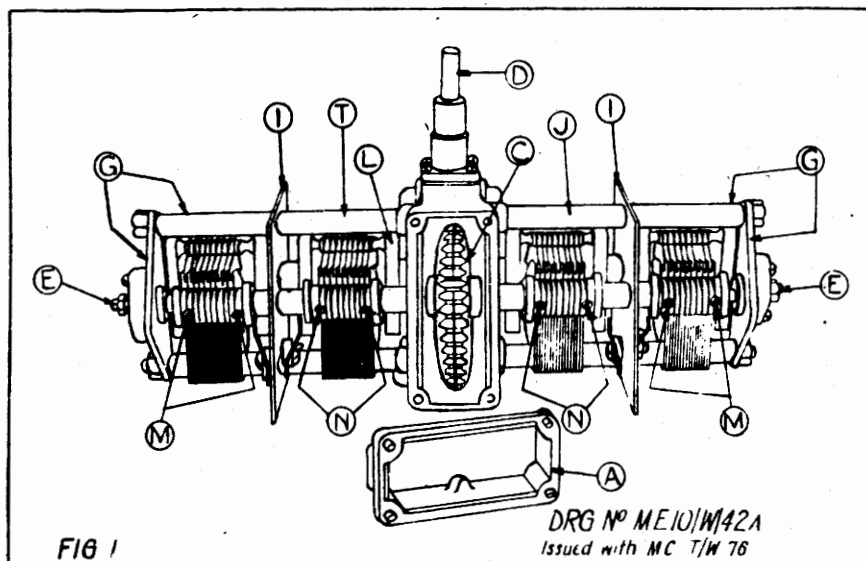
FIGURE 1.—Main tuning condenser assembly.

In certain RAS equipments the drive on the main tuning condenser has seized when working under conditions of high humidity. In order to effect a positive cure for this defect it is necessary to completely strip the assembly, remove a small amount from the bearing surface of the main shaft and finally to impregnate the bakelite covering of the shaft with wax to prevent further ingress of moisture. This modification should be carried out as required, or when an equipment is returned for complete overhaul. The necessary steps are as follows:

(6) Remove four screws retaining gear case top cover Figure 1 (A) and four screws retaining gear case cover Figure 2 (B).

(11) Loosen Allen set screws securing outer rotors Figure 1 (M) to spindle and remove rotors taking care not to distort vanes.

(16) Loosen Allen set screws securing inner rotors Figure 1 (N) to spindle and remove rotors, taking care not to distort vanes.

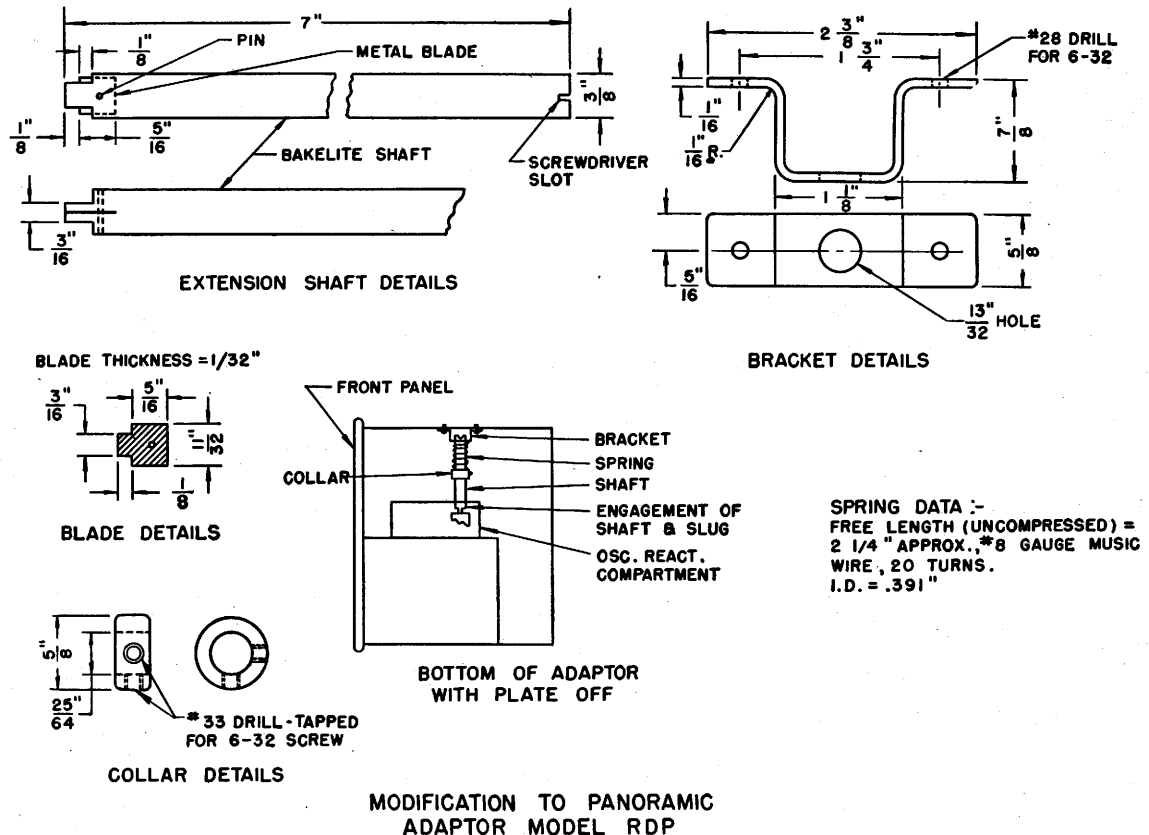
FIGURE 1.—Field change No. 1 to the model RDP panoramic adaptor.

Purpose.—To alleviate alignment difficulties and safeguard personnel.

chassis, and the other end of the shaft is supported by its insertion into the tuning slug assembly. The bracket is mounted by means of 6-32 screws and bolts, for which holes are drilled through the side of the chassis with a #28 drill. A third hole, $1\frac{3}{32}$ -inch in diameter, permits access to the screwdriver slot in the extension shaft. Spring loading is provided

Procedure.—Details of this modification are shown in Figure 1. Minor alterations may be made to meet the particular needs of the activity making the modification.
