4-1 INTRODUCTION

Signal Distortion Resulting from Improper use of Audio Distribution Amplifier Model AD-2 (Cooke Engineering Company)

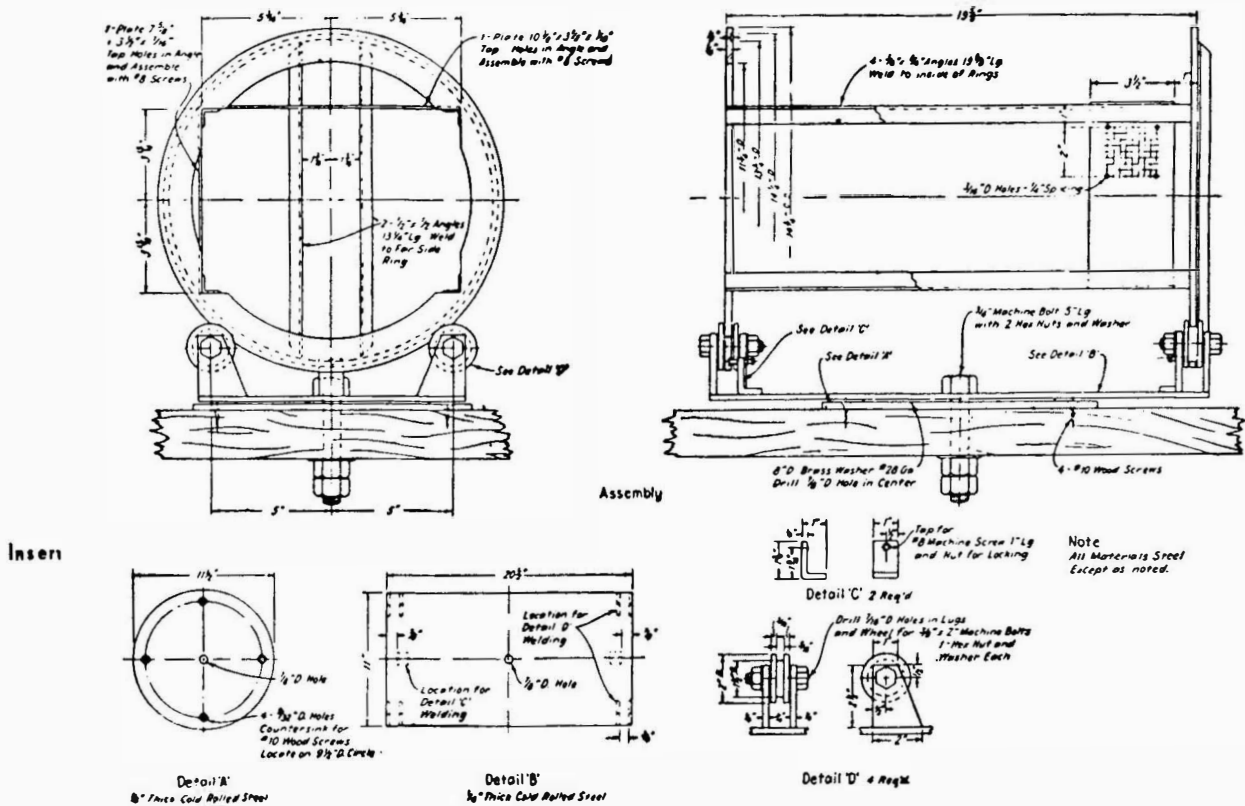
A detail drawing for rotating rack for AN/ARC-1 servicing is shown in figure 1. This type of rack has seen wide use and is a great help whenever any sizeable number of equipments are being repaired. Many activities have manufactured these units but have varied slightly from the original design. The details shown in Figure 1 are those used by NAS Pearl Harbor except for a few slight changes which reduce the amount of machine work and simplify construction.

FIGURE 1 - Detail drawing for the rotary test rack.

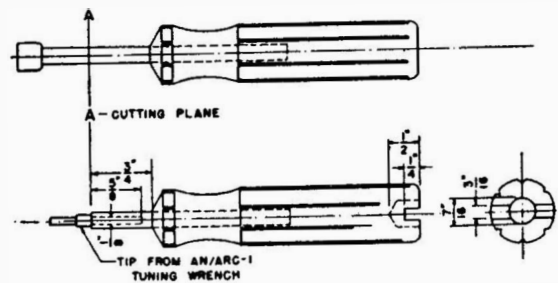
A damaged Excelite nut-driver or screwdriver with slight alteration can be put to good use in maintaining the autotune units of the AN/ARC-1 radio equipments. Figure 1 illustrates how such a damaged article can be utilized together with the autotune adjusting wrench provided with the AN/ARC-1 equipment, to make a useful tool.

FIGURE 1.--Combination tuning and locking wrench

After sawing off the shank at A-A, a 1/8-inch hole is drilled in the end of the shank to a depth of 5/8 of an inch. The tip of the AN/ARC-1 tuning wrench (with the knob removed) is then pressed into the shaft for a press fit. Finally, a 7/16-inch hole is drilled in the handle to a depth of 1/2 inch and a slot cut across the end 3/16 of an inch wide and 1/4 inch deep.

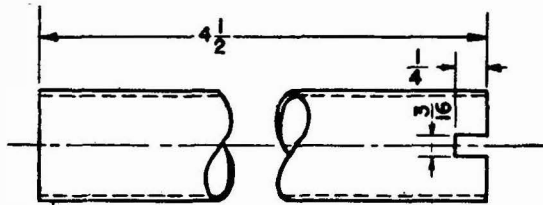
To facilitate this operation and insure the proper tightening of the heads, a technician at NAESU has designed the locking tool shown in figure 2.

FIGURE 1. --AN/ARC-1 locking wrench

It may be constructed in a few minutes out of a piece of seven-eighths inch O. D. brass or fiber tubing.

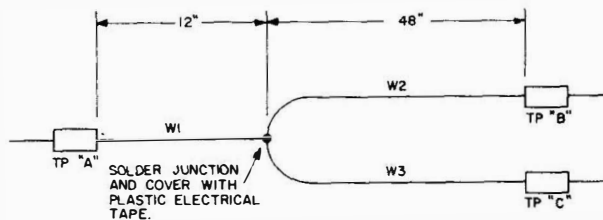
**MATERIAL REQUIRED TO FABRICATE THE SPECIAL TEST LEAD**

1. Remove the special test lead from the system.
2. Set the output level of the TONE KEYER which was under test to the normal operate level.
3. Place the SEND Vu switch on the channel selector panel CS 604 to the 5-8/1-16 position.
4. Set the mode selector switch of the TONE KEYER which was under test to the LINE position. ADVISE OPERATIONS AS TO THE STATUS OF THE CHANNEL CONCERNED.
