**Adjustment Procedures for Amplifier Group AN/GSA-33 and Audio Amplifier AM-413A/G Background.**

**POTENTIAL SHOCK HAZARD IN POWER SUPPLY  
PP-3565/GRC-100A**

**COMMUNICATIONS****AN/PRC-6 REPLACEMENT CAPACITOR C-43**

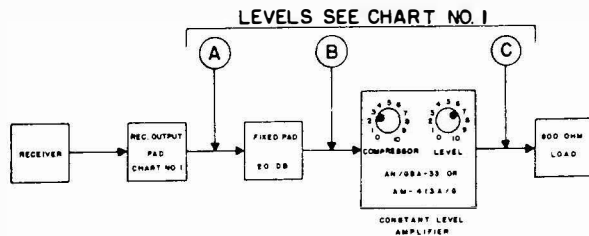
**Figure 1. Adjustment Procedures for: Amplifier Group AN/GSA-33 and Audio Amplifier AM-413A/G.**

The following information is presented, as an interim measure, to aid activities which have experienced difficulty with adjustment of AN/GSA-33 and AM-413A/G amplifiers in an operational status. The basic elements of the system under discussion are shown in block diagram form, figure 1.

The system consists of a receiver, a fixed pad at the output of the receiver (not always required), a fixed 20 db pad at the input to the amplifier, a constant level amplifier, and the load, which in most cases, is either a telephone line or a voice channel in a microwave link.

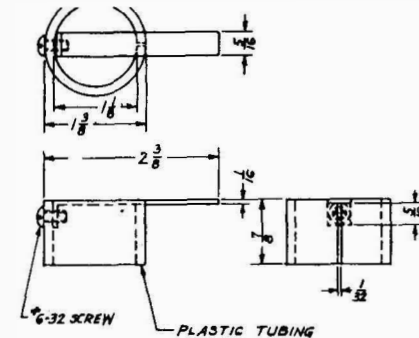
FIGURE - 4

Details of the fast tuning knob, which should be used to turn the tuning knob of the receiver transmitter, are shown in Figure 4. Its use prevents possible injury to fingers,

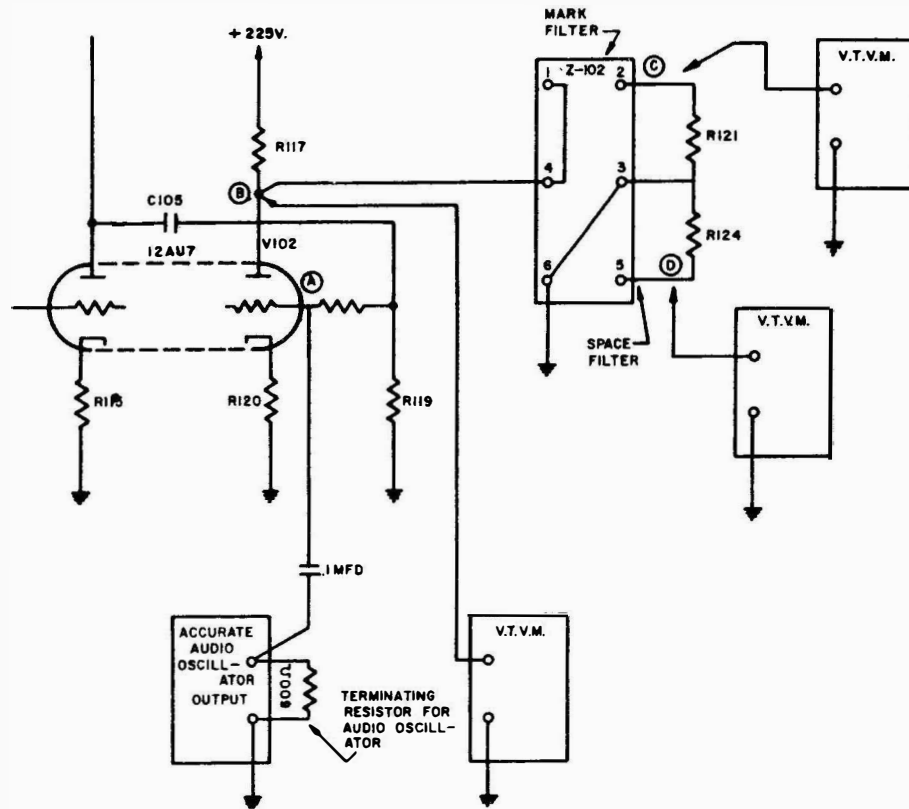
FIG. 2 CONNECTIONS FOR TEST EQUIPMENT

To determine the performance of filter Z102, the test equipment should be connected as shown in figure 2. One vacuum tube voltmeter may be used for all tests. The test procedure follows:

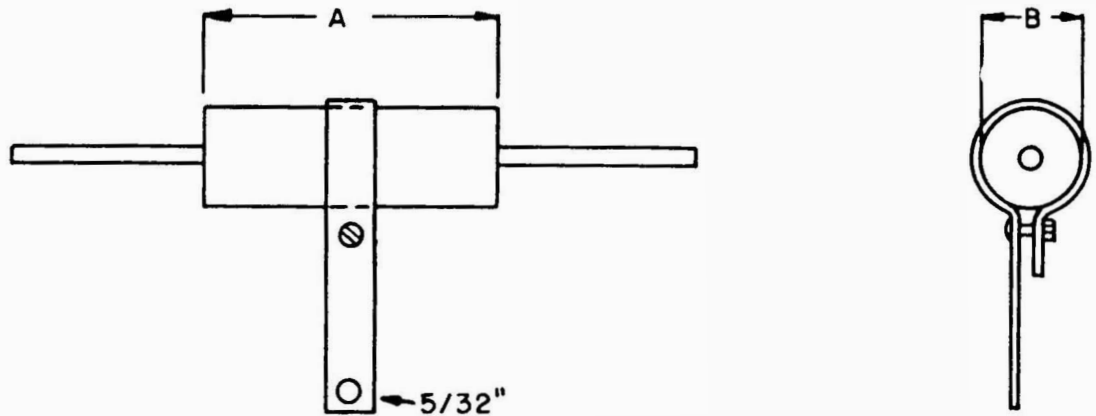
FIG. 4

PHYSICAL DIMENSIONS OF EXTERNAL CAPACITORS

repairs are made by connecting external capacitors in series with the filter. The schematic diagram of the connections is shown in figure 3. The values of capacitors, which will give optimum performance, are best determined by trial and error. To select the range of values to be tried, Table IV may be used as a guide. The test procedure, to determine the performance of the filter should be repeated after each group of external capacitors have been connected into the circuit. If an improvement is noted, the capacitors may be bolted to the chassis and any splices covered with spaghetti. The physical dimensions of the capacitors, are shown in figure 4.
