**AN/SRC-10(), -11(), -12(), -13(), -14(), -15()
REMOVAL OF AUDIO RECEPTACLE WATERPROOF
CAPS**

**AN/SRC-10() THRU -15() AN/SRC-16() THRU -18()
MISLEADING RF OUTPUT INDICATIONS**

**AN/SRC-10 through 15 and AN/URC-16 through 18 Series
Radio Sets-Possible Wiring Discrepancy**

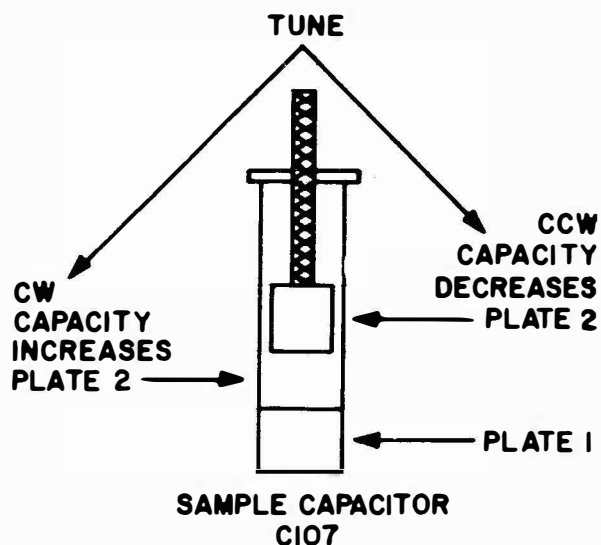
Figure 1. Principle of Rotation vs. Capacitance in Trimmer Capacitor

As an example of rotation versus capacity, tune the sample trimmer capacitor C107 in figure 1 clockwise. The capacity increases as plate 2 moves closer to plate 1. Tune the capacitor counterclockwise and the capacity decreases as plate 2 moves away from plate 1.

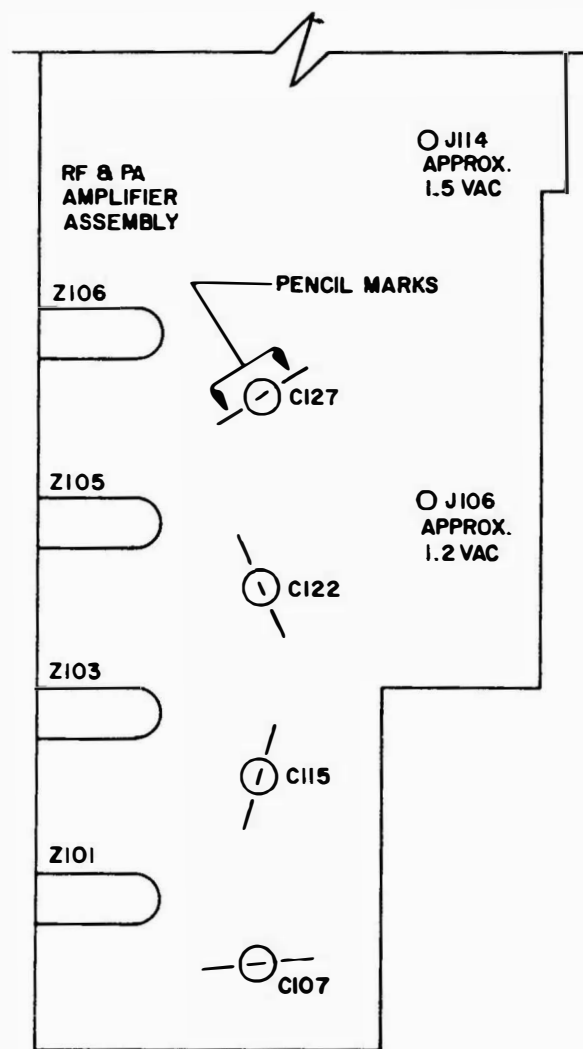
Figure 2. Method of Marking Trimmer Capacitor Positions Before Tuning (754)

- a. Align the RF and PA assembly at 399.9 MHz in the transmit condition.
- b. Pencil mark the position of the trimmer capacitors (see C127 in figure 2).
- c. Decrease the frequency by 10 MHz
- d. Tune the trimmer capacitors and note the direction of rotation versus the up/down direction of PAig on the front panel meter.
- e. Return the trimmer capacitors to the pencil marks.
- f. Bend the tabs of Z101, etc., indicated as follows, based on results of foregoing step d.

Trimmer	PAig	Result
CW	Increase	more capacity required; bend tab in.
CCW	Increase	less capacity required; bend tab out.
CW & CCW	Decrease	optimum capacity do not bend tab.

- g. Repeat steps c through f until tracking is completed. (754)

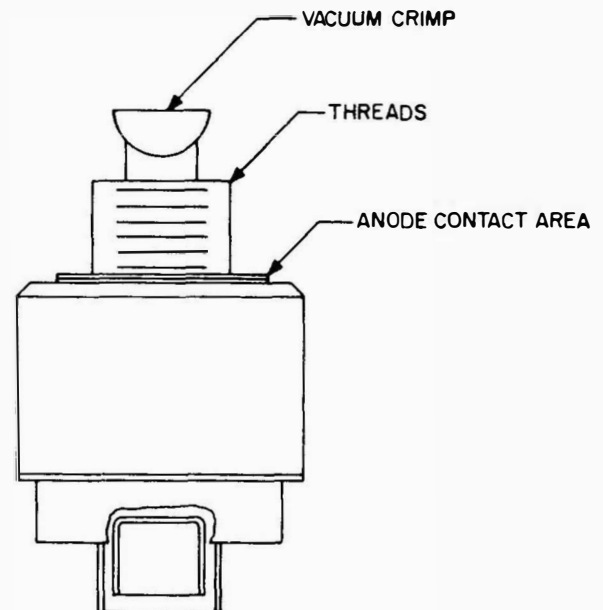
Figure 1. Outline Drawing.

When replacing tubes in the module, extreme care should be taken to ensure that no thermal compound is placed on the anode portion of the tube. Thermal compound should be applied to the vacuum crimp (see figure 1) and carefully applied to the threads. No excess compound should squeeze out of the threads onto the anode contact area when the tube is firmly seated in its socket.

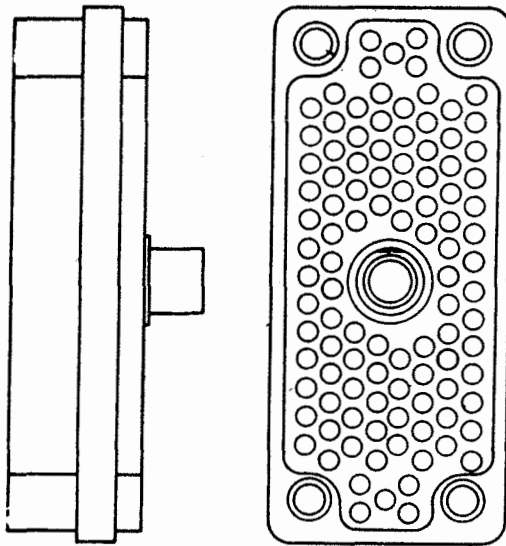
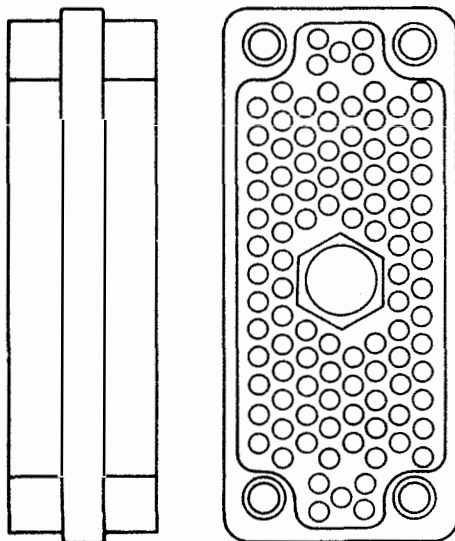
Figure 1. Burndy Connector Identification

Two types of connectors have been used in equipment of Data Display Group AN/SYA-1(V). The two types can be identified by the position of the mounting flange, as shown in figure 1, and the part number marking. The Burndy connector (HAC part number 712230-016) has an off-centered mounting flange; the Hughes connector (part number 712230-038) has a centered mounting flange. Should any damage occur to a Hughes connector or associated pins or sockets, replace with Burndy connector, pins, and sockets, as supplied by the Electronics Supply Office. Remove from the mating wires pins and sockets which mated in the Hughes connect and replace them with the 0.847-inch Burndy pins (stock number N5935-856-3130) and 0.690-inch Burndy sockets (stock number N5935-873-2637), respectively. Always replace a damaged Hughes connector with the Burndy connector (stock number N5935-829-7732).

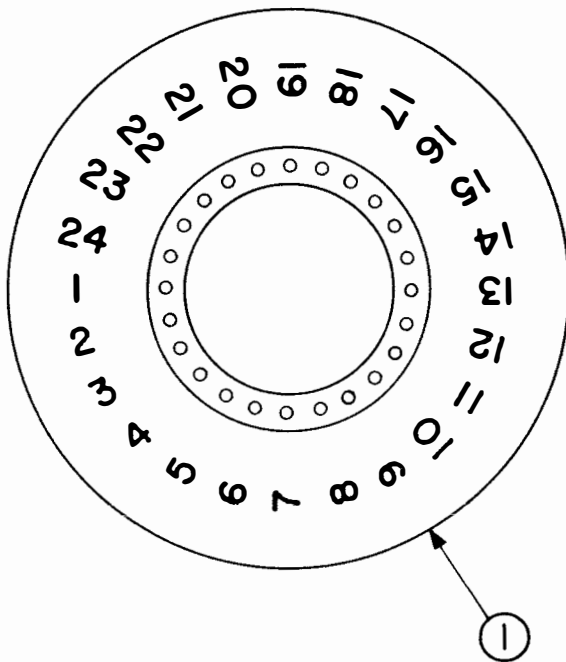
Figure 1. Skirt

It has been found that after the electro-luminescent panels have been dis-assembled and reassembled, the retainer clips (Fig. 3, Item 4) have been pushed too far up the shaft of the plungers, (Fig. 3, Item 5) thereby inhibiting the plunger assemblies from applying pressure to the bottom of the Skirt. When the Skirt is not held up against the knob assembly, the plunger assemblies should be examined for proper spring action. (685)

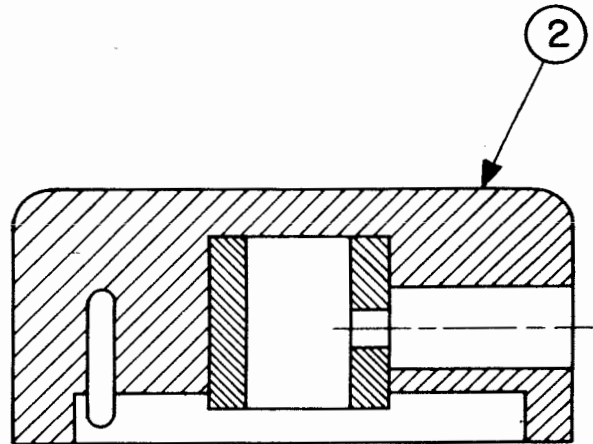
Figure 2. Knob Assembly

The spring loaded plunger, (Fig. 3, Item 5) presses against the underside of the numbered Skirt (Fig. 4, Item 1) holding it firmly against the knob assembly (Fig. 4, Item 2). The pin on the knob assembly engages the hole corresponding to the selected channel number. Any ten consecutive numbers may be chosen to correspond with the ten channels fed to the selector switch.

1. Determine channel numbers to be used (i.e., 8 through 17).
2. Rotate selector switch to furthest counter-clockwise position.
3. Depress numbered skirt until free of guide pin on knob and rotate until first number of group (in this case, #8) appears over lighted area. Release the Skirt, insuring the guide pin enters the corresponding hole.
4. Rotate switch through all ten channels to insure the desired numbers appear over lighted area.

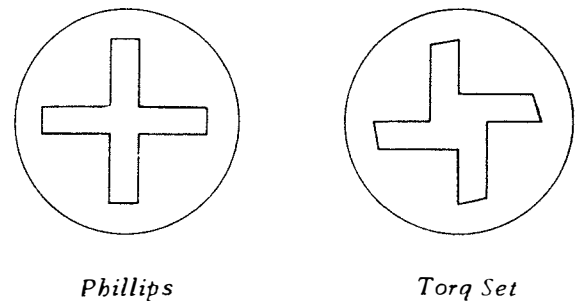
The AN/SYA-4(V) equipments use "Torq Set" (offset cruciform drive) machine screws where mechanical strength is required; for example, in hinges and structural assemblies. "Torq Set" machine screws are similar in appearance to the more familiar "Phillips" (cruciform drive) machine screws (see figure 1). Because a "Phillips" driver could easily damage a "Torq Set" screw head making it difficult, if not impossible, to remove later, even if the proper tool is used, maintenance personnel should be alert to the differences.

With the rapid turnover of maintenance personnel at shore facilities, not to mention the great volume of temporarily assigned personnel and trainees involved, activities having AN/SYA-4(V) equipments installed should frequently call these differences to the attention of all maintenance personnel and continual use of the proper type and size of tool should be ensured. (5S)

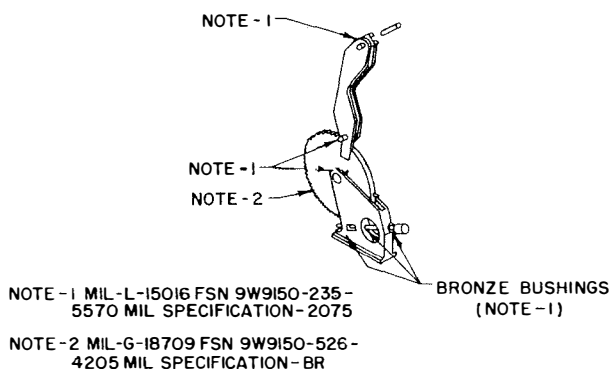
Figure 1. Crankout assembly (581443).

Excessive vibration occurs on some consoles while being cranked open or closed. This may cause the crank-out assembly to break, allowing the console to fall.

1. De-energize the console; observe all safety precautions.
2. Remove the display programmer drawer (A-27) and the data output data unit drawer (A-28) (refer to NAVSHIPS 94629 para. 4-4h.)
3. Crank the console open to approximately 45°.
4. Apply a few drops of oil (Note 1, figure 1) between the worm shaft and bronze bushing, while moving the console up and down the oil around the bushings.
5. Crank the console fully open to expose the sector gear. Apply a film of grease to the teeth as shown (Note 2, figure 1). Crank the console up and down a few times to work the grease in the worm.
6. Close the console, replace A-27 and A-28.
7. Energize the console and check for proper operation. (647)

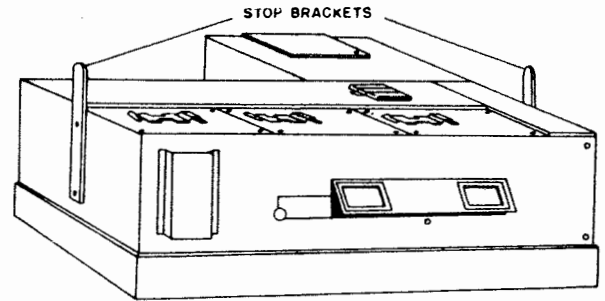
FIGURE 1.

The suggested brackets (see fig. 1) allow the equipment operator to pull out the 2nd sliding tray supporting the typing reperforator without danger of damaging the open (upright) tape gates. (Damage to the tape gates throws the five code pins out of adjustment, the adjustment of these pins being critical to the operation of the AN/TGC-1 equipment). The stop brackets prevent the sliding tray from being pulled out beyond a safe distance by inexperienced personnel.

The brackets are installed by drilling two holes in each bracket, removing the two screws holding the side panels of the multiple transmitter distributor and using these screws to attach the brackets.

The suggestor points out that a bracket of other dimensions—longer or wider—of any strong metal would be suitable for protection to the equipment. This suggestion may be used at all activities where the AN/TGC-1 is in use to prevent similar damage to the equipment.

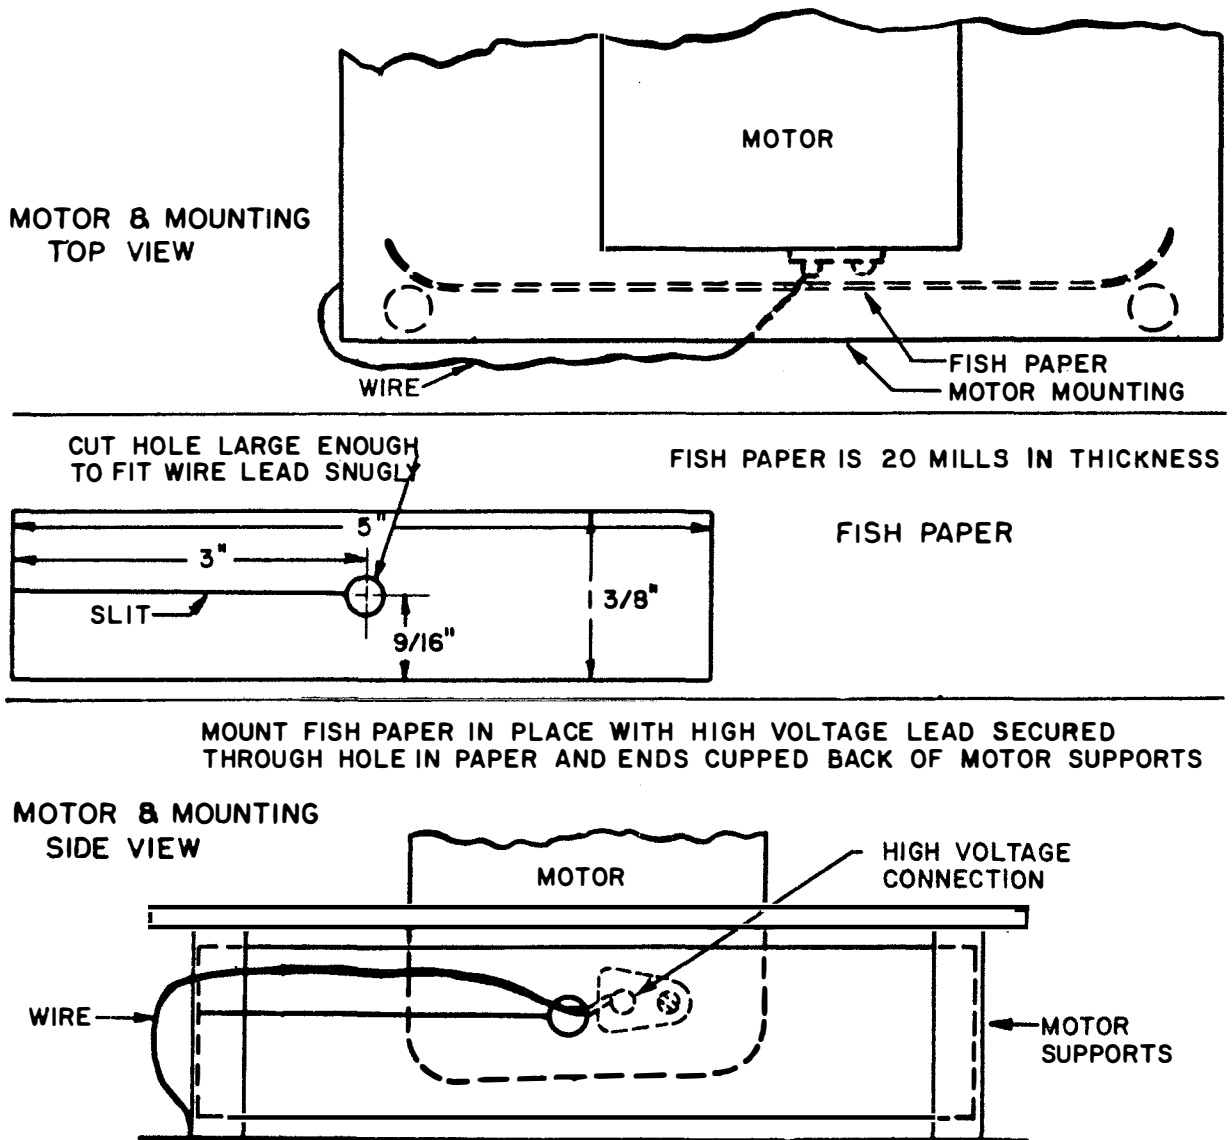
Figure 1

The following points out the danger of accidental shock from the exposed lug on the synchronous motor of the AN/TXC-1() and the TT-41()/TXC-1() facsimile transceivers when the housing for the motor and clutch assembly is removed. During normal servicing, power should not be applied to the transceiver with the cover removed. If emergency repairs modify

this safety practice, Mr. Berube suggests that insulating material be threaded over the wire lead and cupped behind the supports of the synchronous motor. The details of fabrication and installation are given in figures 1 and 2.
