**MK 3 Ships Inertial Navigation — Maintenance
Hint**

NAVSEA 0967-LP-000-0010

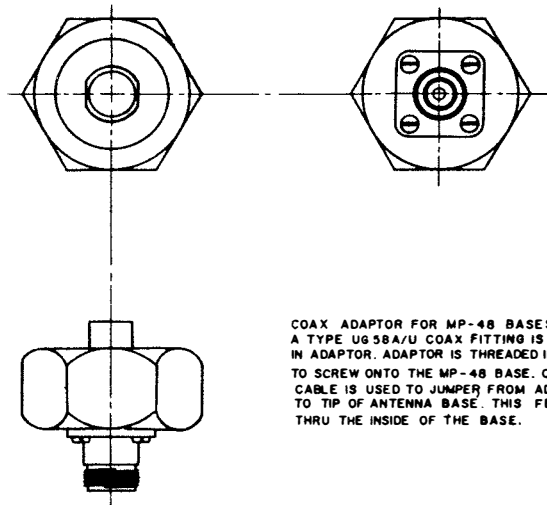
Figure 1

By adding a coax adapter to the bottom of the antenna base, a coax jumper is made up at the base of the antenna and is fed through to the bottom of the antenna and a tip is soldered to the end of the coax cable. See Figure 1.

COAX ADAPTOR FOR MP-48 BASES
A TYPE UG 58A/U COAX FITTING IS USED
IN ADAPTOR. ADAPTOR IS THREADED INSIDE
TO SCREW ONTO THE MP-48 BASE. COAX
CABLE IS USED TO JUMPER FROM ADAPTOR
TO TIP OF ANTENNA BASE. THIS FEEDS
THRU THE INSIDE OF THE BASE.

All cable shall be solidly fastened to the base of the antenna, so that it will not float free.

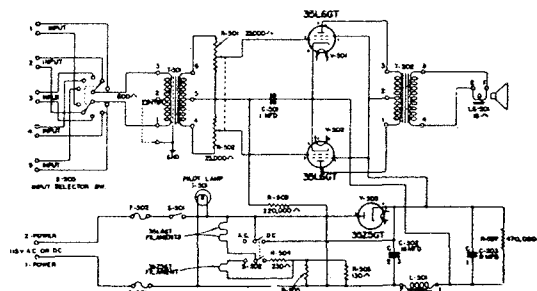
FIGURE 1.--Speaker-amplifier CMX-49131C

FIGURE 1. --The center-tap lead on the primary of input transformer should be removed

Occasionally feedback is present between the 49131 series speaker-amplifier unit and a microphone or handset connected to the same circuit or a radiophone unit. The press-to-talk switch in the microphone or handset operates a relay in the associated 23211 or 23423 radiophone unit. The relay is intended to cut out the speaker, but actually only breaks one side of the line, leaving the speaker not entirely inoperative due to a sneak circuit through ground. The center-tap of the speaker-amplifier input winding is grounded. Therefore, when the receiver connected to the particular radiophone unit has a grounded output, the circuit will be completed through ground and one-half of the input winding. The condition can be eliminated by disconnecting the center-tap lead on the input transformer from ground, as indicated in Figure 1.

To eliminate the possibility of the above condition, it is recommended that all types 49131 units installed on single communication circuits be modified according to Figure 1. Jumpers are installed across the input terminals as indicated, permitting the speaker to operate regardless of the position of the switch.

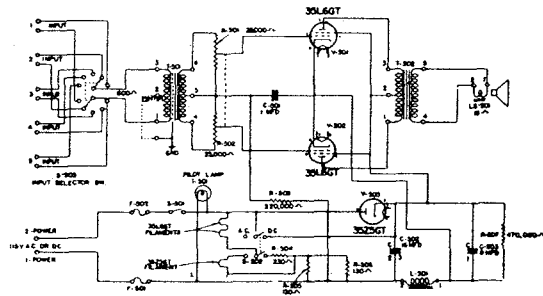
FIGURE 1.--Speaker-amplifier CMX-49131C

POTENTIOMETER FAILURES

Excessive failures of potentiometers R-501 and R-502, have been reported from the field. Investigation discloses that the failures in the large majority of cases are broken stops. This allows the sliding contact to travel farther than it should, causing damages to the winding and also to the coupling link between the sections.

Personnel are cautioned to use these potentiometers with greater care in order that such failures be reduced to a minimum. Every effort should be exerted to inform all hands who have access to the speaker-amplifier that such caution must be practiced. It is suggested that a tag or label be attached to the unit to warn against rough usage.

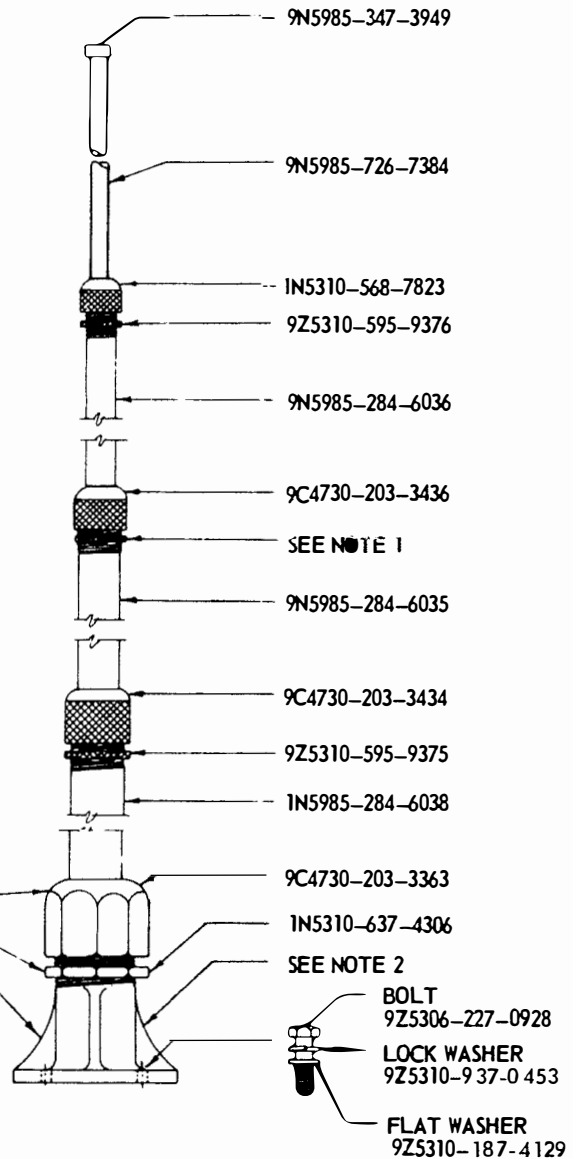
Figure 1. Parts Identification, 28 Ft. Whip Antenna, Navy Type C-66046.

Many discrepancies, found during inspections of 28 foot and 35 foot whip antennas, could be corrected by replacing components of the antenna. In most cases, ships and stations have had to replace the entire antenna due to the extreme difficulty in obtaining component federal stock numbers.
