BUSHIPS

ELECTRON

A
MONTHLY
MAGAZINE
FOR
ELECTRONICS
TECHNICIANS

<i>Capt. Becker Leaves the Bureau of Ships</i>	1
<i>Radio Receiving Set AN/URR-13</i>	2
<i>Fire Control Radar Antenna Alignment</i>	4
<i>Administrative Guide for Electronics Officers</i>	6
<i>Model SX Local Oscillator Tuning Rods</i>	15
<i>Control Tower Modernization at NAS, Patuxent River, Md.</i>	16
<i>Revision of Broadcast Services of Stations WWV and WWVH</i>	21
<i>Marine Corps Notes</i>	21
<i>Model SU Maintenance and Operation</i>	22
<i>False Echos on Model AN/SPS-6 Series Radars</i>	23
<i>Revised Electronic Failure Report NavShips 383</i>	24
<i>Leak Detector for Model QHB/QHBa Transducers</i> ...	26
<i>Model QDA Slewing Switches</i>	27
<i>E.S.O. Monthly Column</i>	28
<i>The Field Engineer Sez</i>	29
<i>Electronics Field Change Index</i>	30

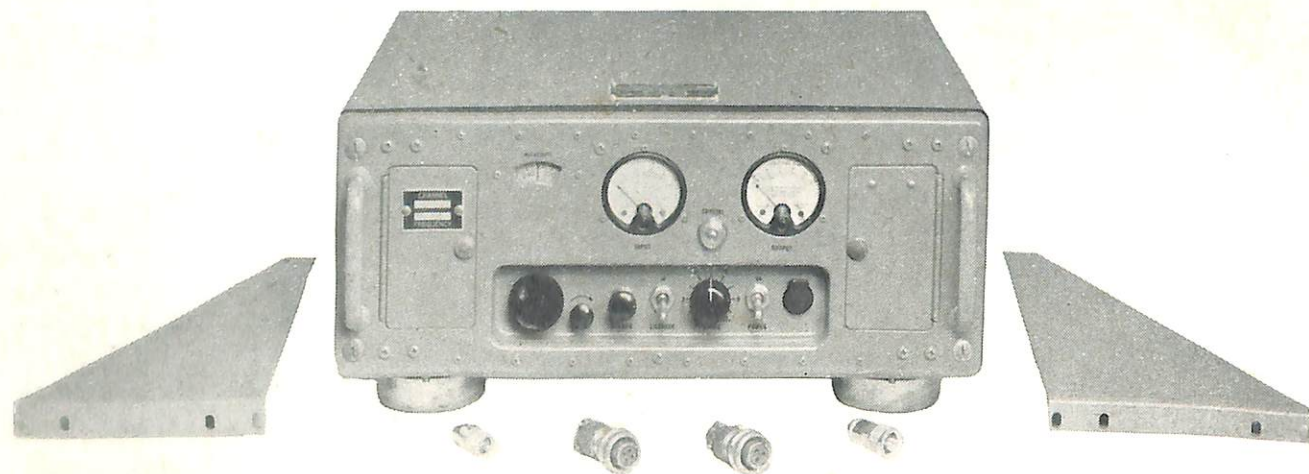
COMPLETE EQUIPMENT including mounting brackets and four connectors (P401-P404).

The circuit parts are grouped on a functional basis into four major sections, namely: the preselector, i-f/a-f, power supply and cable filter sections. The first three sections are assembled on the panel mounted chassis frame. The cable filter section is mounted against the rear of the cabinet. Each section is removable for maintenance and/or replacement purposes.
